(copy) Fuel Tank
LE FUELING - 18 Hrs.

U.S. DEPARTMENT OF TRANSPORTATION FEDERAL AVIATION ADMINISTRATION	Form Approved Budget Bureau No. 04-R060.1
MAJOR REPAIR AND ALTERATION (Airframe, Powerplant, Propeller, or Appliance)	FOR FAA USE ONLY
	OFFICE IDENTIFICATION NM-FSFO-65

1. AIRCRAFT	MAKE Piper	MODEL PA17
	SERIAL NO. 17-4	NATIONALITY AND REGISTRATION MARK N4590H
2. OWNER	NAME (As shown on registration certificate) Donald R. Wilson	ADDRESS (As shown on registration certificate) PO Box 336 Circle, Montana 59215

8. DESCRIPTION OF WORK ACCOMPLISHED (If more space is required, attach additional sheets. Identify with aircraft nationality and registration mark and date work completed.)

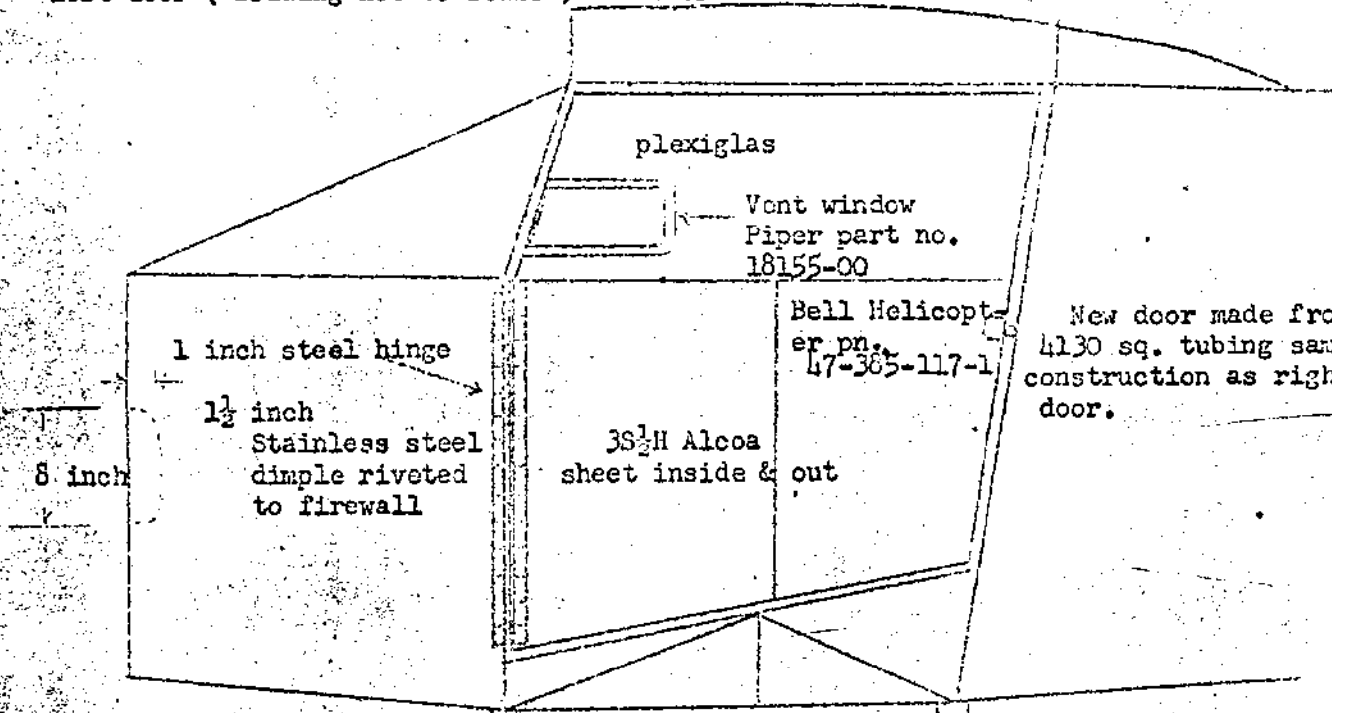
Piper PA-17 N4691H Ser. 17-89 (Drawing # 1)

Door installed in left side of fuselage in the identical manner as the existing door in the right side. The window channel was removed, but the steel tubing geometry was identical and required no alteration.
