DEPARTMENT OF TRANSPORTATION

FEDERAL AVIATION ADMINISTRATION FOR FAA USE ONLY MAJOR REPAIR AND ALTERATION OFFICE IDENTIFICATION (Airframe, Powerplant, Propeller, or Appliance) INSTRUCTIONS: Print or type all entries. See FAR 43.9, FAR 43 Appendix B, and AC 43.9-1 (or subsequent revision thereof) for instructions and disposition of this form. MAKE MODEN Piper PA-20 1. AIRCRAFT SERIAL NO. NATIONALITY AND REGISTRATION MARK 20 - 34N6937K NAME (As shown on registration certificate) ADDRESS (As shown on registration certificate)
7447 E. 126 st. N. 2. OWNER Hudec, John V. & Belinda J. Collinsville, Ck 74021 3. FOR FAA USE ONLY The data identified berein complies with the approach airworthiness requirements and is approved only for the above described aircraft subject to conformity inspection by a person authorized in FAR 43, section 43.7. FAA INSPECTOR-SW-FSDO, OKC 4. UNIT IDENTIFICATION S. TYPE UNIT MAKE MODEL SERIAL NO. ALTER-HOITA AIRFRAME Χ POWERPLANT PROPELLER APPLIANCE MANUFACTURER 6. CONFORMITY STATEMENT A. AGENCY'S NAME AND ADDRESS B. KIND OF AGENCY C. CERTIFICATE NO. John V. Hudec U.S. CERTIFICATED MECHANIC 7447 E. 126 st. N. FOREIGN CERTIFICATED MECHANIC A&P 292428383 CERTIFICA

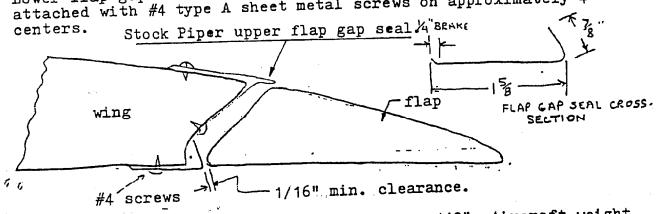
Top seal cross section

Bottom seal cross section

2. Lower flap gap seals constructed of .016" 2024-T3 aluminum and attached with #4 type A sheet metal screws on approximately 4"
