MAJOR REPAIR AND ALTERATION (Airframe, Powerplant, Propeller, or Appliance)

1. Aircraft	Make PIPER	Model PA-22/20-150
	Serial No. 22-7265	Nationality and Registration Mark N3328Z
2. Owner	Name (As shown on registration certificate) Hawley, Luther S.	Address (As shown on registration certificate) 7300 N. San Anna Dr. Tucson, AZ 85704

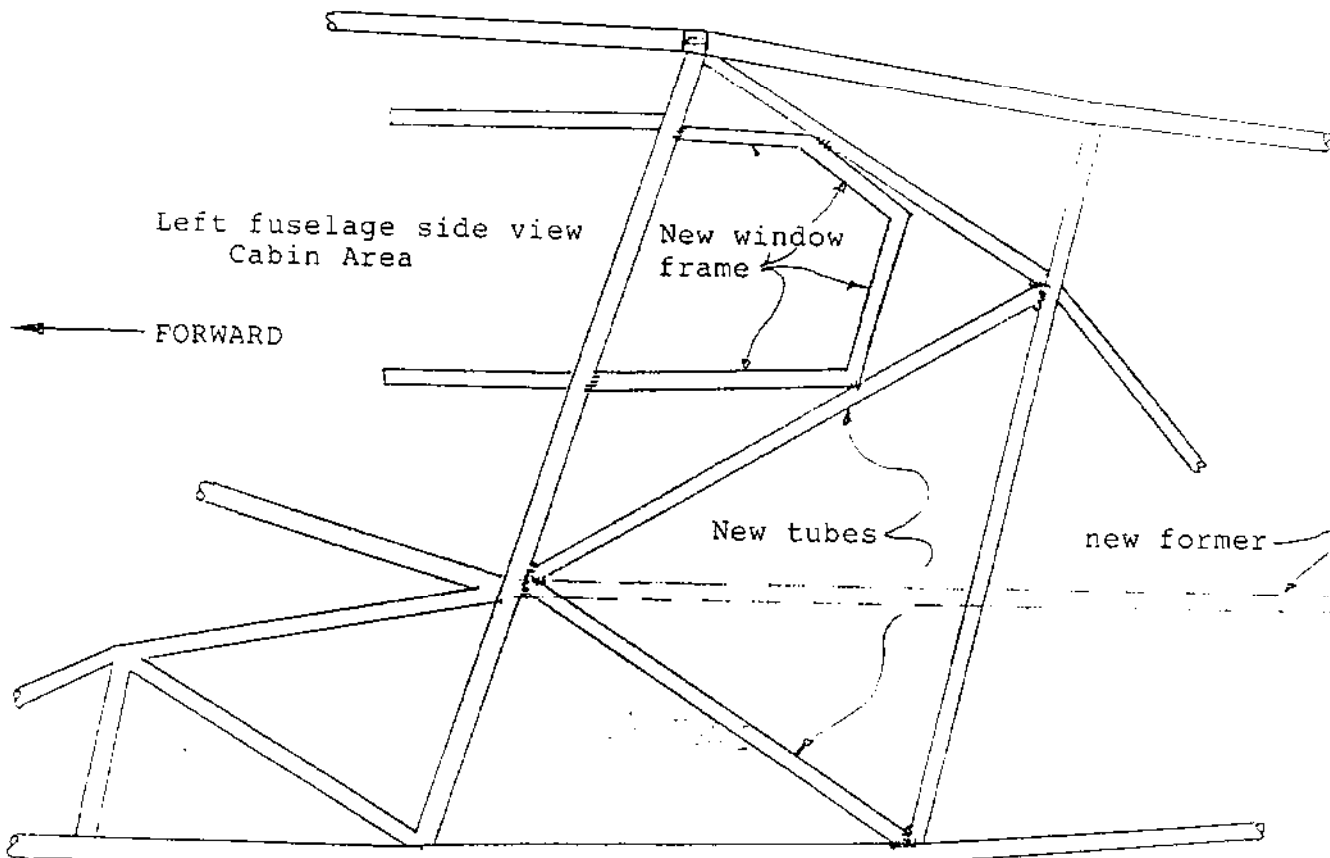
1. Removed and discarded passenger door from left side of fuselage.
2. Welded in two pieces of .035X3/4" 4130 tube exactly as Piper did on the PA-22-108 COLT series of aircraft. (see sketch)
3. Fabricated and welded into fuselage a window frame exactly like the one on the right side of the aircraft. Extended lower left former over door area.
4. All materials and welding was done in accordance with the directions and principles prescribed in AC43.13-1A, Section 2.
