Curved Rear Windows

MAJOR REPAIR AND ALTERATION (Airframe, Powerplant, Propeller, or Appliance)	Form Approved OMB No. 2120-0020
	For FAA Use Only
	Office Identification WP 07

1. Aircraft	Make PIPER	Model PA-22/20-150
	Serial No. 22-7265	Nationality and Registration Mark N3328Z
2. Owner	Name (As shown on registration certificate) Hawley, Luther S.	Address (As shown on registration certificate) 1285 W Paintbrush Pl. Tucson, AZ 85704

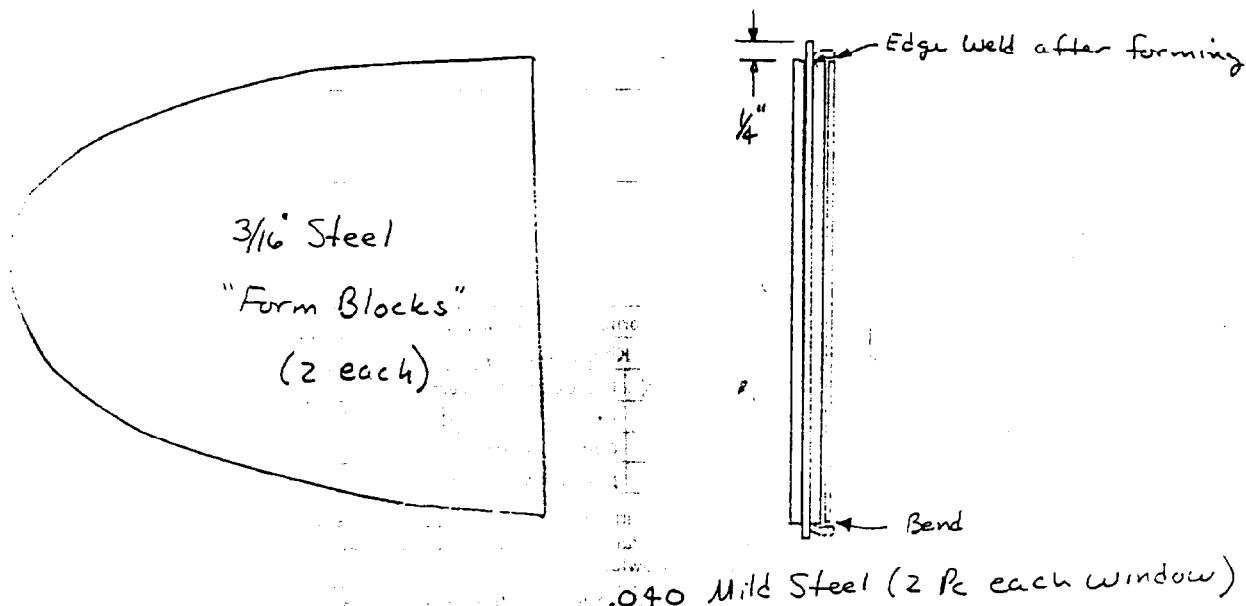
Sketch below indicates method used to fabricate window frames.

A piece of .040 mild steel was cut $\frac{1}{4}$ " larger than the outside finished dimension of the frame. It was then firmly clamped between the two steel form blocks and the $\frac{1}{4}$ " edge formed over one of the blocks. The second side was cut to the actual size, clamped to the block assembly and edge welded to the $\frac{1}{4}$ " lip. The centers of the frames were then removed by bandsaw and sanded smooth. The results were perfect.
