MAJOR REPAIR AND ALTERATION (Airframe, Powerplant, Propeller, or Appliance)

1. Aircraft	Make PIPER	Model PA-22
	Serial No. 22-1605	Nationality and Registration Mark USA N3330A
2. Owner	Name (As shown on registration certificate) JORDON, Don T.	Address (As shown on registration certificate) 7050 Shiloh Road Midlothian, Tx. 76065

INSTRUCTIONS FOR INSTALLING SHOULDER HARNESS USING AERO FABRICATORS INC. KIT #H-700-114

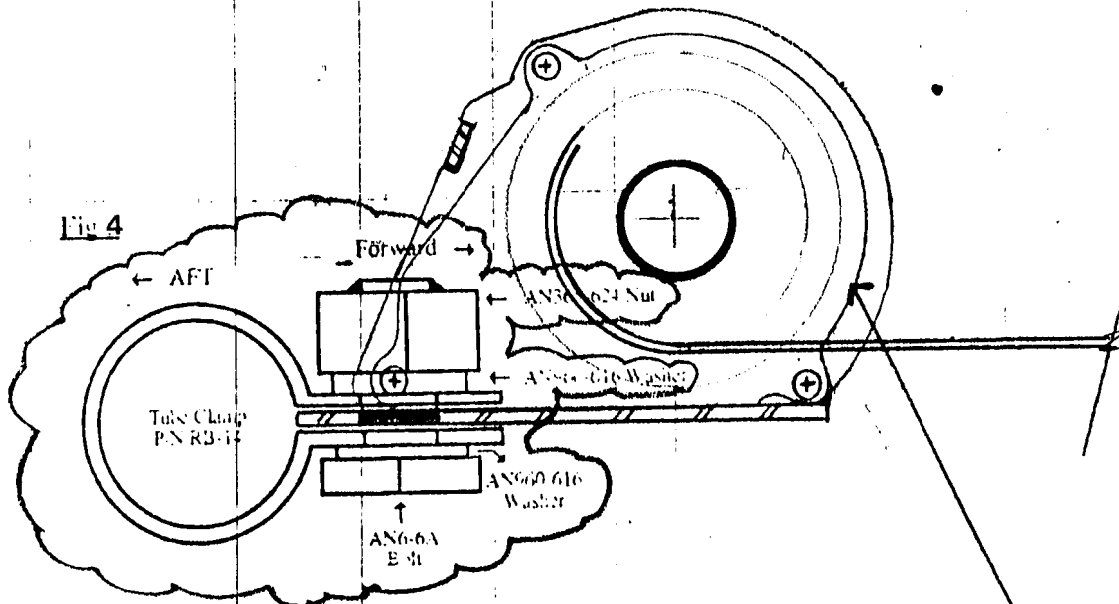
Fig 4

EXISTING CONNECTION POINTS, PREVIOUSLY APPROVED & INSTALLED UNDER STC# SA 1493GL, AERO FABRICATORS INC.

REMOVED AERO FABRICATORS INC. P/N RB-9 TRIANGULAR FITTING AND REPLACED WITH AM-SAFE P/N 501580-401 REEL

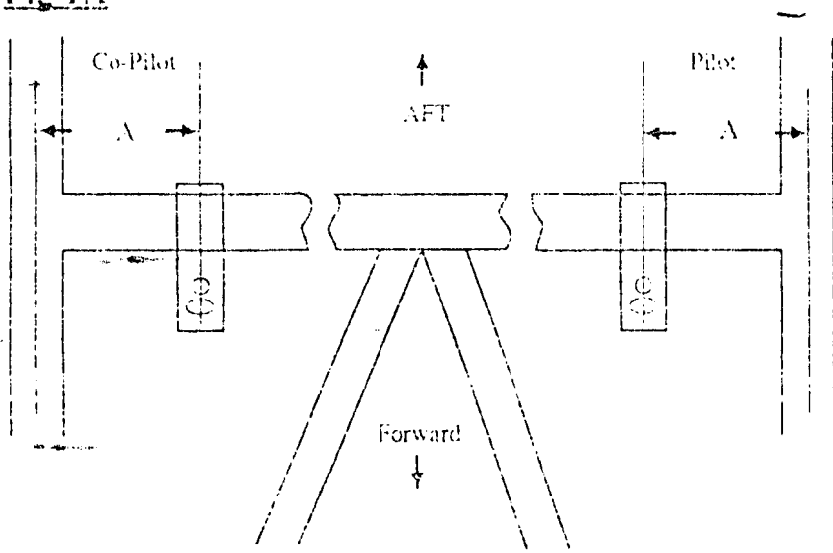
Fig 1A

1. Gain access to the upper cabin area through opening in headliner.
2. Locate cross tube as shown in Fig #1 and 1A.
3. Locate pilot installation point. Dimension A, from the centerline of upper left longeron tube as shown in Fig 1A. (If installing co-pilot use same procedure using upper right longeron as shown in Fig 1A.)

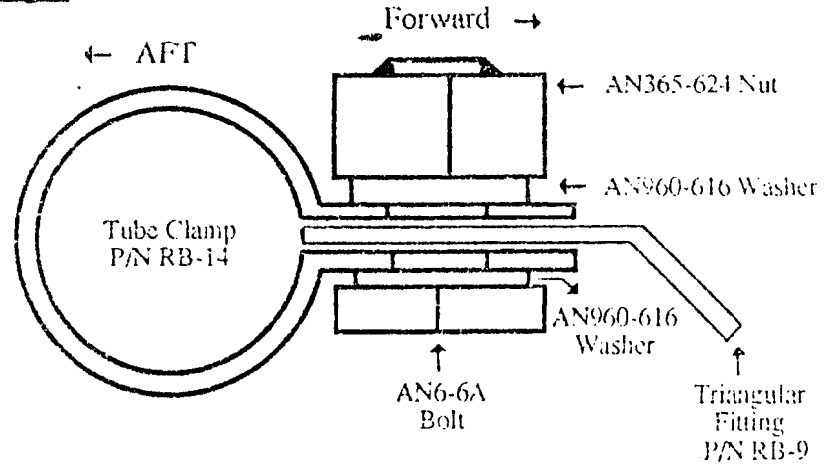
Fig 2

4. Install tube clamp, P/N RB-14, and triangular fitting, RB-9, using AN hardware supplied with kit as shown in Fig 2. (Triangular fitting will be pointing forward and down.)

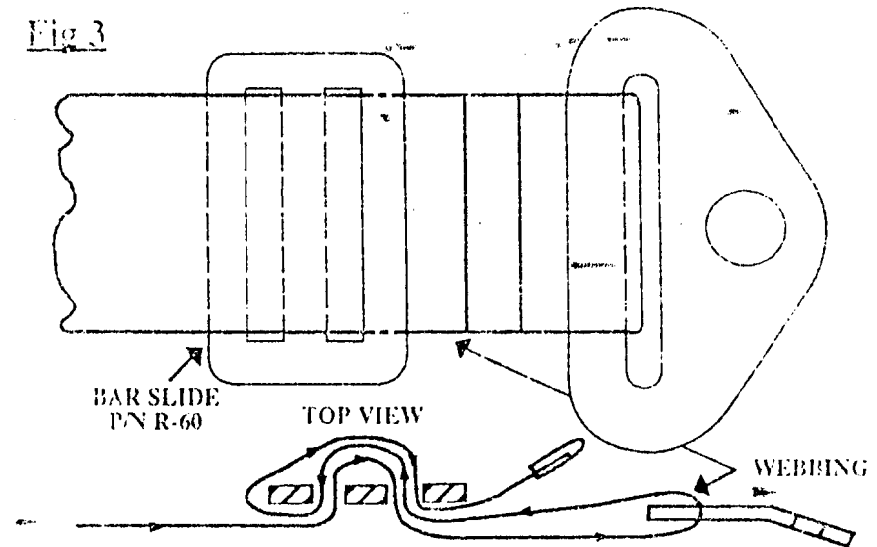
Fig 3

7. Install Aero Fabricator shoulder harness P/N H-702 using 3-bar slide as shown in Fig 3.
8. Install Aero Fabricator seatbelt assembly per instructions included with the safety belt.
