78-10-03 PIPER: Amendment 39-3212. Applies to all J-3, J-4, J-5, PA-11, PA-12, PA-14, PA-16, PA-18, PA-20 and PA-22 type aircraft.

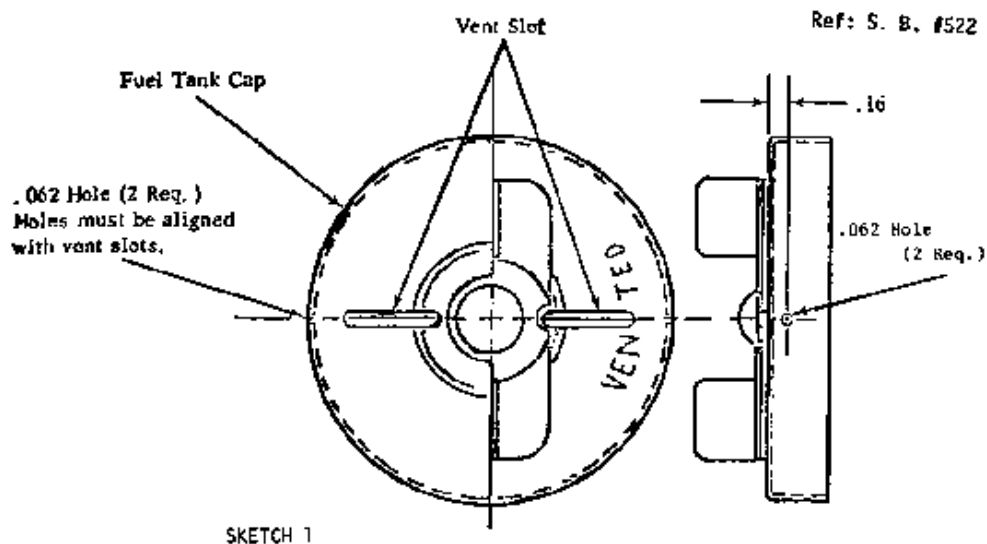
VIEW OF FUEL TANK CAP - P/N 15296-02

In order to prevent inadequate fuel venting, accomplish the following:

(a) Modify fuel caps and inspect fuel tank inlet rubber seal in accordance with Piper Service Bulletin No. 522 dated September 28, 1976, (former AD 77-09-09 Sketch 1) or approved equivalent. AD 78-10-03
