**90-04-06 R1 TEXTRON LYCOMING:** Amendment 39-6427 as revised by Amendment 39-6915. Docket No. 89-ANE-21.

Applicability: All Textron Lycoming four cylinder piston engines equipped with a rear mounted propeller governor and external oil line, manufactured prior to January 1, 1990.

To prevent oil line fracture and loss of engine oil, accomplish the following:

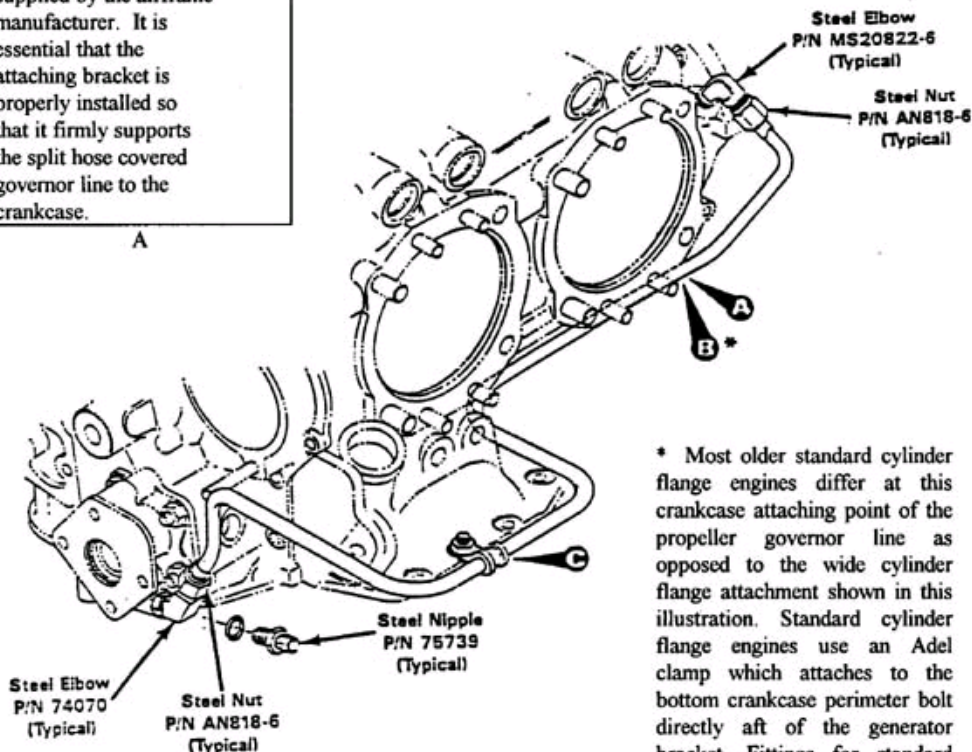
Figure 1. Propeller Governor Line Support PART 1

(1) Inspect the propeller governor external oil line for abrasions, cracks, and oil leaks along the length of the line and at the end attachment fittings. Inspect to determine that the two cushion type support clamps or clips are properly installed as shown in Figure 1 of Appendix 1 to this AD, and assure that sufficient clearances exist between the oil line and adjacent components.

\* Most older standard cylinder flange engines differ at this crankcase attaching point of the propeller governor line as opposed to the wide cylinder flange attachment shown in this illustration. Standard cylinder flange engines use an Adel clamp which attaches to the bottom crankcase perimeter bolt directly aft of the generator bracket. Fittings for standard cylinder flange line may be -5 (5/16") instead of -6 (3/8"). Also, some earlier model propeller governor drives used 1/4" NPT fittings in the prop. governor adapter. If any of these fittings are found, replace with equivalent AN or MS steel fittings.

(2) If any leaks, chafing, or interference condition exists or if the two support clamps or clips are not properly installed, replace the governor oil line and its attachment end fittings with new parts even though the parts show no visible damage. Refer to Figure 1 in Appendix 1 to this AD, for parts identification, line routing, and location of support clamps or clips. The fittings in the engine case and governor must be replaced if they are damaged or are made of aluminum.

(b) At the next engine overhaul or anytime the governor oil line is removed for any reason, whichever occurs first, but no later than May 1, 1992, remove any governor oil line assembly having integral aluminum connecting nuts and reinstall an oil line assembly with corresponding steel connecting nuts. Replace any engine case/governor aluminum fittings with corresponding steel fittings as shown in Figure 1 of Appendix 1 to this AD.

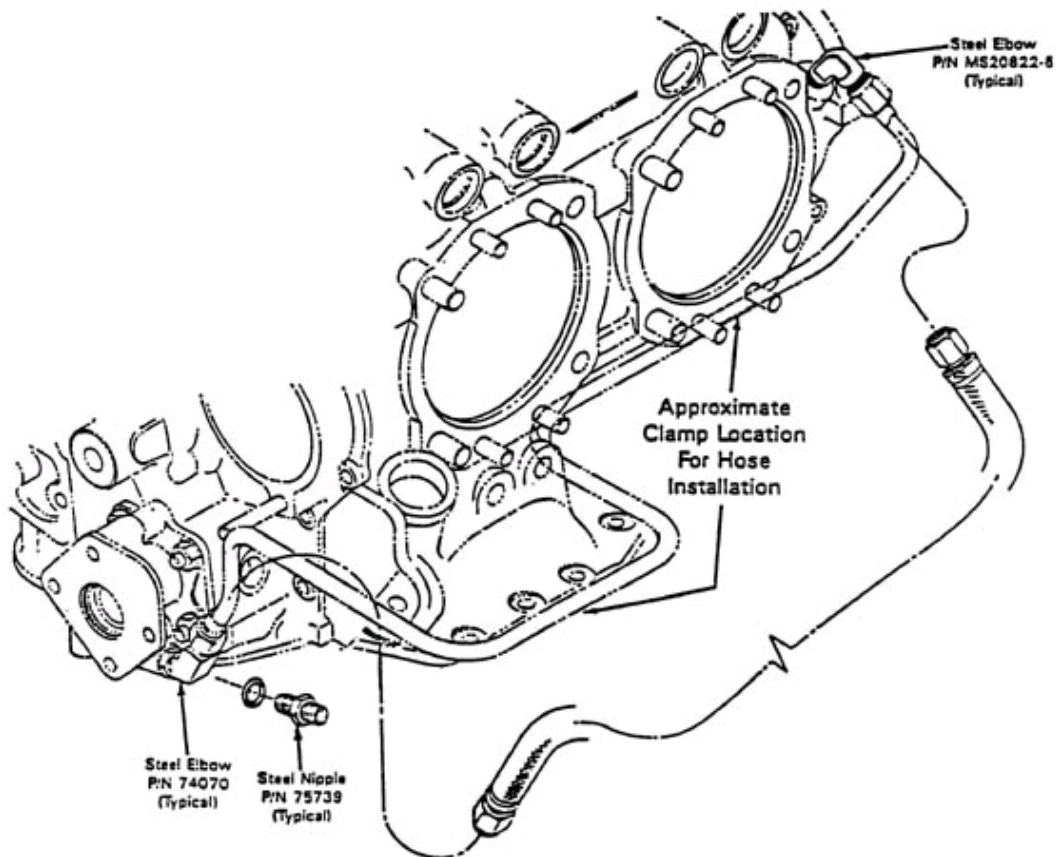
**Figure 1. Routing, Fittings and Clamping Detail**

If -5 (5/16") fittings have been installed on some standard cylinder flange crankcase model engines, the propeller governor drive fitting and front crankcase fitting must be changed to the appropriate steel fitting to accommodate the new -6 (3/8") line. When re-installing new stainless steel tube assembly, appropriate -5 steel fittings must be re-installed.

IT IS MANDATORY THAT THIS FLEXIBLE HOSE BE REPLACED AT EACH OVERHAUL.

- a. Determine proper hose length as required for your particular installation.
- b. No sharp bends are permissible. Ascertain that no "kinks" exist while routing and

clamping hose.

c. Hose must not be routed near a heat source, such as any portion of the exhaust system.

d. Hose is to be clamp supported to the engine (not to an airframe component) at a minimum of two locations.

e. No clamping to cylinder head drain back tubes is allowed.

f. After installation is complete, ensure that hose is not pinched. Make certain that engine motion during startup and shutdown does not pull or pinch the hose.
