SERVICE BULLETIN

Service Bulletin 176

Replacement of Accessory Drive Adapter Gasket

All O-320 Engines With Fixed Pitch Propellers

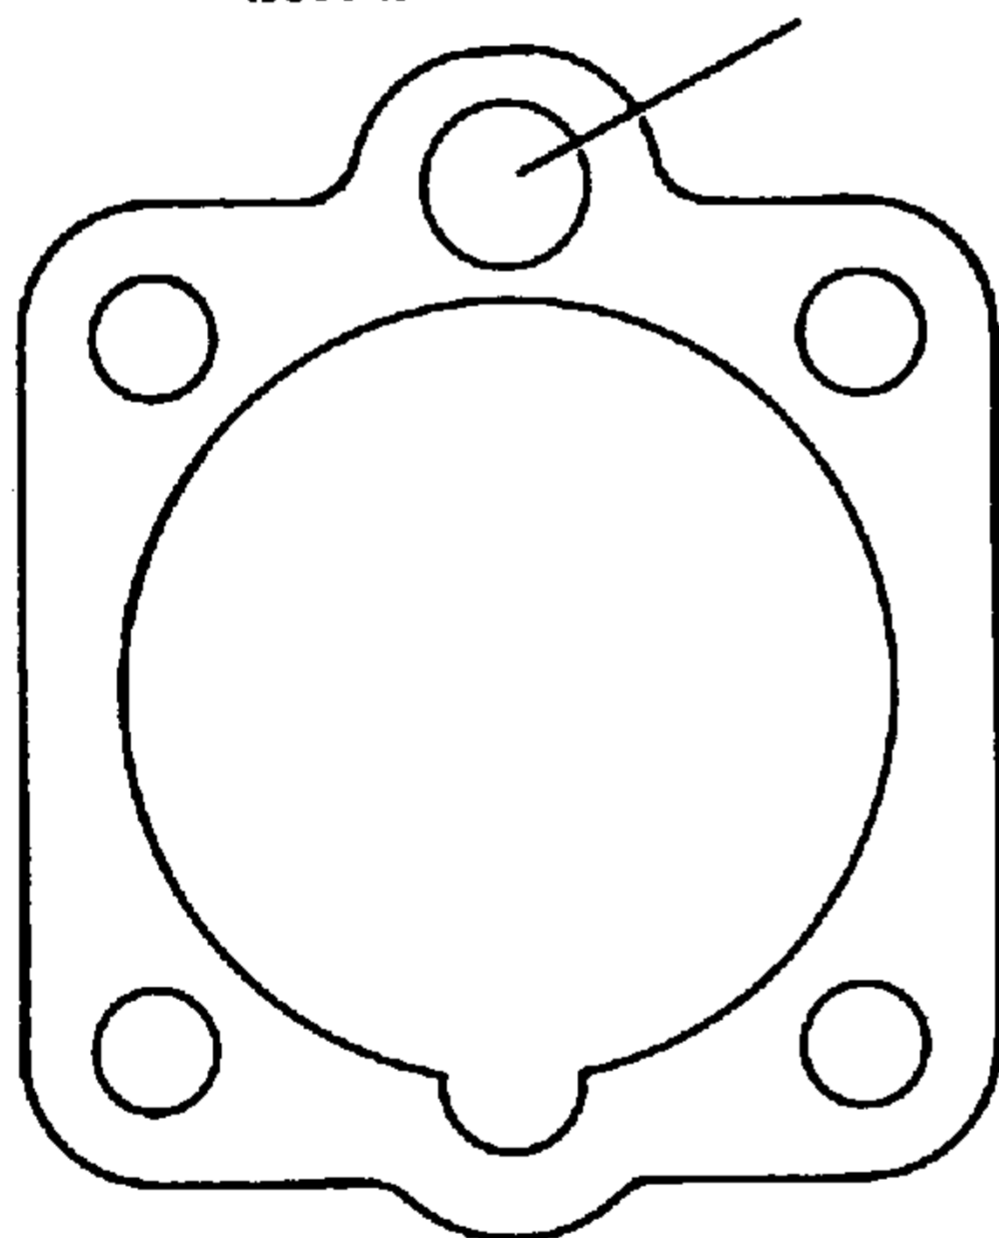
This gasket has a hole at this location

Fig. 1. No. 68315 Propeller Governor Drive Gasket
This gasket must be replaced with No. 69551
If the engine is operated without a propeller
governor drive.

On all LYCOMING O-320 engines being operated without a propeller governor drive, the existing accessory drive adapter gasket, Part No. 68315, (Fig. 1), must be replaced with a modified gasket, Part No. 69551, (Fig. 2). As shown on the accompanying sketches below, the replacement gasket has no oil supply line hole, thus eliminating any possibility of gasket failure at this point. Under no circumstances may the 68315 gasket be used when the engine is not equipped with a propeller governor drive.

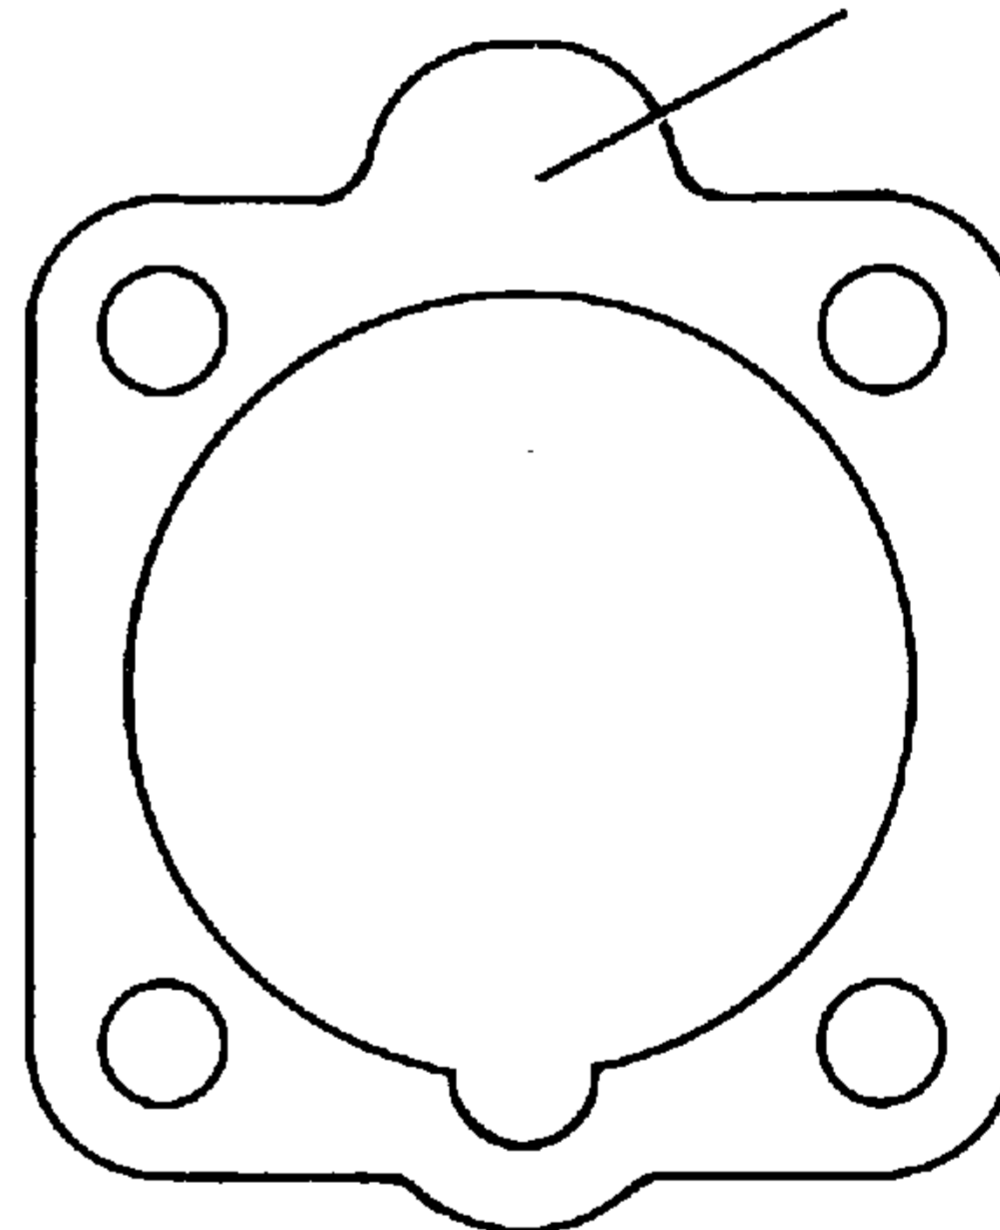
This gasket does not have a hole at this location

Fig. 2. No. 69551 Propeller Governor Drive Gasket
This gasket must be used on engines operated
without a propeller governor drive.

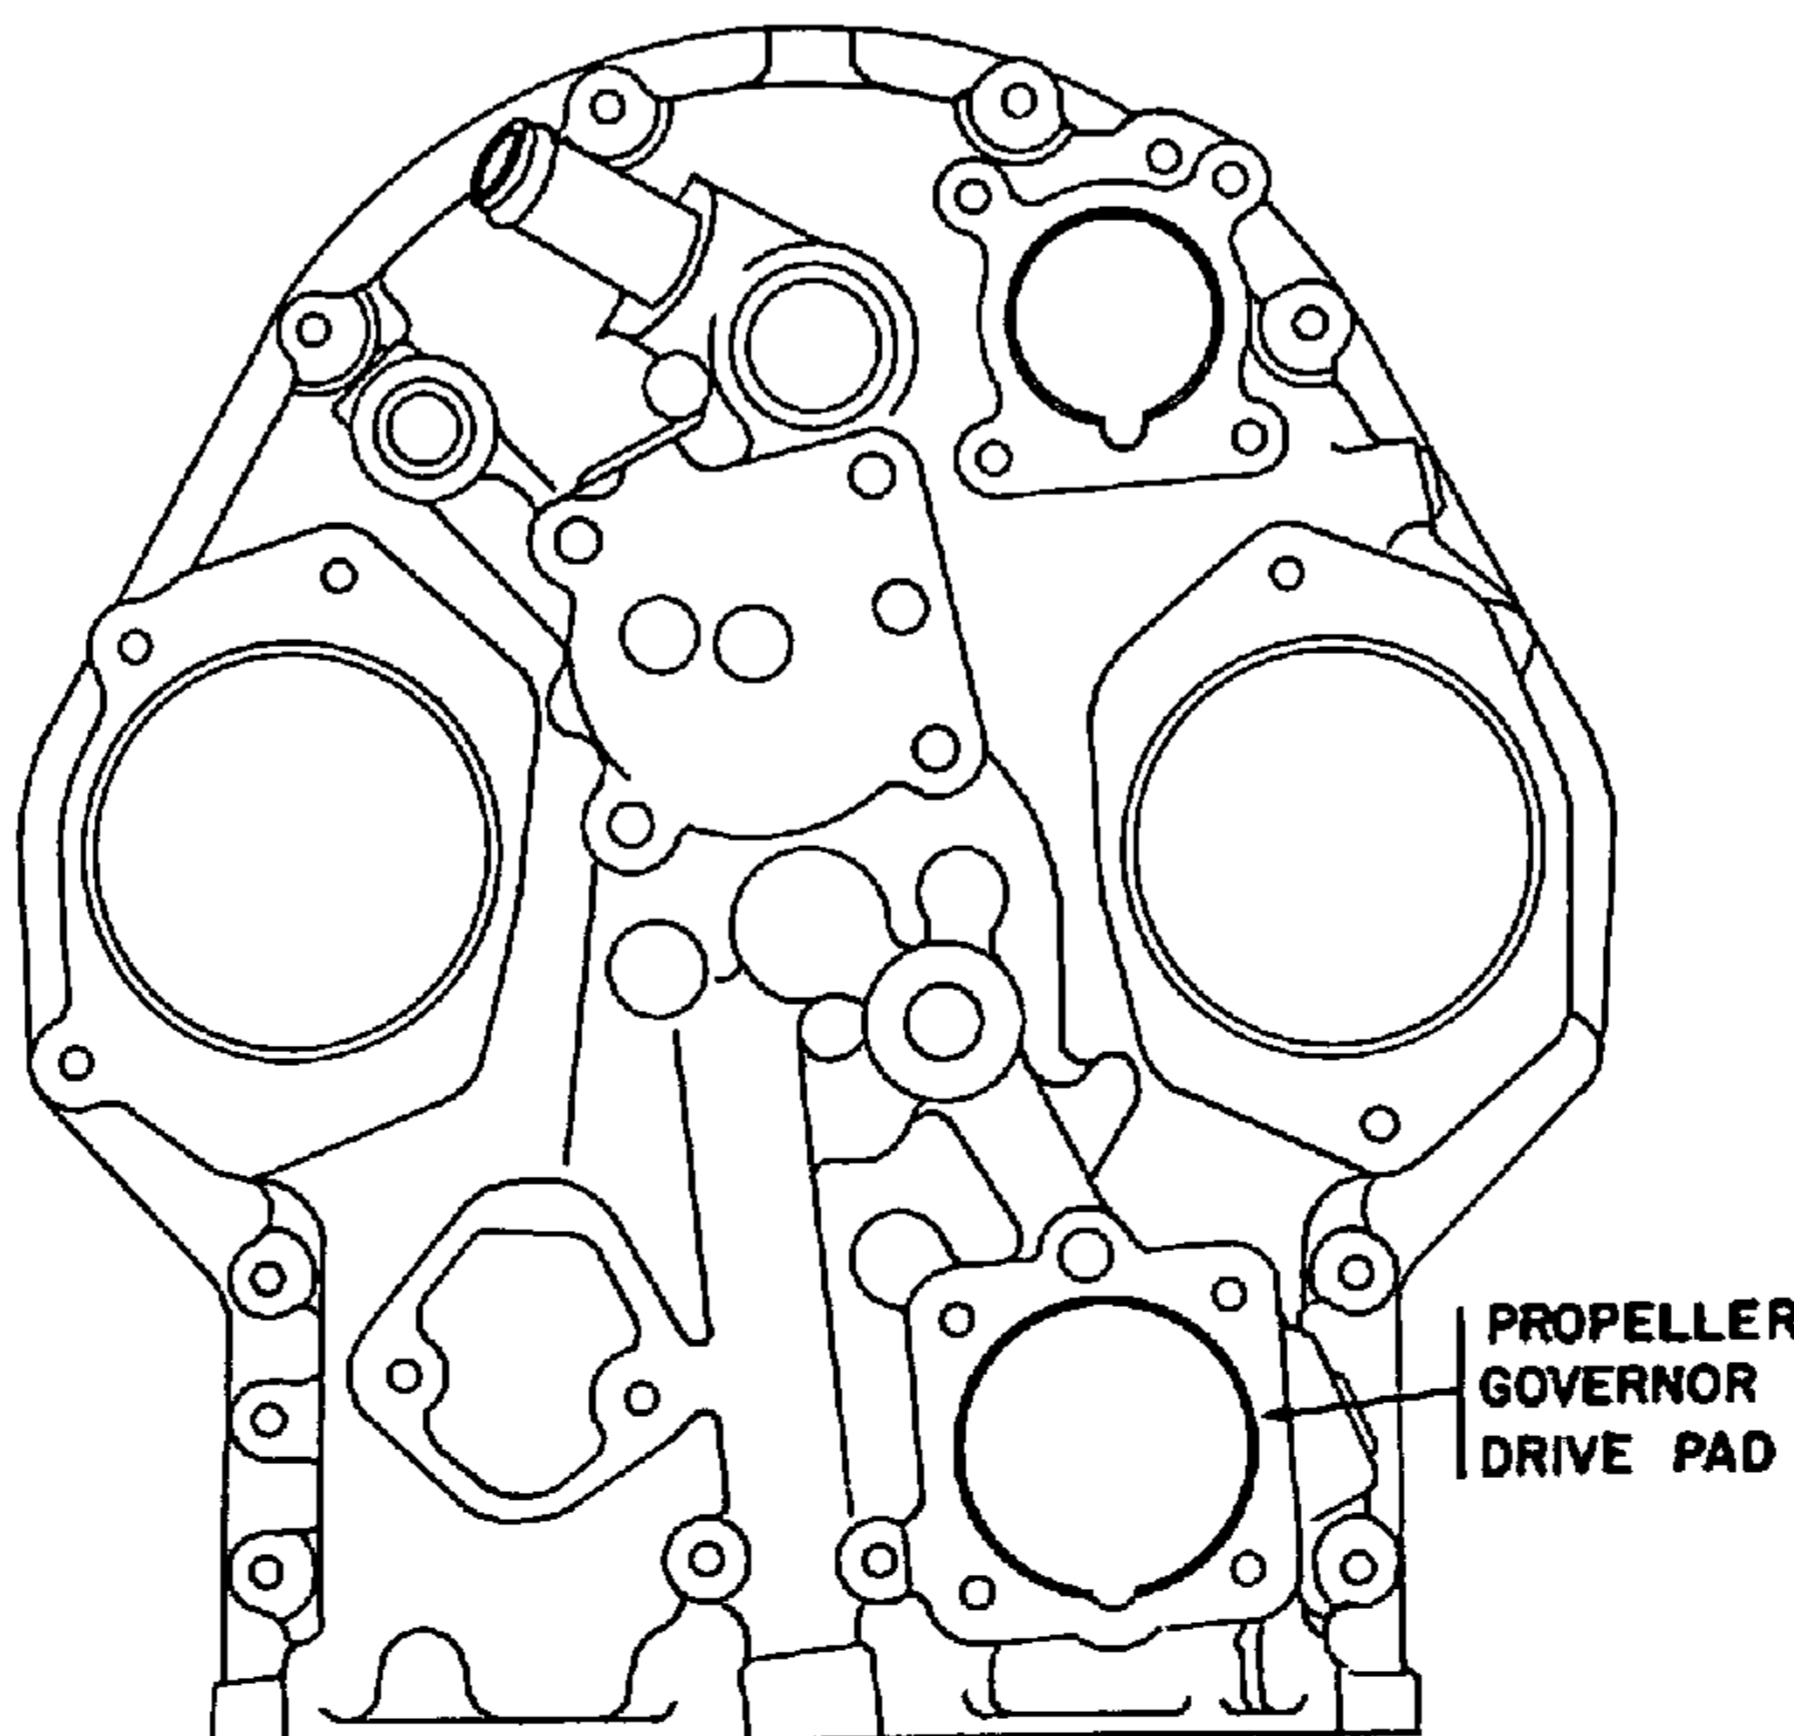
Fig. 3. Rear view of accessory drive housing showing
location of propeller governor drive pad.
