MANDATORY SERVICE BULLETIN

Service Bulletin No. 253A
(Cancels Service Bulletin No. 219 and
Supersedes Service Bulletin No. 253)
Approved by FAA

SUBJECT: Replacement of Propeller Flange Bushings

MODELS AFFECTED: Part I: Lycoming Model O-340-A Series Aircraft Engines Equipped with Hartzell Controllable Pitch Propellers
Part II: Lycoming Model O-320 Series Aircraft Engines Equipped with Hartzell Controllable Pitch Propellers

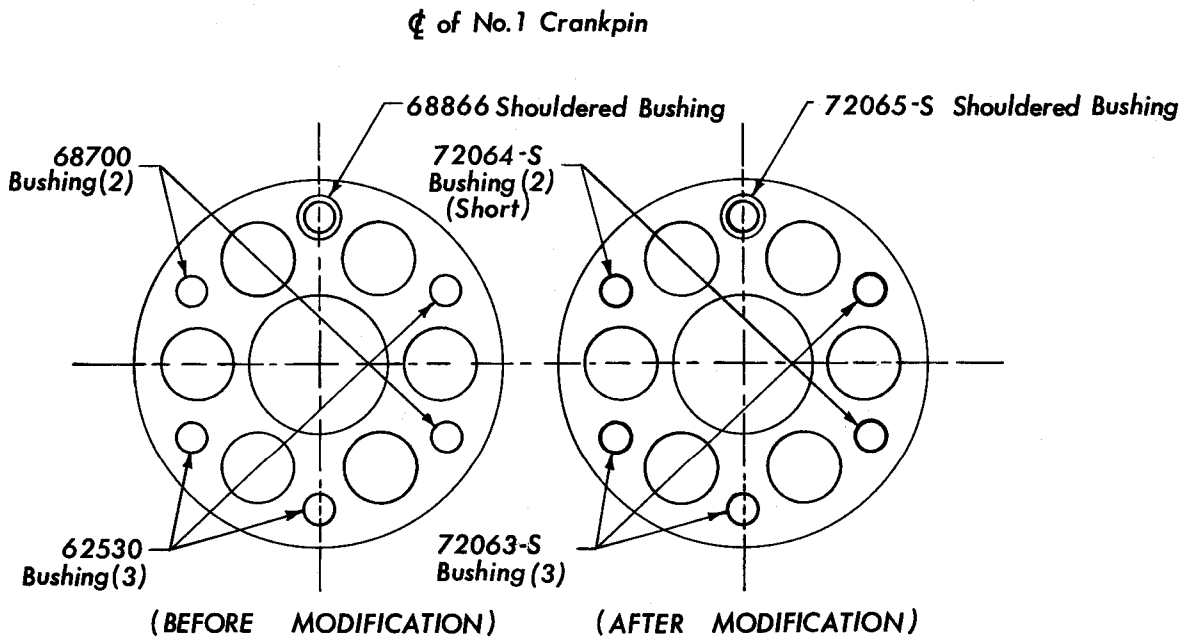
Figure 1. Location of O-340 Crankshaft Flange Bushings

Reports from the field have shown there is a possibility of failure of the 3/8" propeller attaching bolts used on the O-340 and the O-320 series aircraft engines when used in conjunction with Hartzell controllable pitch propellers. (At the next overhaul of any of the subject engines, an inspection must be made to determine the size of the propeller attaching bolts.) All engines with 3/8" bolts must be modified, at overhaul, to accommodate the stronger 7/16" bolts now used on this series of engines. To accomplish this modification it will be necessary to replace the present propeller flange bushings with newly designed bushings that will accommodate the larger bolts. These new bushings also have a heavier flange that eliminates the possibility of bushing failure. Part I of this bulletin pertains to the replacement of O-340 propeller flange bushings, while

- a. Remove the propeller.
- b. Remove the ring gear assembly by tapping lightly with a hammer.
- c. Use the crankshaft flange bushing tool (Lyc. P/N 64869) to remove the shouldered bushing (Lyc. P/N 68866).

Reverse the puller and insert the new bushing (Lyc. P/N 72065-S). See Figure 1.

- d. Use the puller to remove the two (Lyc. P/N 68700) bushings. See Figure 1. Reverse the puller and install the two (Lyc. P/N 72064-S) bushings.
- e. Remove the remaining three (Lyc. P/N 62530) bushings. Figure 1. Install the new bushings (Lyc. P/N 72063-S).
