MANDATORY
SERVICE BULLETIN

Service Bulletin No. 293B
 (Supersedes Service Bulletin No. 293A)

SUBJECT: PART I: Inspection of Exhaust Valve Guides
 PART II: Installation of New Camshafts

MODELS AFFECTED: All Avco Lycoming O-320 Series Aircraft Engines except the following which were either manufactured or factory remanufactured with P/N 74167, 70492 or 70492-YA camshaft assemblies (detail part numbers of these camshafts are 74166, 70491 and 70491-YB, respectively).

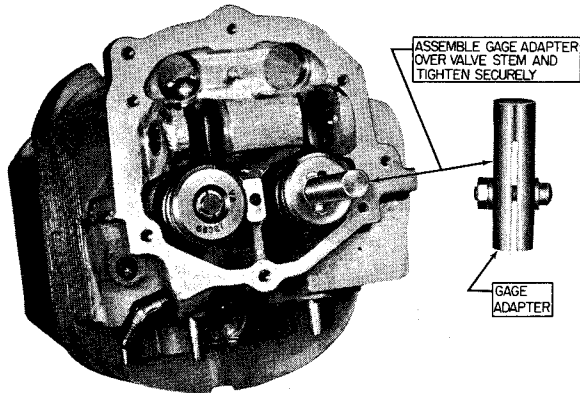
Figure 1. Gage Adapter Assembled on Exhaust Valve Stem

3. Wipe oil from area of exhaust valve spring retainer.
4. Assemble the split gage adapter (figure 1) over the end of the exhaust valve stem and tighten it securely. If the adapter can be moved by hand, it is not correctly assembled nor securely tightened.

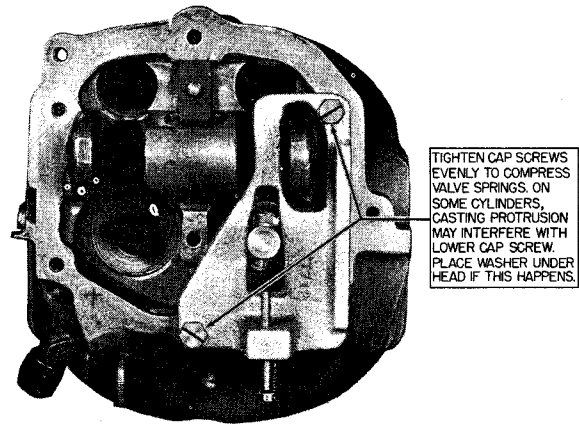
Figure 2. Compressor Plate Fixture Installed on Rocker Box

6. Install the pressure plate (figure 2). Use two 1/4 x 20 x 1.25 inch long hex head cap screws; turn the screws alternately to compress the valve spring evenly. On some cylinders, a casting protrusion on the cylinder head may interfere with the end of the lower capscrew; if this happens, place several flat washers under the head of the capscrew before tightening. See figure 2.

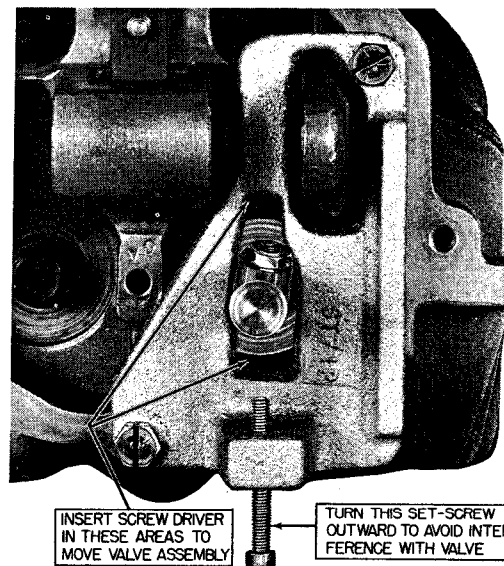
Figure 3. View Showing Area of Exhaust Valve with Components of Gage Fixture Assembled

7. Use finger to push against split gage adapter to move the valve toward its open position as far as possible.
8. Insert the blade of a screwdriver in the area between the exhaust valve spring and the pressure plate as shown in figure 3. Using the pressure plate as a pivot, press the blade of the screwdriver against the exhaust valve spring, forcing it toward the exhaust port side of the cylinder, as far as it will go, figure 4. Friction

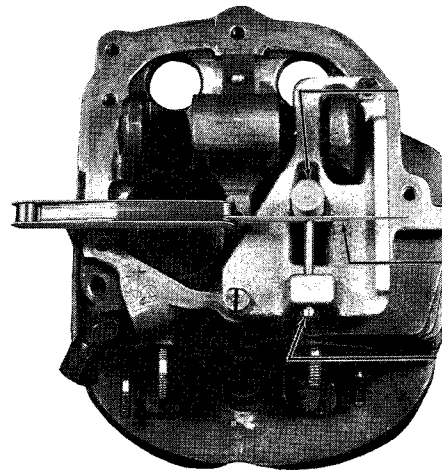
Figure 5. Feeler Gage in Position Between Set-Screw and Gage Adapter

9. Select a .010 inch feeler gage and insert it between the gage adapter and the set-screw as shown in figure 5.
10. Turn the set-screw toward the gage adapter to obtain a slight drag on the feeler gage. Be careful not to turn the screw far enough to move the valve stem; also be careful not to change the position of the screw after it has been correctly set.

12. Using the feeler gages, measure the gap between the set-screw and the gage adapter. Do not force the feeler gage in the gap; this will cause the split gage adapter to move. If the gap is found to be less than .040 inch the valve stem and guide are satisfactory. However, if the gap is .040 inch or more the guide is excessively worn and the cylinder must be removed for exhaust valve and guide replacement.

It is important that both exhaust valve guide and exhaust valve be replaced if excessive wear is indicated by the above procedure. Replacement of the valve or guide alone will not prevent subsequent valve damage.

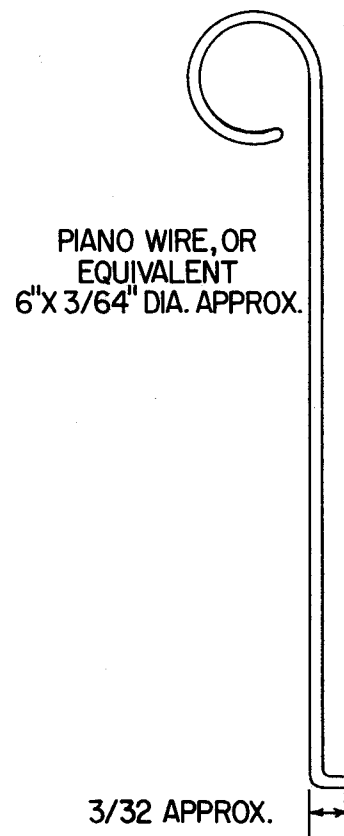
Figure 6. Hooked Tool for Pulling Valve

6. Fabricate a small, hooked tool as shown in figure 6 and insert it into the gap between the valve keys and

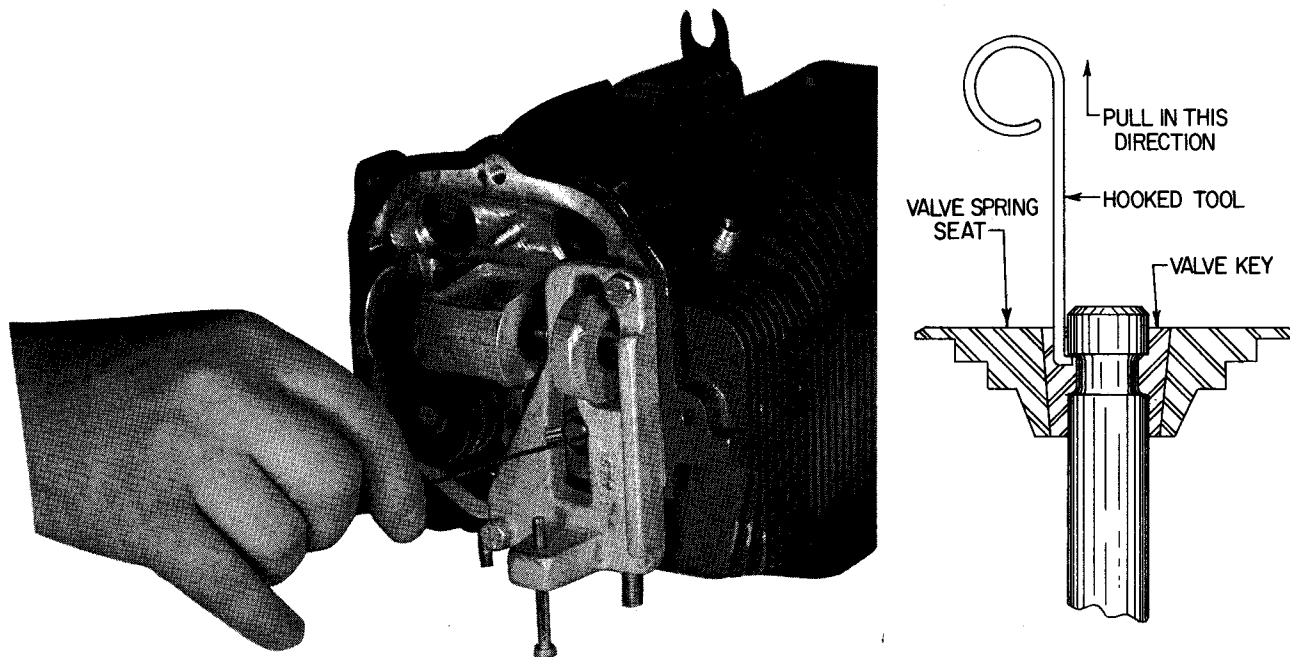
Figure 7. Method of Using Hooked Wire Tool to Pull Valve (Solid Stem) in Position for Removal of Keys

engage the hook of the tool with the underside of the valve tip as shown in figure 7.
