SERVICE BULLETIN

Service Bulletin No. 381C
 (Supersedes Service Bulletin No. 381B)
 Engineering Aspects are
 FAA (DEER) Approved

SUBJECT: Oil Pump Woodruff Key Drive and Impeller Replacement

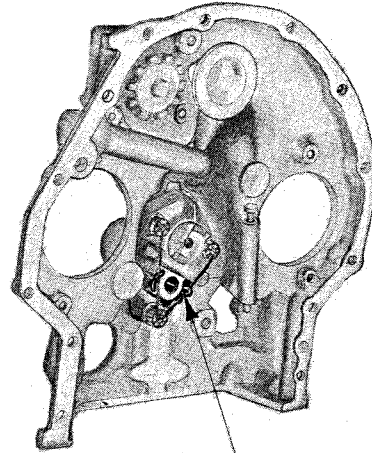
Figure 1. Interior View of Accessory Housing Showing Location of Cotter Pin in Oil Pump Idler Shaft

INSPECTION: Applicable remanufactured engines shipped after December 21, 1972 should be inspected to determine if this modification is required: first of all, if the engine log book indicates the engine has not been modified in accordance with Service Instruction No. 1230 or No. 1272, proceed to remove the accessory drive cover from the mounting pad at the lower right side of the accessory housing to obtain access to the area between the crankcase and the accessory housing. On some engines this accessory drive pad is not machined, in this event it will be necessary to remove either the left magneto or the *fuel pump to obtain access to the area between the crankcase and the accessory housing. Regardless of which accessory pad is used, determine if the oil pump idler gear is secured with a cotter pin at the location shown in figure 1. This can be accomplished using an inspection mirror, preferably an illuminated one. If the cotter pin is visible, it is unnecessary to perform the modification required by this bulletin.

IF IDLER SHAFT IS SECURED WITH A COTTER PIN AT THIS LOCATION MODIFICATION IS NOT REQUIRED

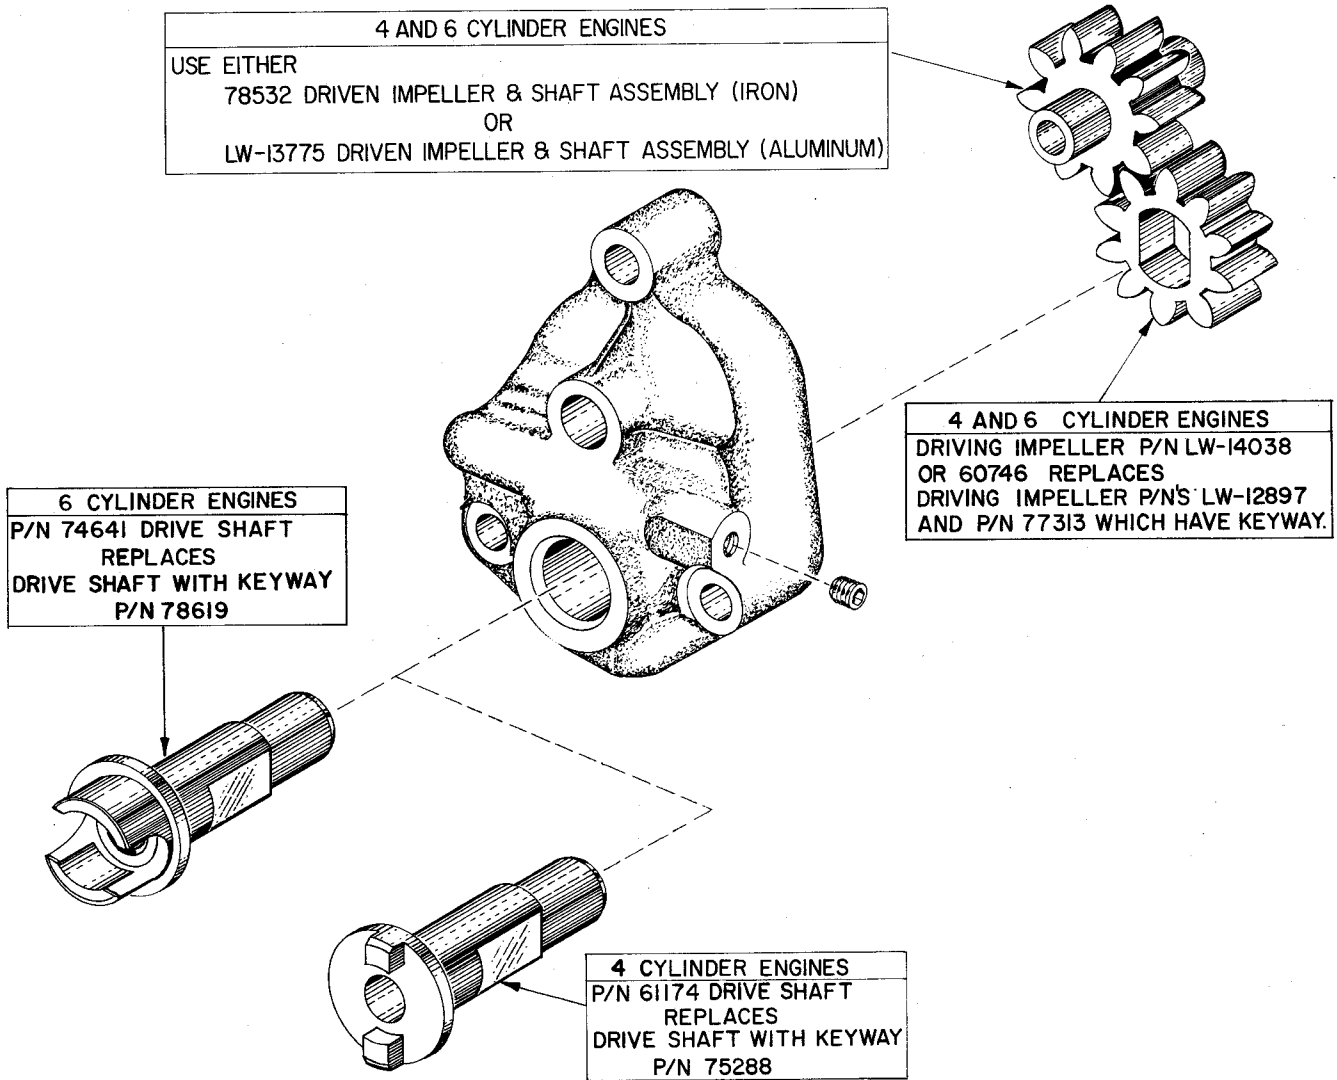
Figure 2. Oil Pump Drive Assembly

This modification consists of replacing the oil pump drive shaft and drive impeller to eliminate the Woodruff key drive which has proven to be the cause of excessive wear in the keyway of the hardened drive impeller. Therefore, it is recommended that all of the applicable engines installed in aircraft listed above, as well as any others that may have been modified in accordance with Service Instruction No. 1272, use the following procedure for parts replacement.

3. Reassemble the oil pump using the new drive shaft and drive impeller supplied with the kits shown in the following "Parts Data" section. See figure 2. Be sure all of the parts are lubricated thoroughly during assembly. After assembly, turn the drive shaft several revolutions to determine if it moves freely; if not, open the pump and correct the cause before the unit is reassembled on the engine.

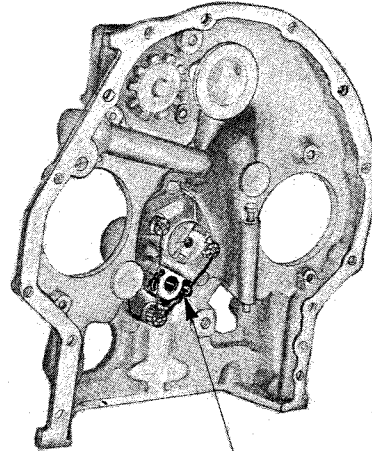
Figure 1. Interior View of Accessory Housing Showing Location of Cotter Pin in Oil Pump Idler Shaft

IF IDLER SHAFT IS SECURED WITH A COTTER PIN AT THIS LOCATION MODIFICATION IS NOT REQUIRED
