DATE: October 3, 1975Service Bulletin No. 385C
(Supersedes Service Bulletin No. 385B)
Engineering Aspects are
FAA (DEER) Approved**SUBJECT:** Oil Pump Impeller and Drive Replacement**MODELS AFFECTED AND TIME OF COMPLIANCE:** See chart on page 3.

SERVICE BULLETIN

Supplement No. 1
to Service Bulletin No. 385C

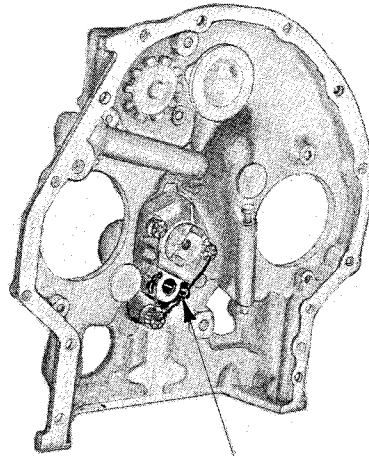
Figure 1. Interior View of Accessory Housing Showing Location of Cotter Pin in Oil Pump Idler Shaft

INSPECTION: Applicable remanufactured engines shipped after December 21, 1972 should be inspected to determine if this modification is required: first of all, if the engine log book indicates the engine has not been modified in accordance with Service Instruction No. 1230 or No. 1272, proceed to remove the accessory drive cover from the mounting pad at the lower right side of the accessory housing to obtain access to the area between the crankcase and the accessory housing. On some engines this accessory drive pad is not machined, in this event it will be necessary to remove either the left magneto or the *fuel pump to obtain access to the area between the crankcase and the accessory housing. Regardless of which accessory pad is used, determine if the oil pump idler gear is secured with a cotter pin at the location shown in figure 1. This can be accomplished using an inspection mirror, preferably an illuminated one. If the cotter pin is visible, it is unnecessary to perform the modification required by this bulletin.

IF IDLER SHAFT IS SECURED WITH A COTTER PIN AT THIS LOCATION MODIFICATION IS NOT REQUIRED

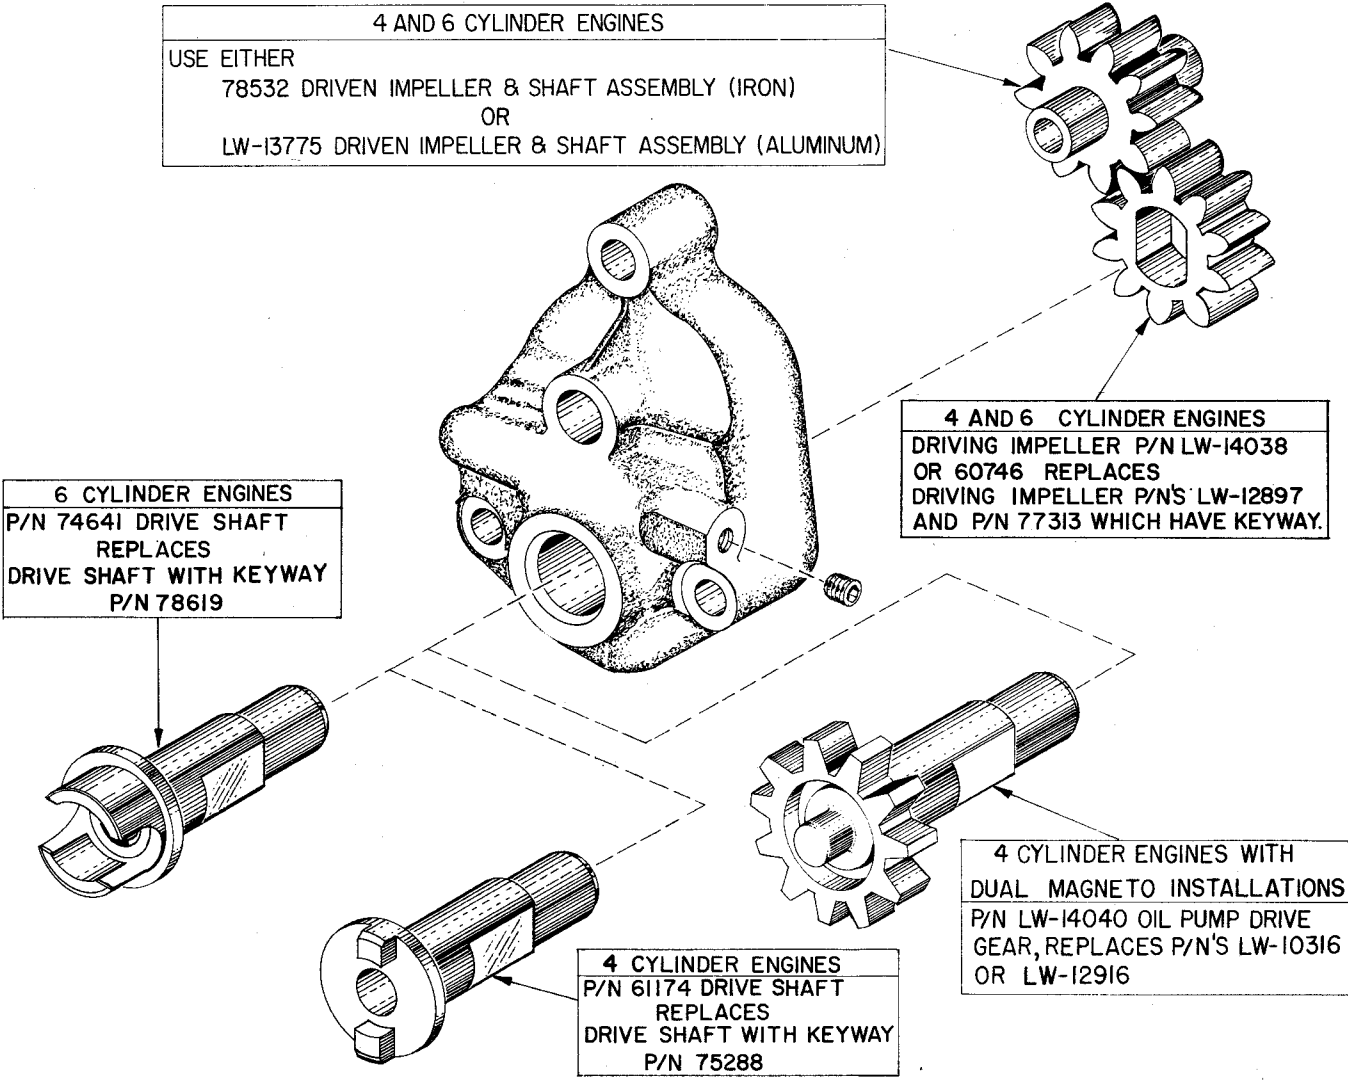
Figure 2. Oil Pump Drive Assembly

This modification consists of replacing the oil pump drive shaft and drive impeller to eliminate the Woodruff key drive which has proven to be the cause of excessive wear in the keyway of the hardened drive impeller. Therefore, it is recommended that all of the applicable engines listed in the chart, as well as any others that may have been modified in accordance with Service Instruction No. 1272, use the following procedure for parts replacement.

3. Reassemble the oil pump using the new drive shaft and drive impeller supplied with the kits shown in the following "Parts Data" section. See figure 2. Be sure all of the parts are lubricated thoroughly during assembly.

After assembly turn the drive shaft several revolutions to determine if it moves freely; if not, open the pump and correct the cause before the unit is reassembled on the engine.
