February 16, 1987

Service Bulletin No. 477A
(Supersedes Service Bulletin No. 477)
Engineering Aspects are
FAA Approved

Inspection and Rework of P/N LW-18790 Rocker Arm Assembly

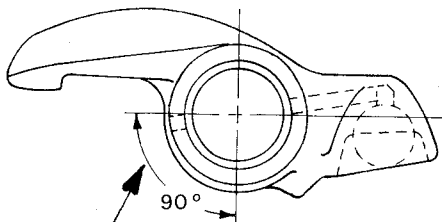
Figure 1. P/N LW-18790 Rocker Arm Assembly Showing Area for Measuring Wall Thickness

Recent reports of rocker arm failure have been received by the Avco Lycoming Textron Williamsport Division. These failures all involve the P/N LW-18790 Rocker Arm Assembly, which supersedes the P/N 74636 Rocker Arm Assembly in the exhaust position and the P/N 69444 Rocker Arm Assembly in the intake position on all parallel valve-type engines except O-235 Series and O-290 Series.

P/N LW-18790 ROCKER ARMS WITH LESS THAN .075 INCH WALL THICKNESS MAY DEVELOP CRACKS IN THESE AREAS AND MUST BE REPLACED.

MEASURE ROCKER ARM OUTER EDGE WALL THICKNESS AT THINNEST POINT WITHIN THIS AREA. BOTH SIDES OF ROCKER ARM.

3. Measure the wall thickness of the outer edge of the bushing bore boss in the area shown in Figure 1. If a ball-type micrometer or similar method is used to measure the combined thickness of the rocker arm wall and bushing, subtract .062 inch from the total measurement (.062 inch equals the bushing wall thickness).

4. Replace any P/N LW-18790 rocker arm that does not have at least a .075 inch wall thickness at the thinnest point within the 90° area, on both sides, as shown in Figure 1.
