SERVICE

NUMBER 110

BULLETIN

SUBJECT: WINDSHIELD ATTACHMENT

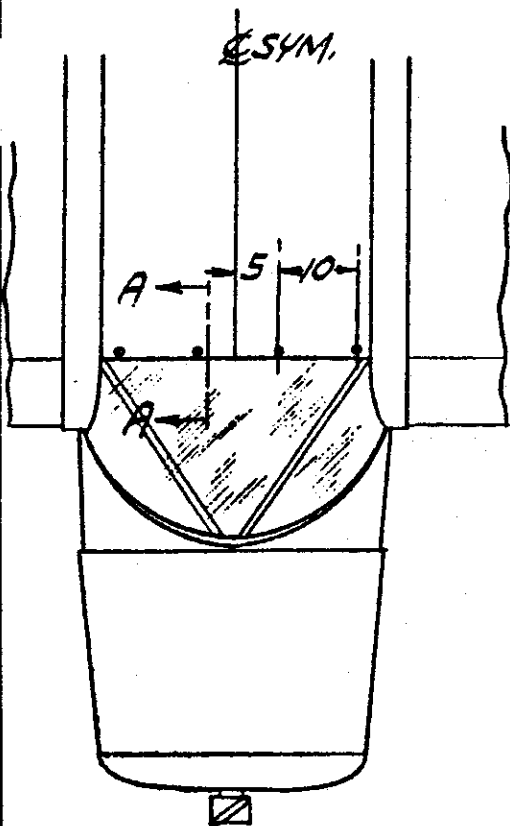
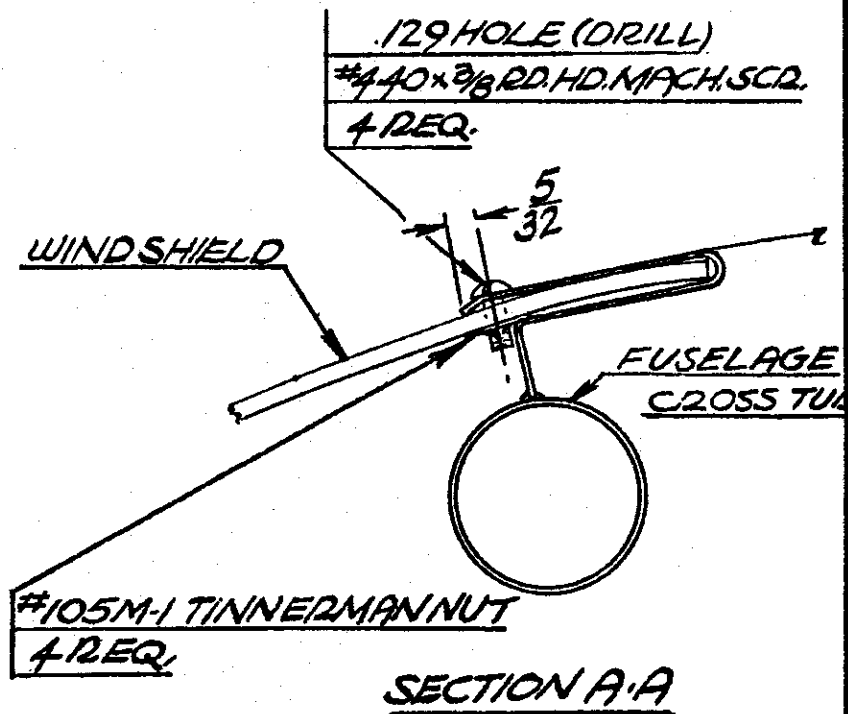
In order to eliminate the possibility of the windshield coming out of its top retaining channel (channel located on tube between front wing hinge fittings) it is strongly recommended that the windshield attachment be reworked to incorporate the use of four machine screws installed in accordance with the sketch below.

NOTE
DO NOT FORCE DRILL THRU PLEXIGLAS

An appropriate entry should be made in the aircraft log book when the recommended change has been made.
