IMMEDIATE ACTION

NUMBER 116

March 9, 1951

SUBJECT: Battery Box Lid

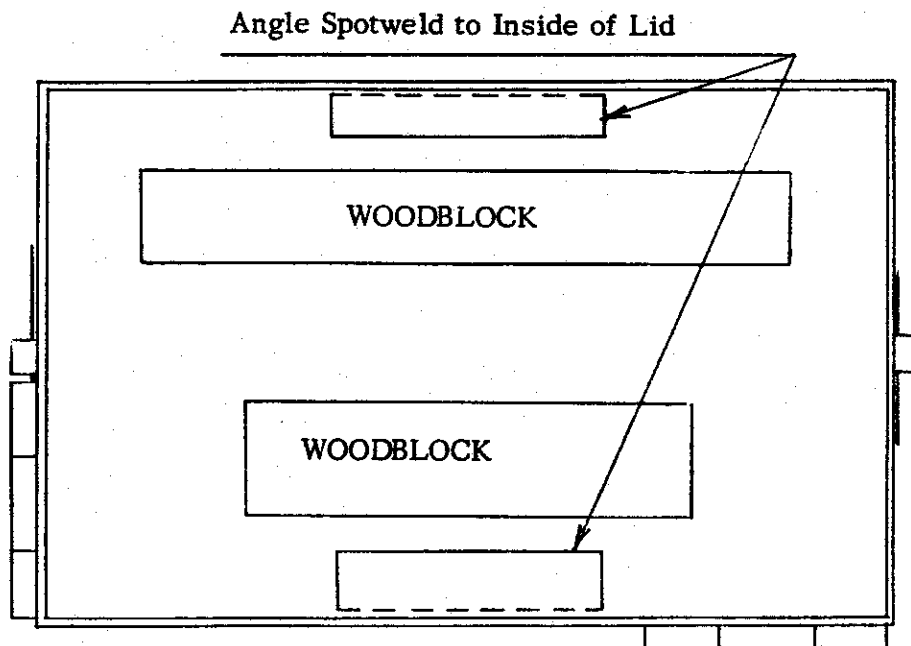
SKETCH #1

Lids of the type construction shown in Sketch No. 1 are satisfactory without rework.

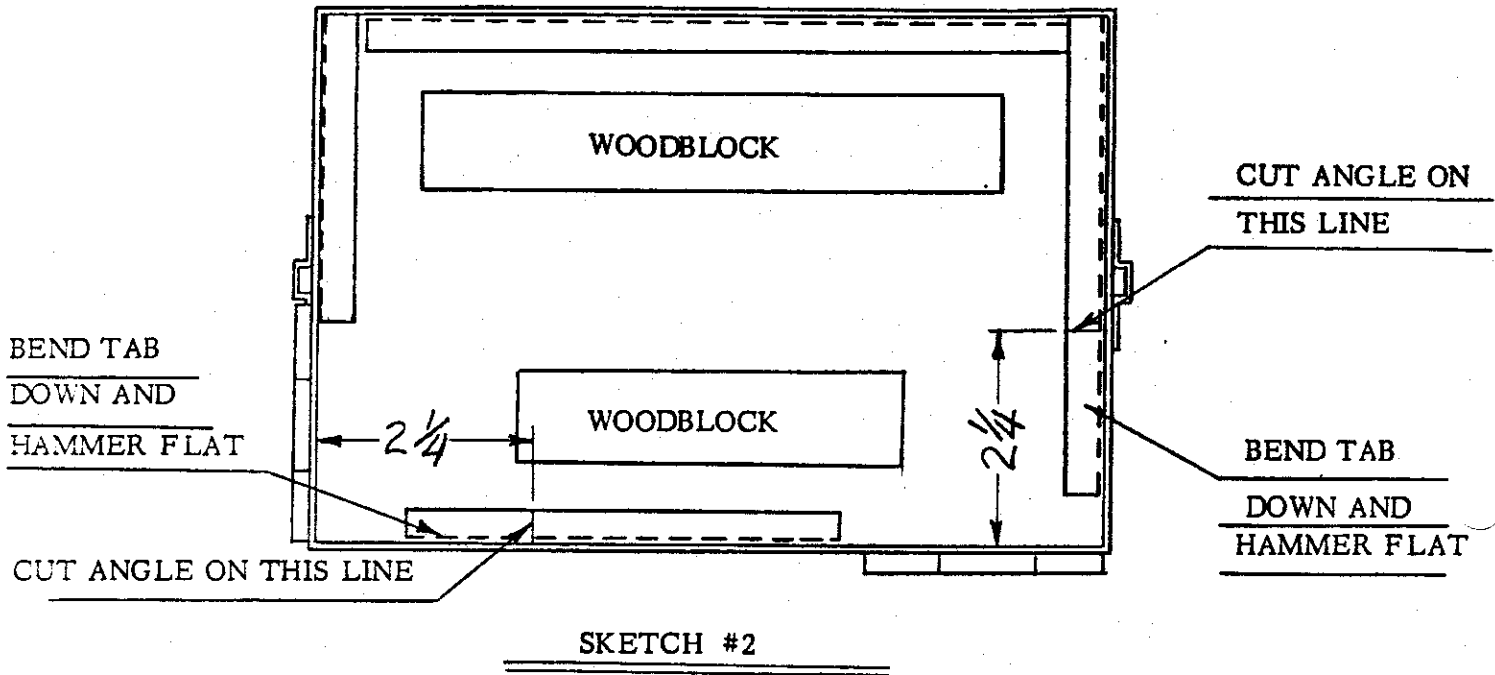
Lids of the type construction shown in Sketch No. 2 must be reworked as indicated.

FOUR ANGLES SPOTWELD TO INSIDE OF LID
