# SERVICE No. 1172 BULLETIN

Date: July 3, 2006

**LIFT STRUT ATTACHMENT BOLT INSPECTION**

ATA: 5700

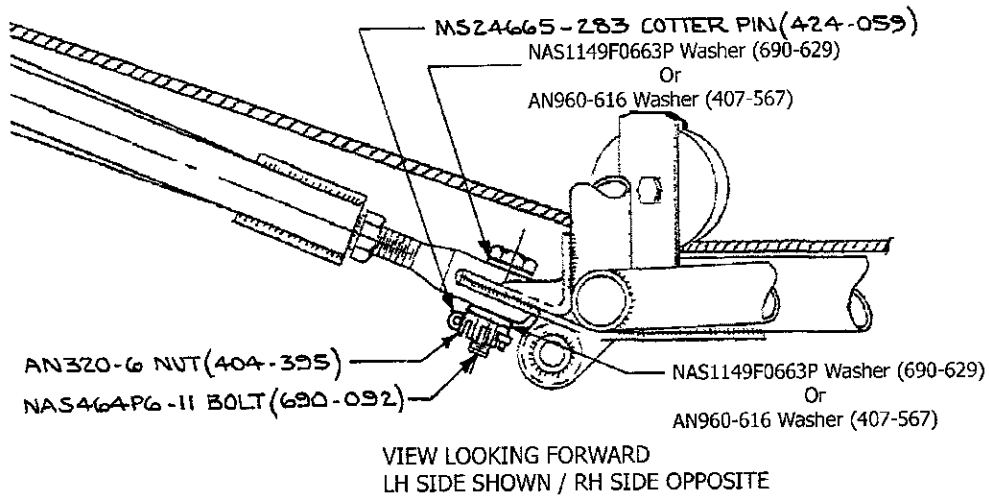
A small number of aircraft were delivered from the factory with the hardware configuration shown in Figure 1. Although this configuration does provide adequate clearance from the landing gear as delivered from the factory, it does not provide as much clearance as the configuration shown in Figure 2. Therefore, aircraft conforming to the hardware configuration shown in Figure 1 are more likely to have an interference condition occur when Parts Manufacturer Approval (PMA) parts are used in place of Piper-approved parts.

For Figure 1, the bolt head marking reads NAS 464P.

**Figure 1**  
Acceptable for up to 500 hours of operation.

2. Aircraft conforming to Figure 1 are acceptable for use up to 500 hours of operation, as a temporary measure, to allow time for the operator to order and install the hardware shown in Figure 2.

**After 500 hours of operation, all aircraft must conform to Figure 2.**

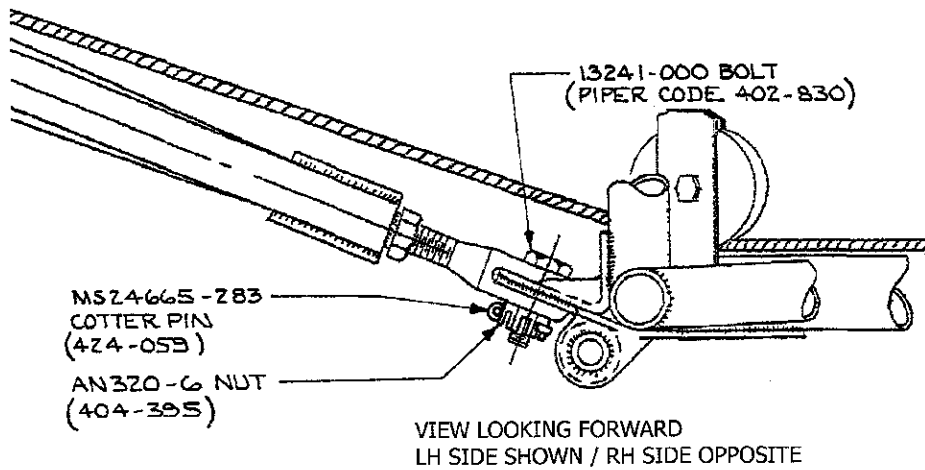
For Figure 2, the bolt head marking reads 13241.

**Figure 2**  
Hardware configuration required for compliance with this Service Bulletin.

This Service Bulletin provides for the mandatory inspection (and if necessary, replacement) of the Lift Strut Attachment Bolts, to insure that the hardware configuration of all affected aircraft are in agreement with Figure 2.

3. After verifying that the lift strut attach bolts at all 4 locations on the aircraft are in agreement with Figure 2, make a logbook entry indicating compliance with this Service Bulletin.
