SERVICE

BULLETIN

NUMBER 118

SUBJECT: Battery Box Lid Modification

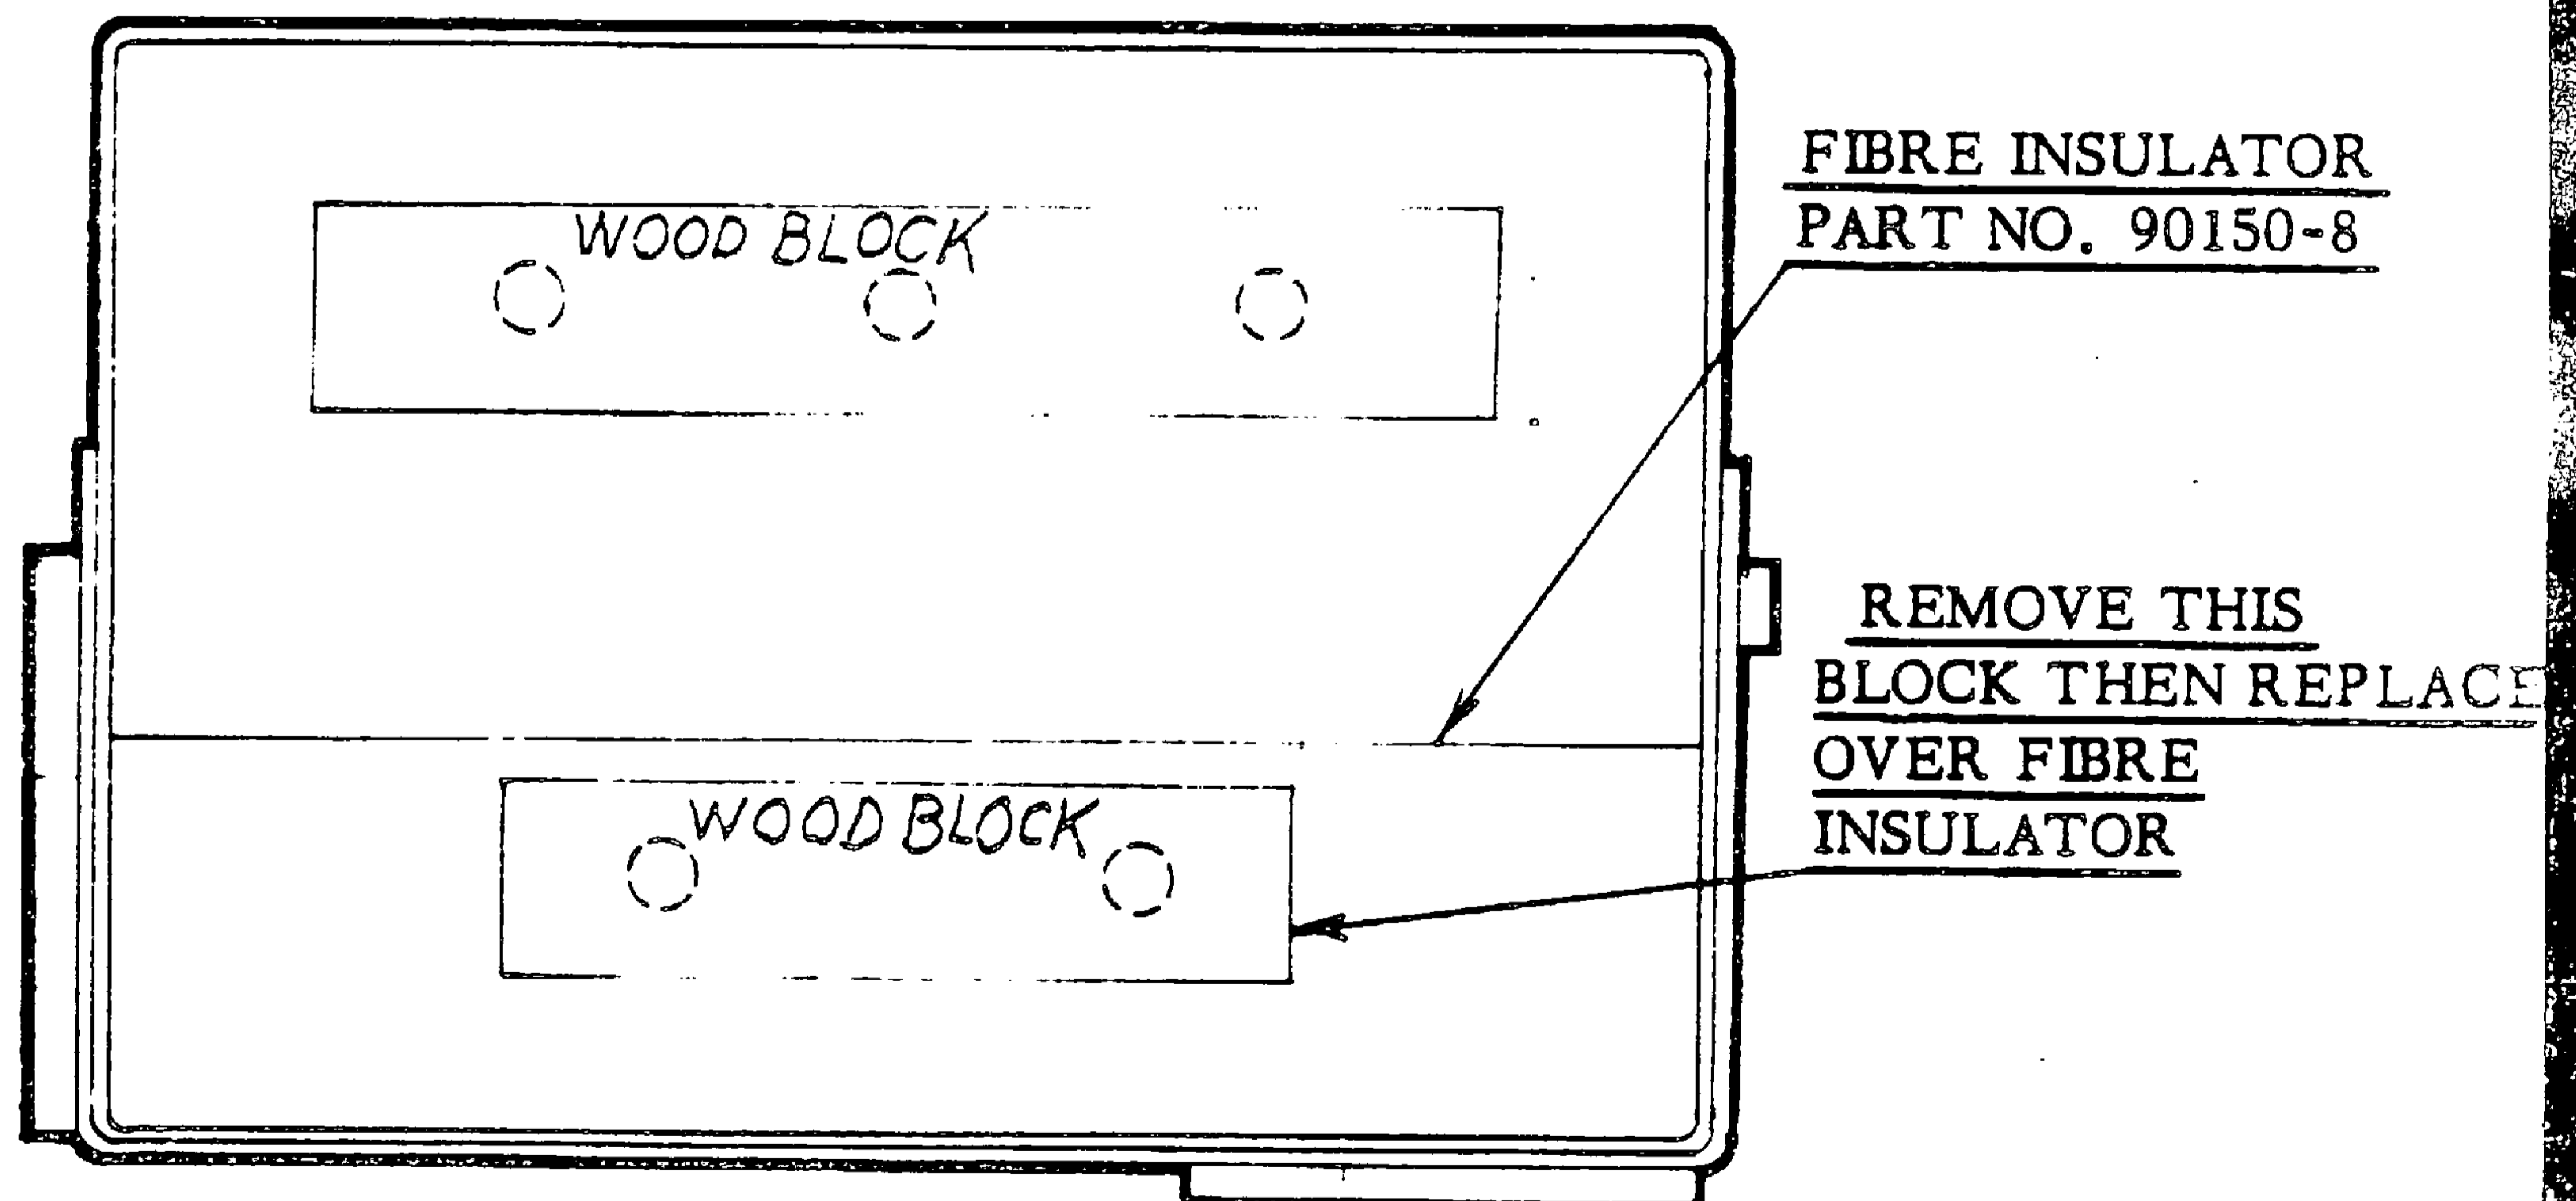
It is necessary that the battery box lids in the above listed airplanes be modified in accordance with the following instructions, to eliminate the possibility of "shorting" the battery terminal wing nuts.

Remove the wood block located between the battery cable openings. Place the fibre insulator, Piper Part Number 90150-8, inside the lid as shown in the following sketch. Replace the wood block using the same screws.
