SERVICE

BULLETIN

NUMBER 119

SUBJECT: Freezing of Nose Wheels

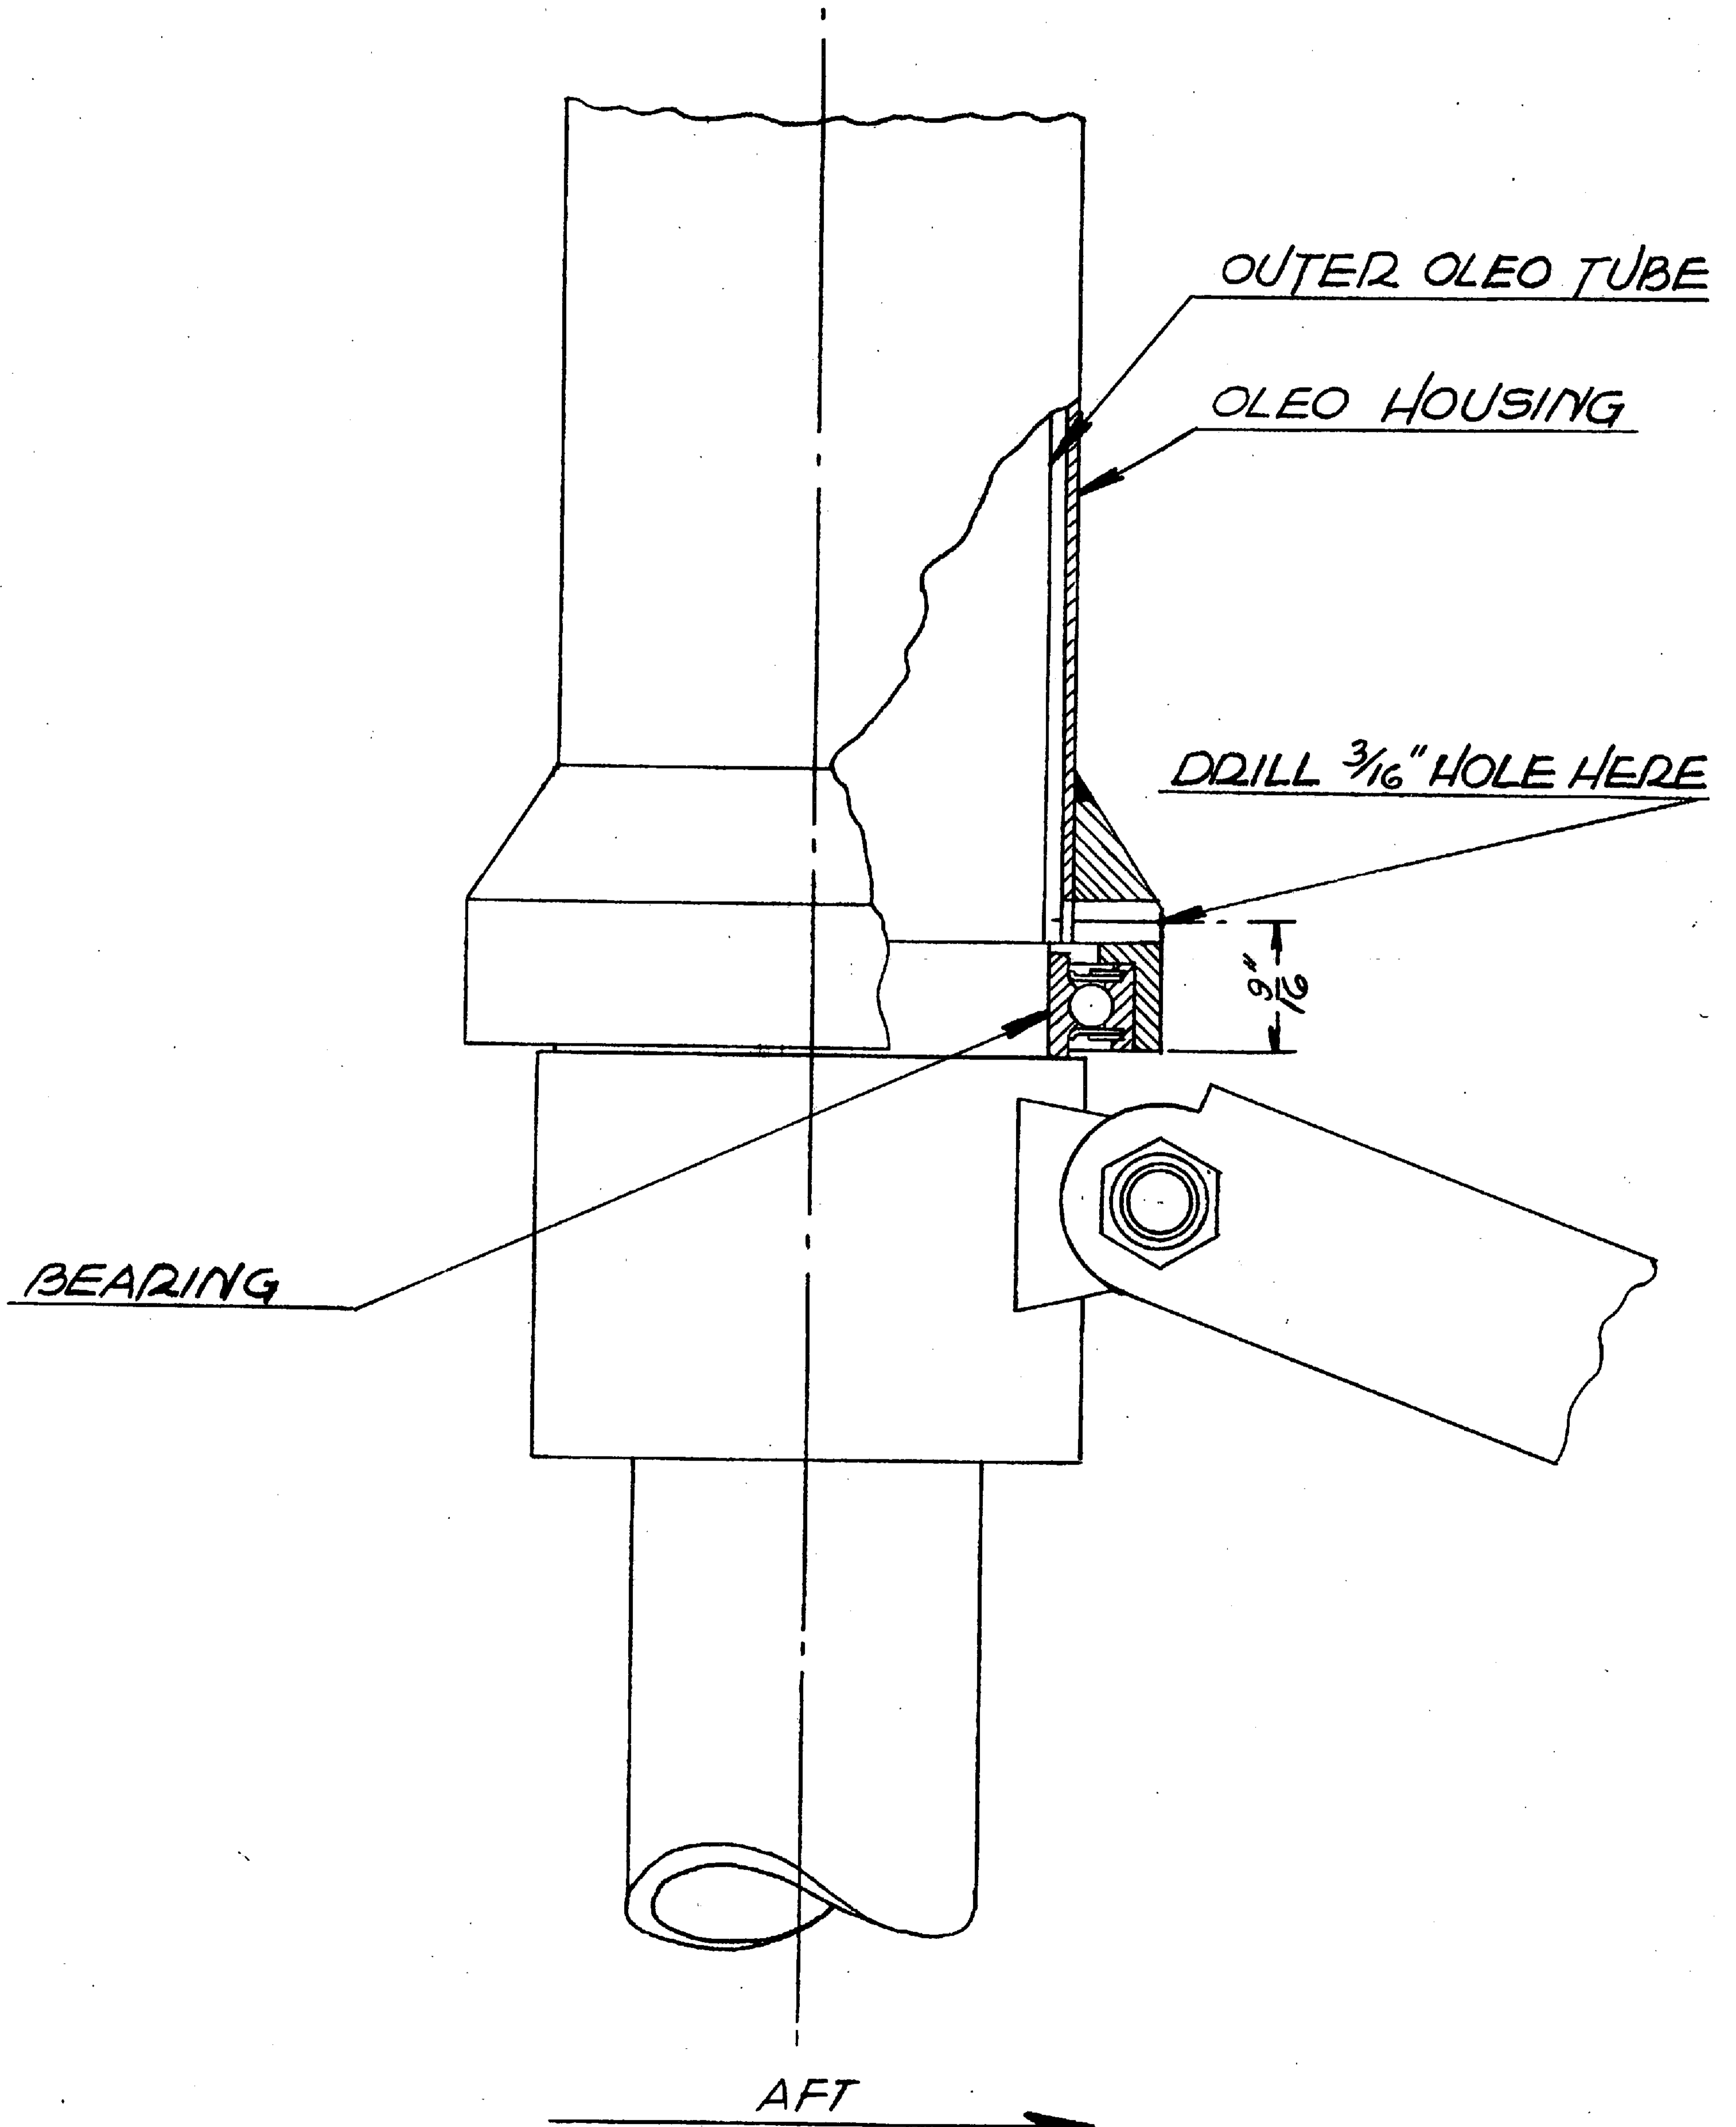
It has been found that when operating in hard driving rain or when washing the airplane water can enter the oleo housing through the upper bearing.

During freezing weather any water which may have entered the 1/16" space between the housing and the oleo will freeze causing the nose wheel to become inoperative insofar as directional steering is concerned, both on the ground and in the air.

1. Using a small punch and hammer make a mark 9/16" above the bottom edge of the lower bearing retainer ring which is located at the lower end of the nose wheel mount housing. The punch mark is to be made on the rearward side of the retainer ring (See sketch on the reverse side of Page 2).

2. Using a Number 30 drill, drill a small pilot hole through the retainer ring, being very careful not to drill the oleo tube. The thickness of the material at this point is 13/32". There is only 1/16" clearance between the housing and the oleo. Do not drill into the oleo tube.

3. Using a Number 11 of 3/16" drill enlarge the size of the pilot hole which was drilled in accordance with Step 2. The purpose of the 3/16" hole is to provide a drain for any water which might have found its way into the oleo housing.

4. The airplane should be placed in a warm hangar to make sure that all traces of ice have melted and drained out of the oleo housing.
5. Apply a generous quantity of cup grease to the top of the oleo housing to prevent further seepage of water. The upper bearing and retainer nut should be completely covered.
