SERVICE BULLETIN

No. 123

Piper Aircraft Corporation

SUBJECT: Front Spar Interference

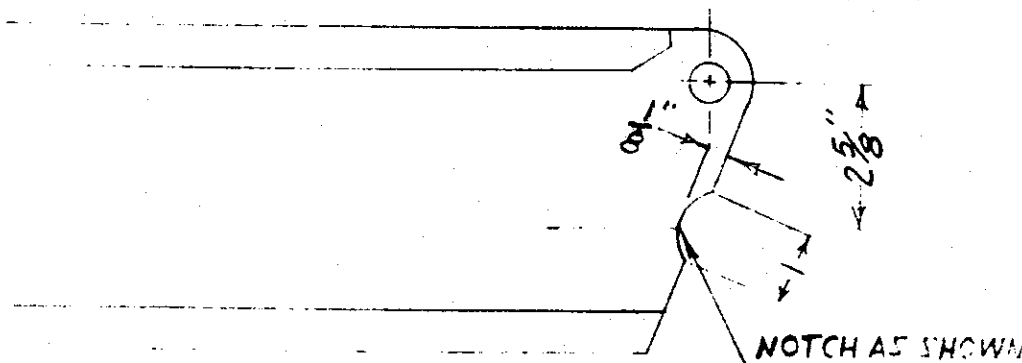
It is requested that an inspection be made to determine whether or not there is interference between the inboard end of the front spar web and the aileron pulley attachment bolt in the area of the front wing hinge fitting.

If there is less than one-eighth inch clearance between these two points, then the spar web should be filed out and sanded smooth in accordance with the following sketch:
