NUMBER 124

August 30, 1954

SUBJECT: PA-22 Landing Gear

MODELS AFFECTED: All Model PA-22 Airplanes

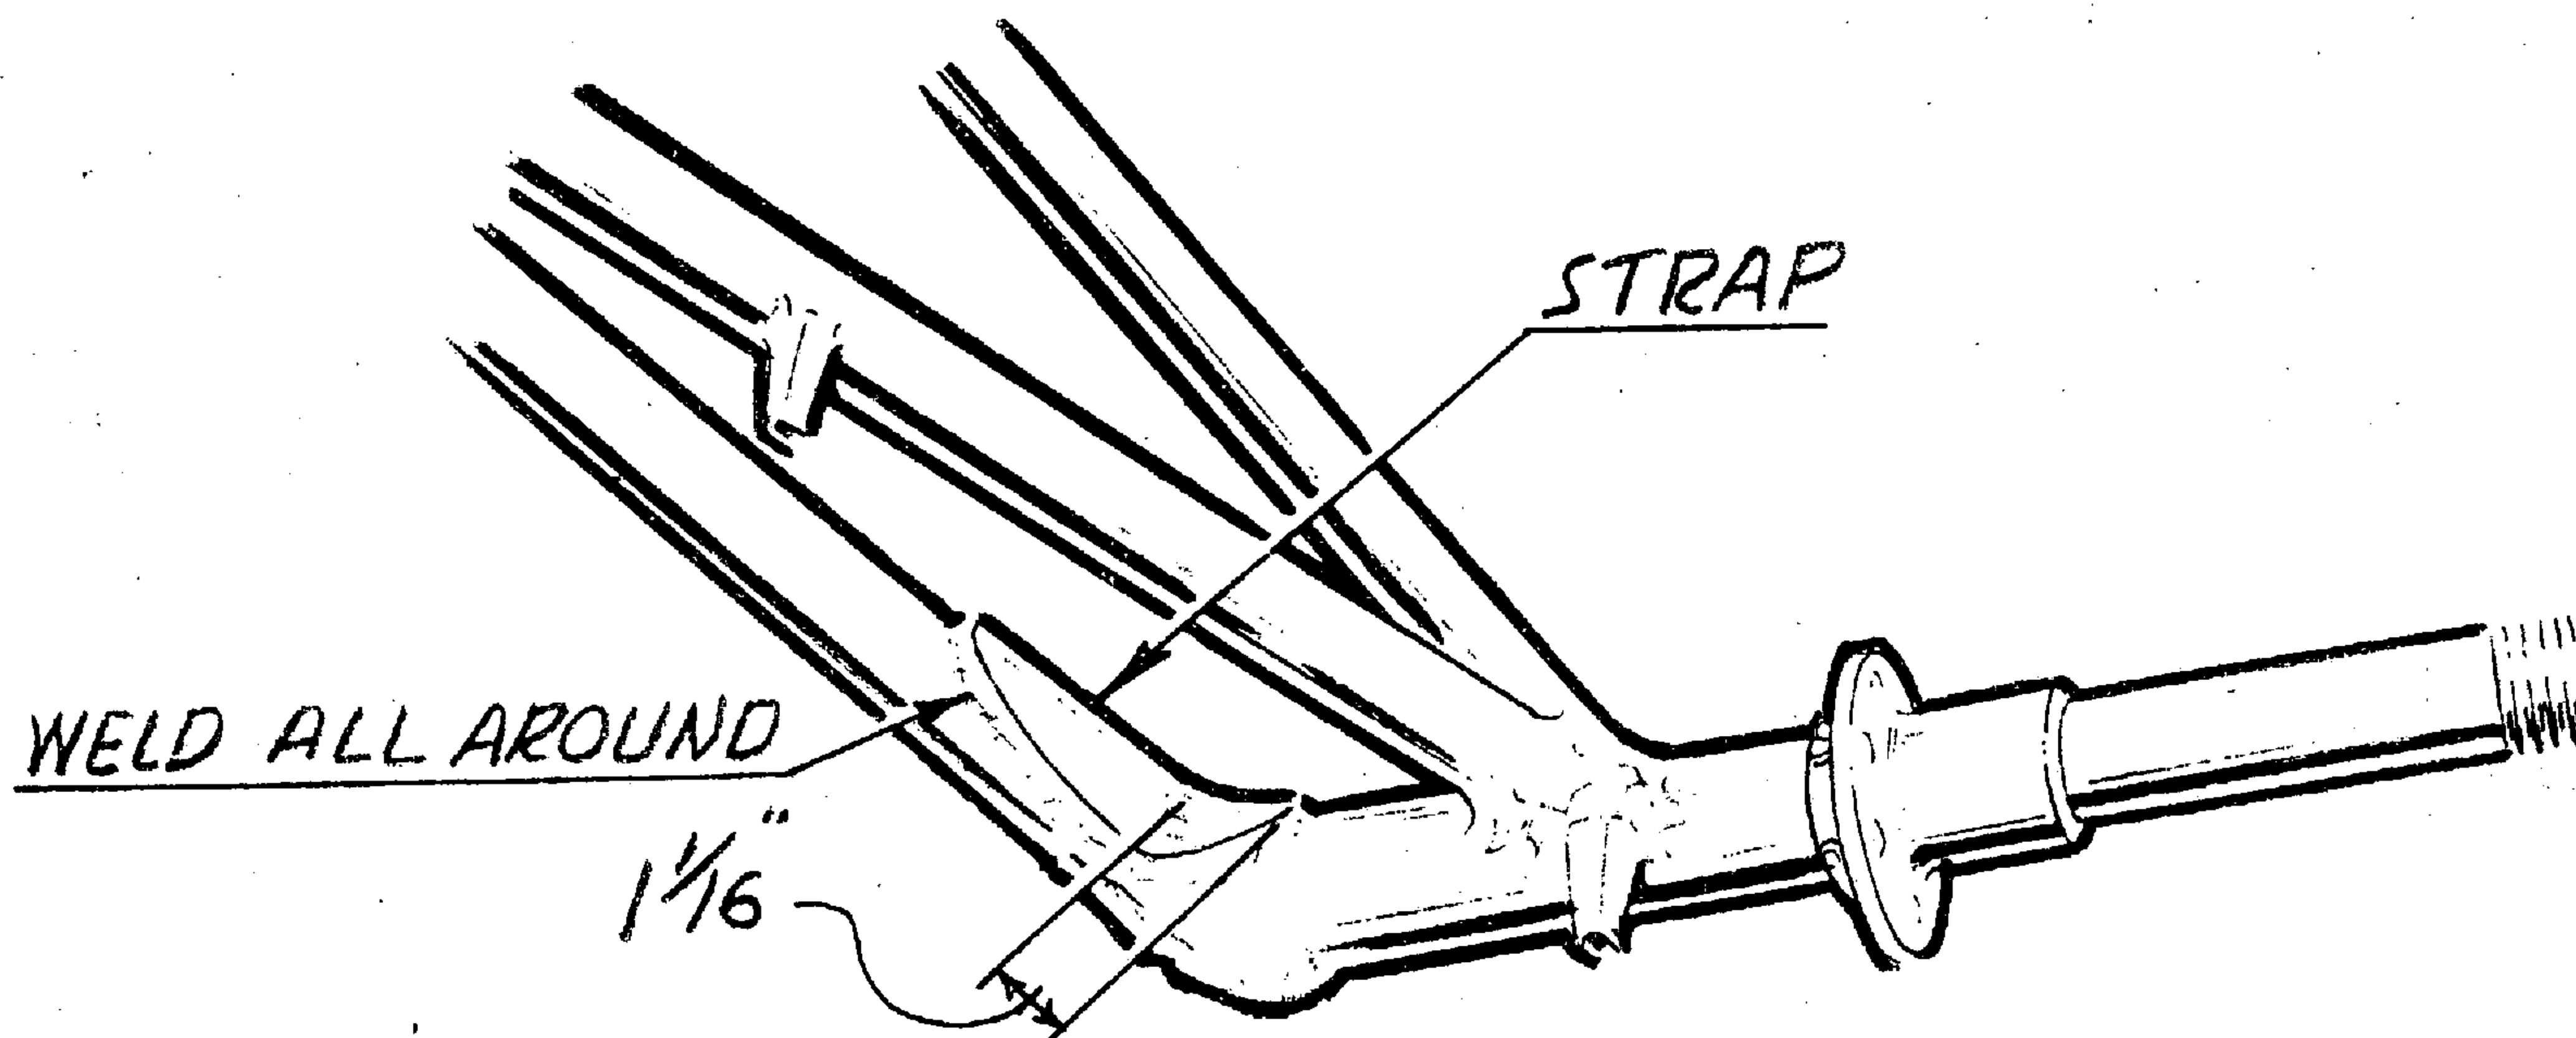
A number of field service reports have been received to the effect that cracks have been appearing in the leading edge of the streamlined tube of the PA-22 landing gears at a point where it joins the inboard end of the axle.

Indications are that this is a fatigue failure and it is requested that all Model PA-22 airplanes listed above be modified by installing a reinforcing strap, part number 14415-00, as per the sketch below.

The reinforcement strap can be obtained from the Service Department of the Piper Aircraft Corporation, free of charge.
