SERVICE

NUMBER 148A

SUBJECT: Fuel Tank Caps

MODELS AFFECTED: PA-18-18A, L21B and PA-22

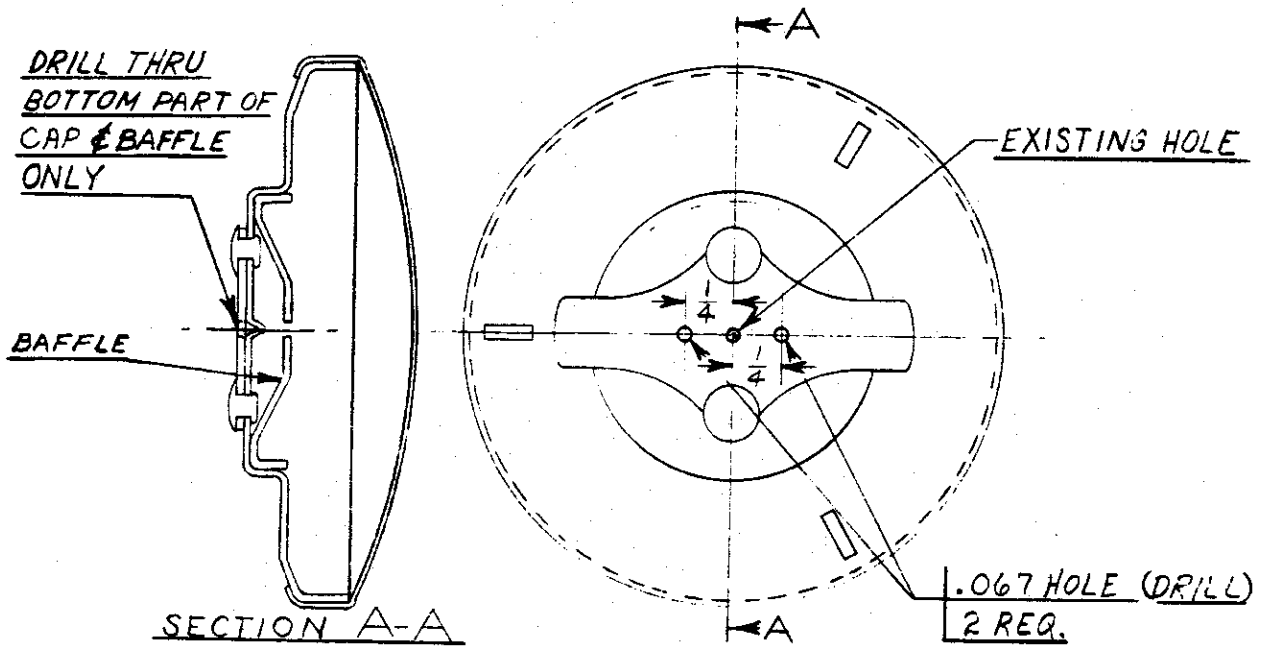
SERVICE BULLETIN 148A

During the past four months we have received fuel tank caps from our vendor which were changed slightly in design. This design change created a possible hazard to the venting system and it is, therefore, requested that the fuel tank caps on all PA-18-18A's, Serials 18-5189 to 18-5412 inclusive and 18-5416 to 18-5419 inclusive, and all L21B's, Serials 18-4011 to 18-4042 inclusive, and all PA-22's, Serials 22-4334 to 22-4337 inclusive; 22-4339 to 22-4387 inclusive; 22-4389 to 22-4455 inclusive; 22-4457 to 22-4509 inclusive; 22-4511 to 22-4554 inclusive; 22-4556 to 22-4565 inclusive; 22-4567, 22-4569, 22-4570, 22-4572, 22-4573, 22-4575 to 22-4577 inclusive; 22-4580 to 22-4587 inclusive; 22-4589 to 22-4591 inclusive; 22-4597; 22-4599; 22-4602; 22-4603; 22-4605 and 22-4613 be immediately reworked by drilling two (2) .067 holes 1/4" away from the present vent hole located in the underside of the cap, in the center of the flat spring. See sketch on reverse side for drilling details.
