SERVICE BULLETIN

161A

SUBJECT: Fire Hazard

MODELS AFFECTED: All PA-16, PA-20 and PA-22 Airplanes, serial numbers 22-1 to 22-6194 inclusive

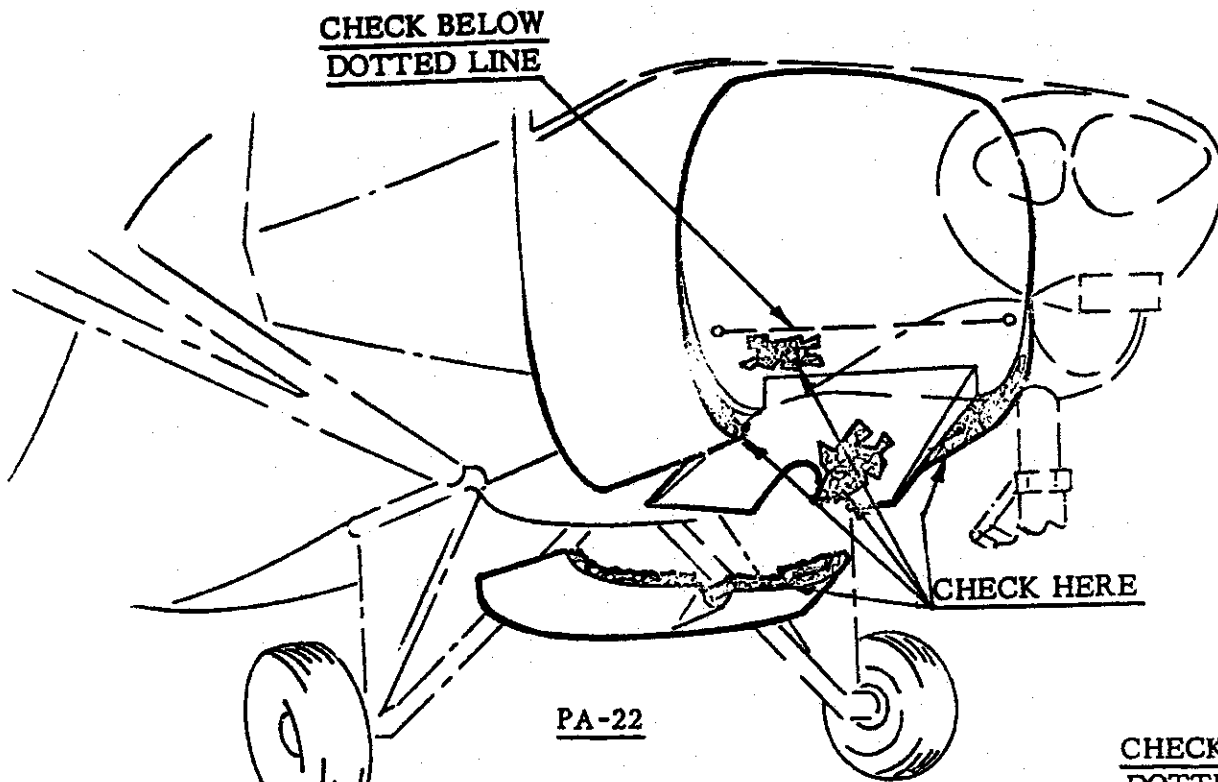
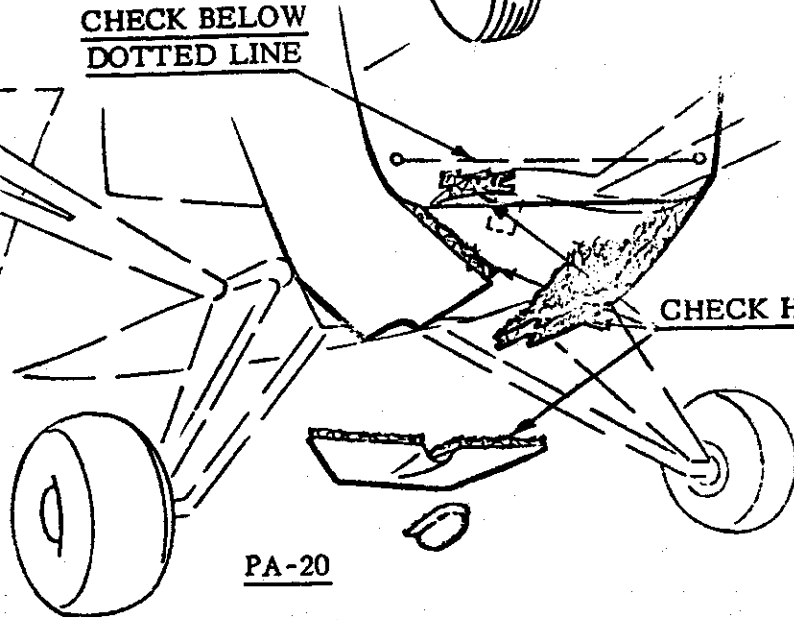
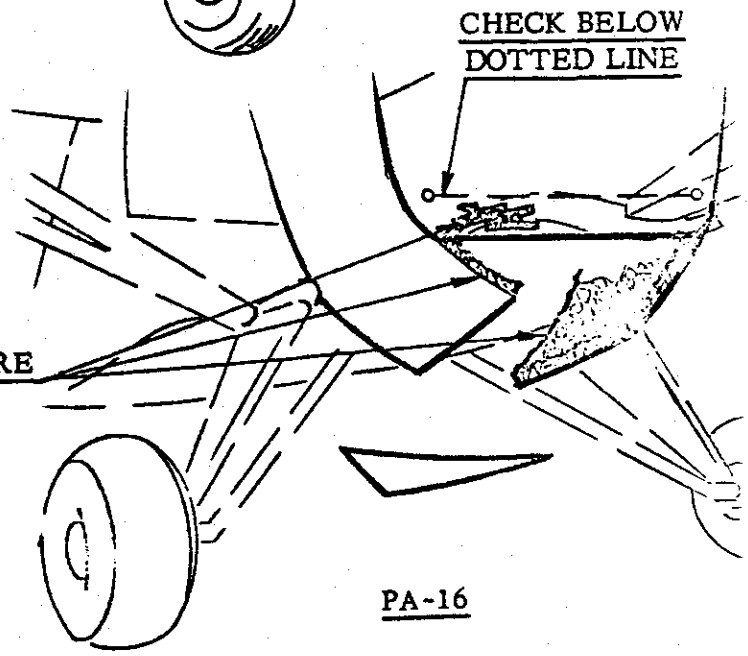
To preclude the possibility of in-flight fires, the following inspection and rework is necessary to eliminate combustible material and possible ignition sources from the area aft of the firewall underneath the forward cabin floor. Access to this section may be gained by removing the metal panels or opening the fuselage side cowl panels rearward of the firewall underneath the aircraft as shown in sketches on reverse side.

Remove and/or open panels as above. Remove and discard any sound-proofing material contaminated with engine or hydraulic oil or any sound-proofing which has the plastic septum separated from the fiberglass or showing signs of drying or cracking. Replacement of a discarded blanket may be made with equivalent fiberglass. Inspect for chafing of wire insulation and replace any inferior electrical wiring. Check for reasonable clearance between hydraulic lines, electrical wires, control cables and fuel lines and provide clearance if necessary.

3. Upon completion of the above, apply a sufficient quantity of B. F. Goodrich non-hardening putty No. 21 or other acceptable aircraft materials between firewall and fuselage cowl blanket to assure an airtight seal when reassembling the opened and removed panels. Non-hardening sealing material is available through your distributor or local aviation supply house.
