SERVICE BULLETIN

No. 174B

Piper Aircraft Corporation

SUBJECT: Inspection and Maintenance of Fuselage Fabric in Area of Windshield Top Attachment Channel

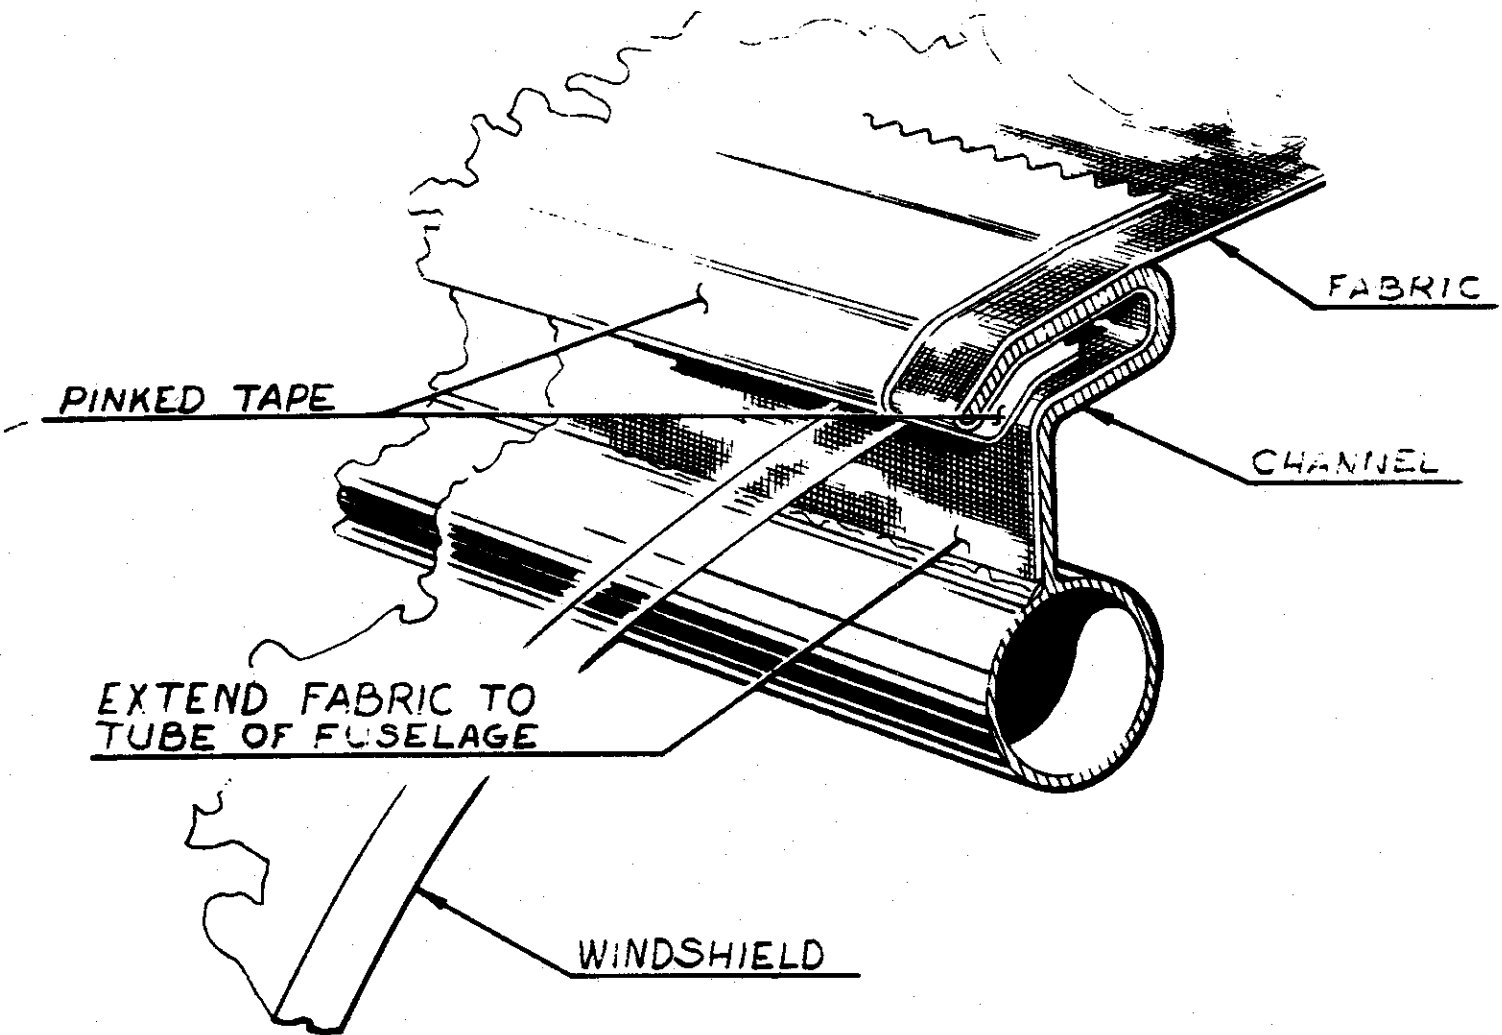
Service experience indicates that, in a few cases, the above mentioned airplanes have had difficulties with the fabric where it attaches to the fuselage under the windshield top and/or directly over the rear edge of the windshield top attachment channel.

During the service life of these airplanes it has been brought to our attention that, during the recovering operation, the fabric at the windshield channel was attached in a very careless manner, resulting in an unsafe condition.

All the above mentioned airplanes shall be carefully inspected at this point and any sign of deterioration of the fabric shall require that a strip of 2-1/2 inch pinked reinforcement tape be added per sketch shown on the reverse side of this bulletin.
