SERVICE *No.* 198 BULLETIN

Piper Aircraft Corporation

SUBJECT: Replacement of Tail Brace Clevises

MODELS AFFECTED: PA-22-108 Colt Aircraft - Serial Nos. 22-8000 to 22-8042 inclusive

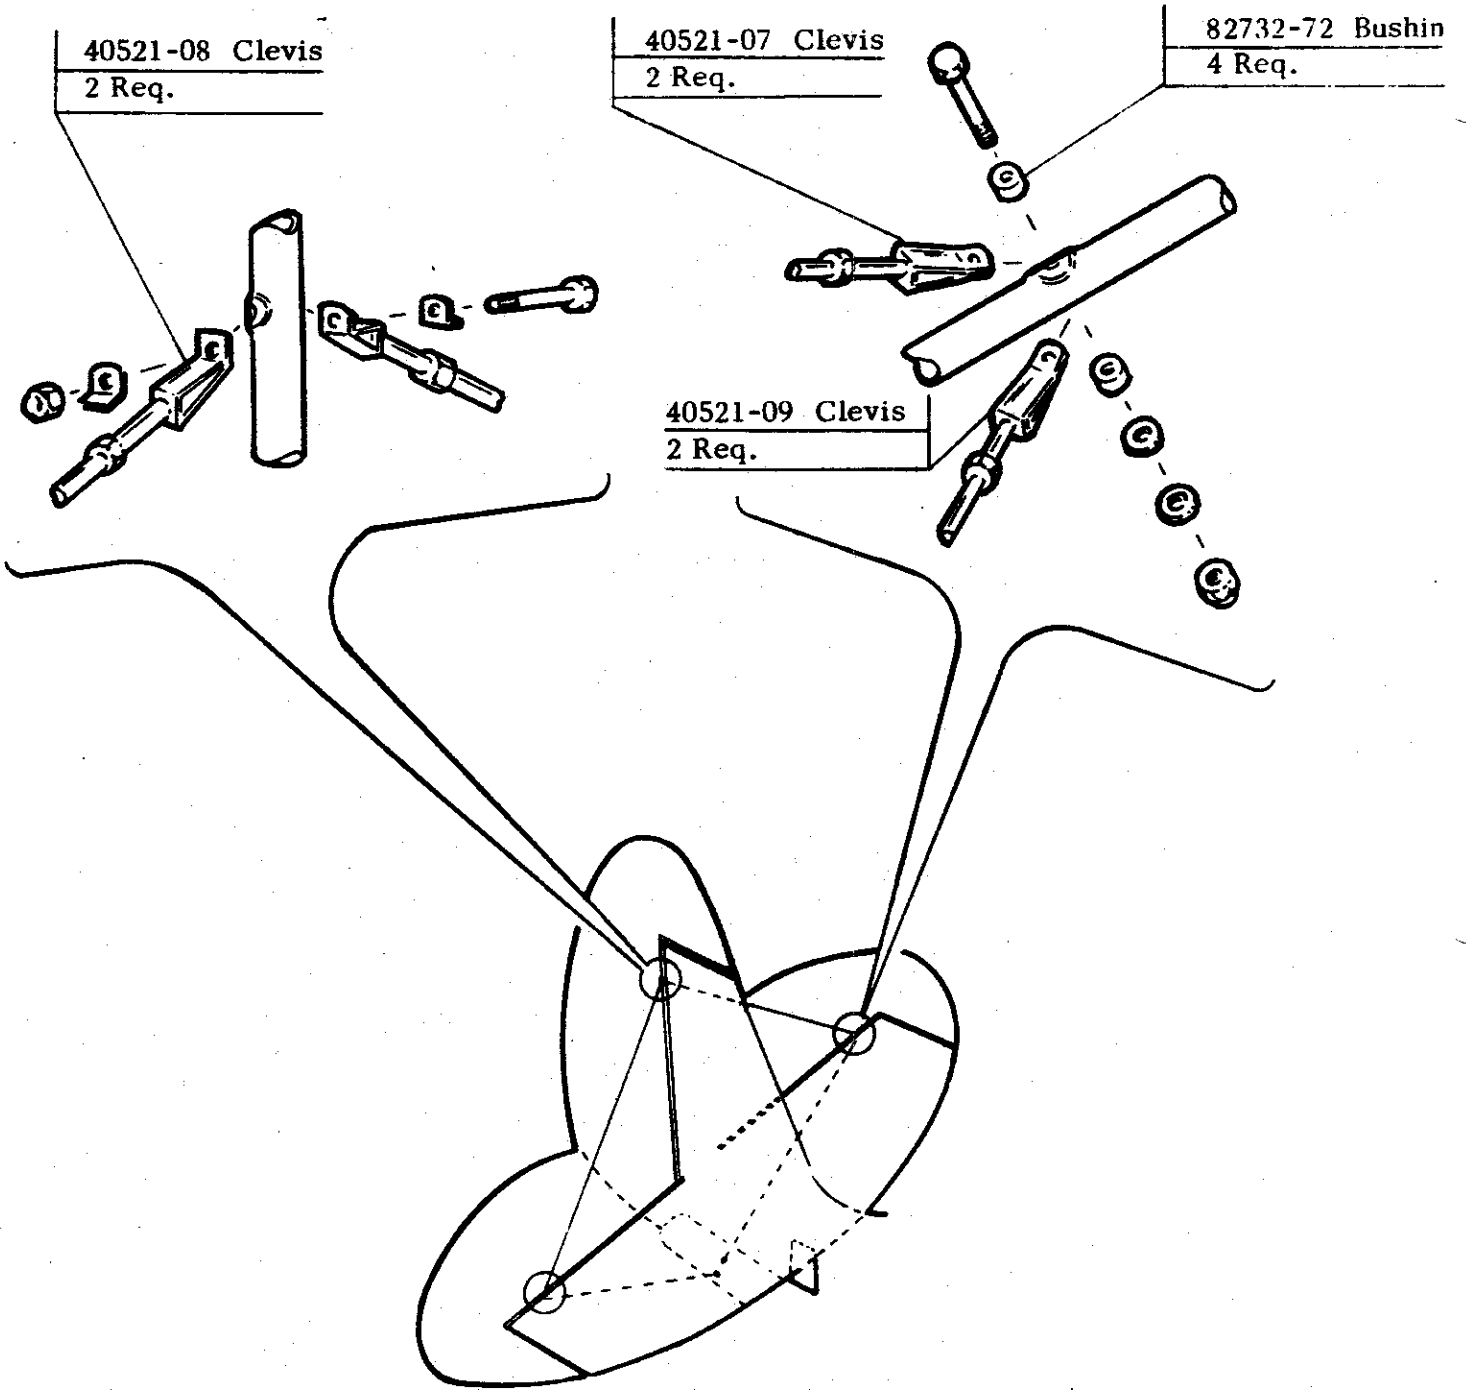
The tail brace clevises and bushings on the aircraft indicated by the above serial numbers are to be replaced.

The sketch on the reverse side of this Service Bulletin will indicate the location of the clevises and bushings to be changed.

Kit No. 754 381, consisting of six (6) clevises and four (4) bushings to comply with this Service Bulletin, will be forwarded by automatic factory distribution. The kit will be provided on a no charge basis. A compliance card is furnished with the kit for this modification. This card must be signed and immediately returned to the factory.
