# SERVICE BULLETIN

No. 351

Piper Aircraft Corporation

Subject: Fuel Line Replacement

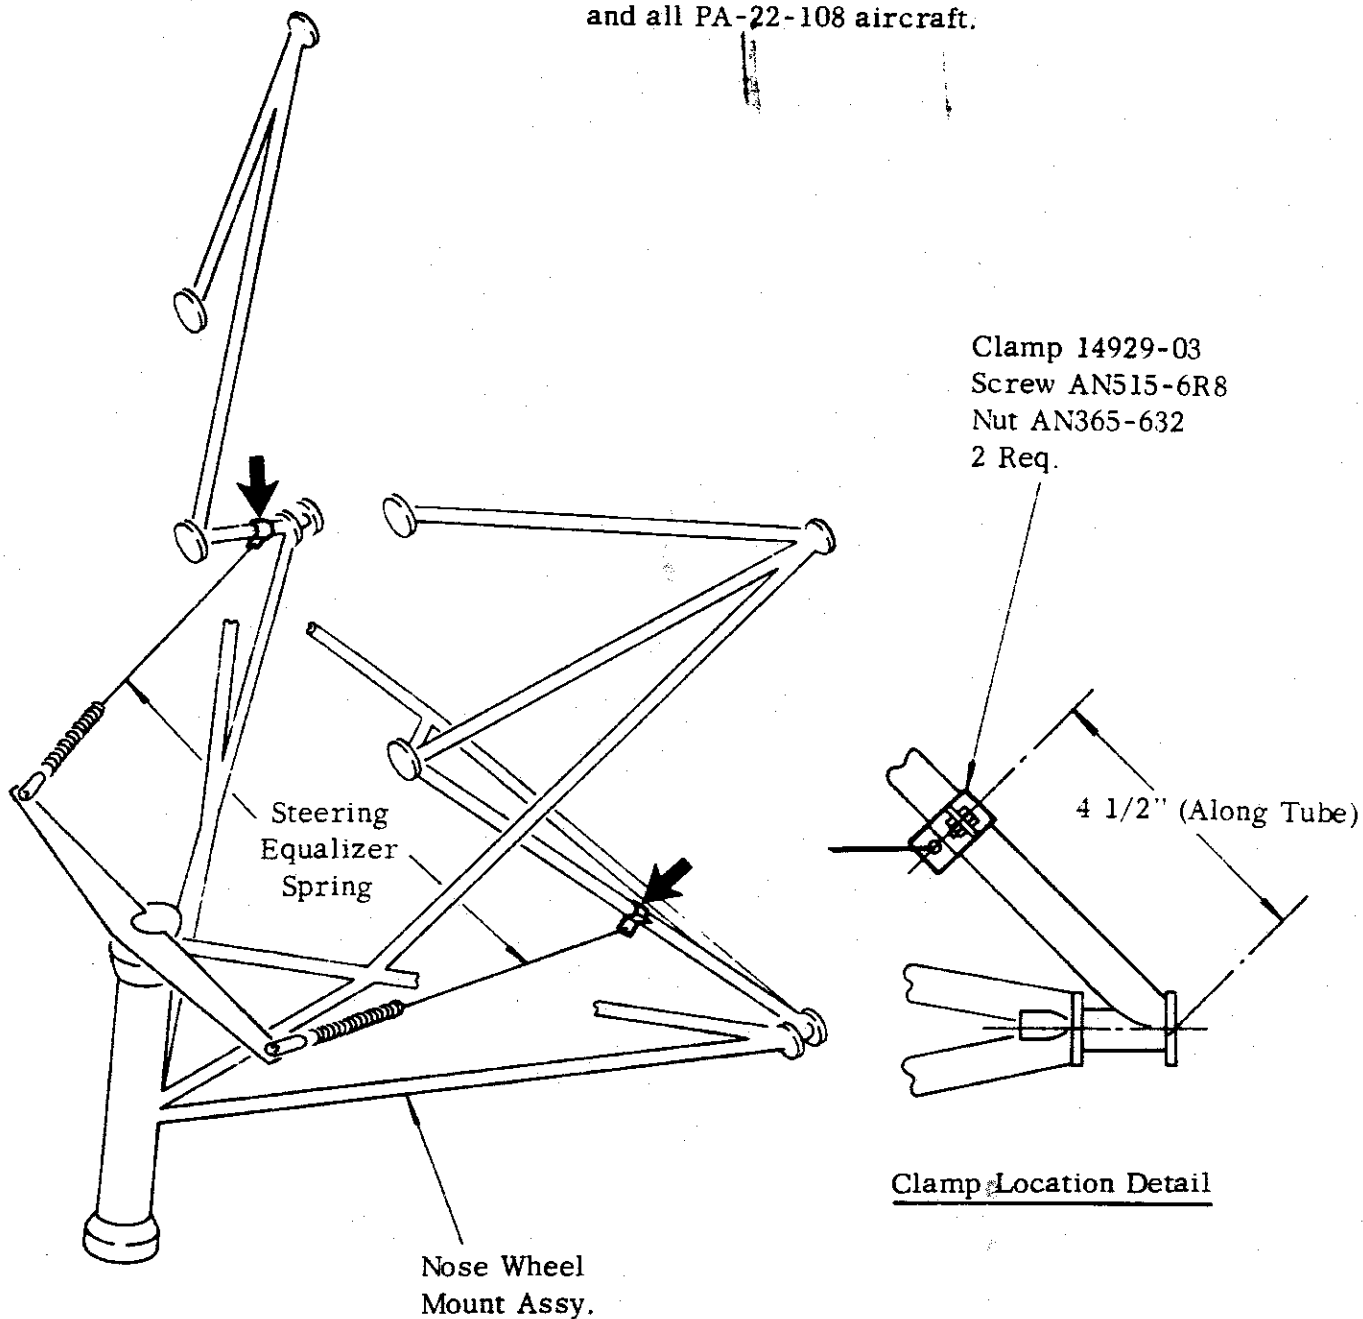
Install clamps 14929-03 as shown on all utility category PA-22-150 and PA-22-160 aircraft and all PA-22-108 aircraft.

1. When replacing original fuel line assembly, Piper part number 70322-32 with newer type fuel line assembly, Piper part number 17766-66, installation kit Piper part number 754 439 is also required (one each per aircraft) @ suggested unit retail price \$1.73C.
2. When replacing the originally installed Piper part number 70322-32 flexible fuel line with the new flexible fuel line, Piper part number 17766-66 on all utility category PA-22-150 and PA-22-160 Tri-Pacers and on all PA-22-108 Colts, serial numbers 22-8000 and up, in addition to the installation kit referenced in Note 1, above, two (2) each clamps Piper part number 14929-03 are required (see sketch on page 3 of this bulletin) @ suggested unit retail price \$4.06.
