# SERVICE BULLETIN

No. 354B

Piper Aircraft Corporation

Subject: Fuel Selector Valve Lubrication

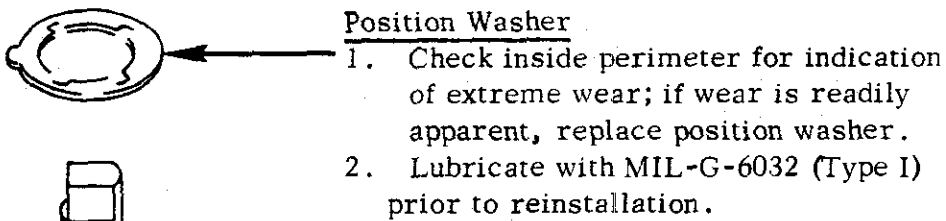
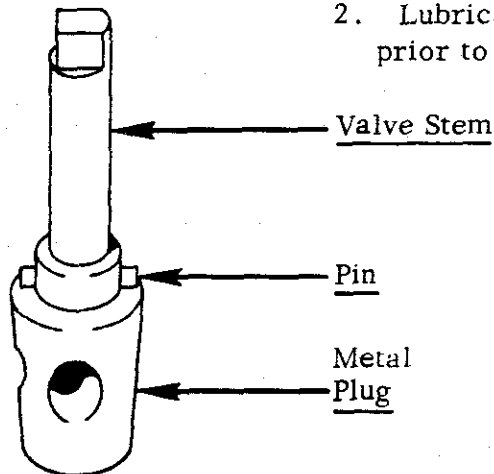
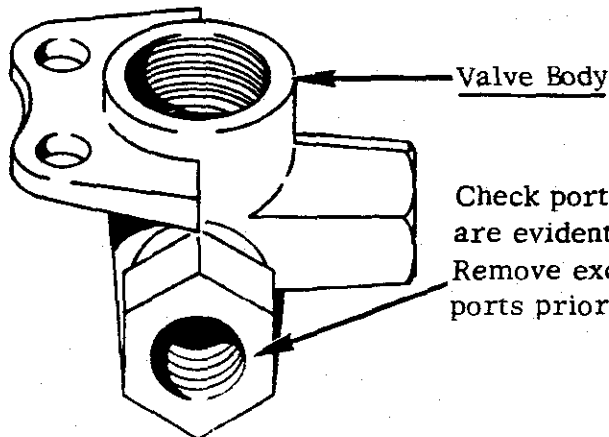
Fuel Selector Valve

3. Check condition of plug and valve body for scored surfaces. The surfaces, if not badly scored, may be conditioned by lapping with a fine grinding compound. Clean away all compound after lapping. If plug will not seat properly or if scoring remains evident, replace valve with Valve Replacement Kit 764 295.

4. Check condition of valve stem in the area where the "O" ring seats. Should the stem be worn or damaged so that the "O" Ring will not seal, replace valve with Valve Replacement Kit 764 295.

Check ports for cracks; if cracks are evident, replace valve. Remove excess grease from ports prior to reinstallation.

1. With the valve removed from the aircraft, remove the valve cap and interior parts (see attached sketch for an exploded view of valve components).
2. Inspect position washer inner perimeter surface for indications of extreme wear; should this be evident, replace position washer. (See Material Required, below.)

6. Clean valve of all foreign matter, lubricate plug with a light film of MIL-G-6032 (Type I) grease, turn the plug several times in its seat and wipe off any excess, especially in the valve ports. Also, lubricate position washer with a light film of MIL-G-6032 (Type I) grease. Reassemble valve with a new "O" ring, Piper Part Number 752 822.
