SERVICE BULLETIN

No. 522

Piper Aircraft Corporation

Wing Fuel Tank Cap Modification.

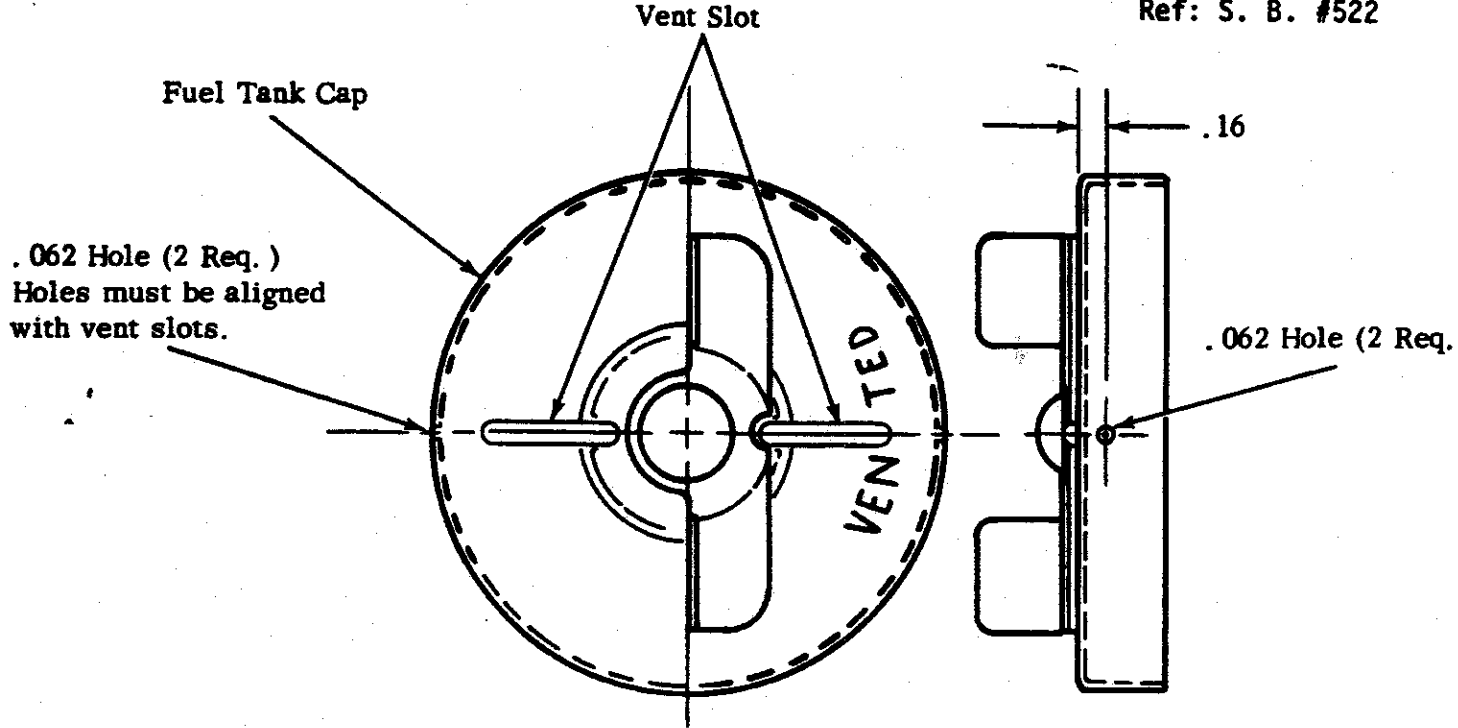
VIEW OF FUEL TANK CAP - P/N 15296-02

Two reports have been received from the field describing collapsed wing mounted fuel tanks, resulting from inadequate venting of the tank. This condition can occur when the fuel tank filler neck gasket is inverted, thus creating a seal between the filler neck and the fuel tank cap, Piper part number 15296-02.

1. Remove fuel tank caps from wings and rework caps by drilling two .062 holes .16 down from top of cap. Holes must be aligned with vent slots as shown.
2. Inspect rubber seal around fuel tank inlet to determine if seal is properly installed as shown.
 - a. If seal is not installed correctly, remove fuel tank cover from wing, reposition seal as shown and reinstall fuel tank cover.
3. Reinstall reworked fuel tank caps and make proper logbook entry of Service Bulletin 522 compliance.
