SERVICE BULLETIN

Piper Aircraft Corporation

Wing Fuel Tank Cap Modification

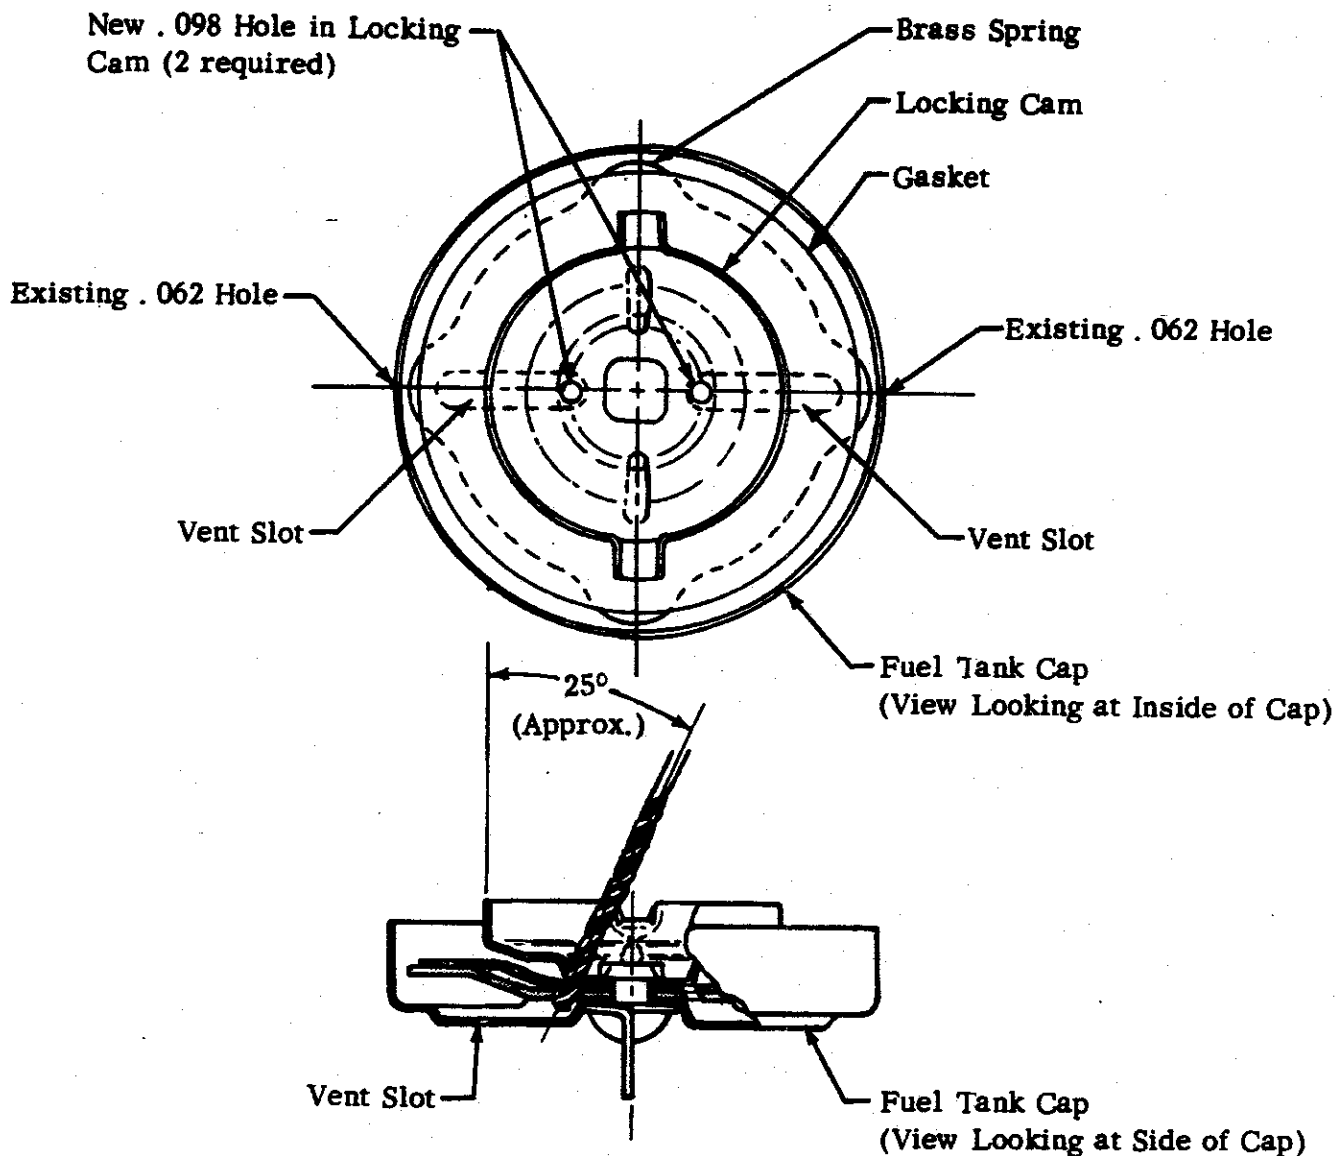
A recent fuel tank collapse was attributed to inadequate venting, caused by obstruction of the cap vent holes (installed per above referenced Service Bulletin). Accumulation of foreign material (corrosion, dirt, ice, etc.) inside the cap "sealed off" the cap internal vent slots.

1. Remove fuel tank caps from wings and rework caps as follows:
 - a. Locate and mark center of two .098 holes on locking cam of cap as shown. Use existing .062 vent holes to index location of new .098 holes.
 - b. Drill two .098 holes (#40 drill) through locking cam. Angle drill to intersect end of vent slots as shown. **CAUTION: Do not allow drill to go through top cover of cap.**
 - c. Insert .032 wire in existing .062 holes. End of wire will be seen in new .098 holes if holes were correctly drilled.
 - d. With .032 wire in .062 holes, slide wire back and forth to loosen any corrosion or dirt that may be in the vent slots. Clean cap thoroughly with compressed air.
2. Reinstall reworked fuel tank caps and make proper Logbook entry of Service Bulletin 573 compliance.
