Piper Aircraft Corporation
Vero Beach, Florida, U.S.A.

SERVICE No. 819 BULLETIN

Fuselage Door Frame Tube Corrosion:
Repair and Protection.

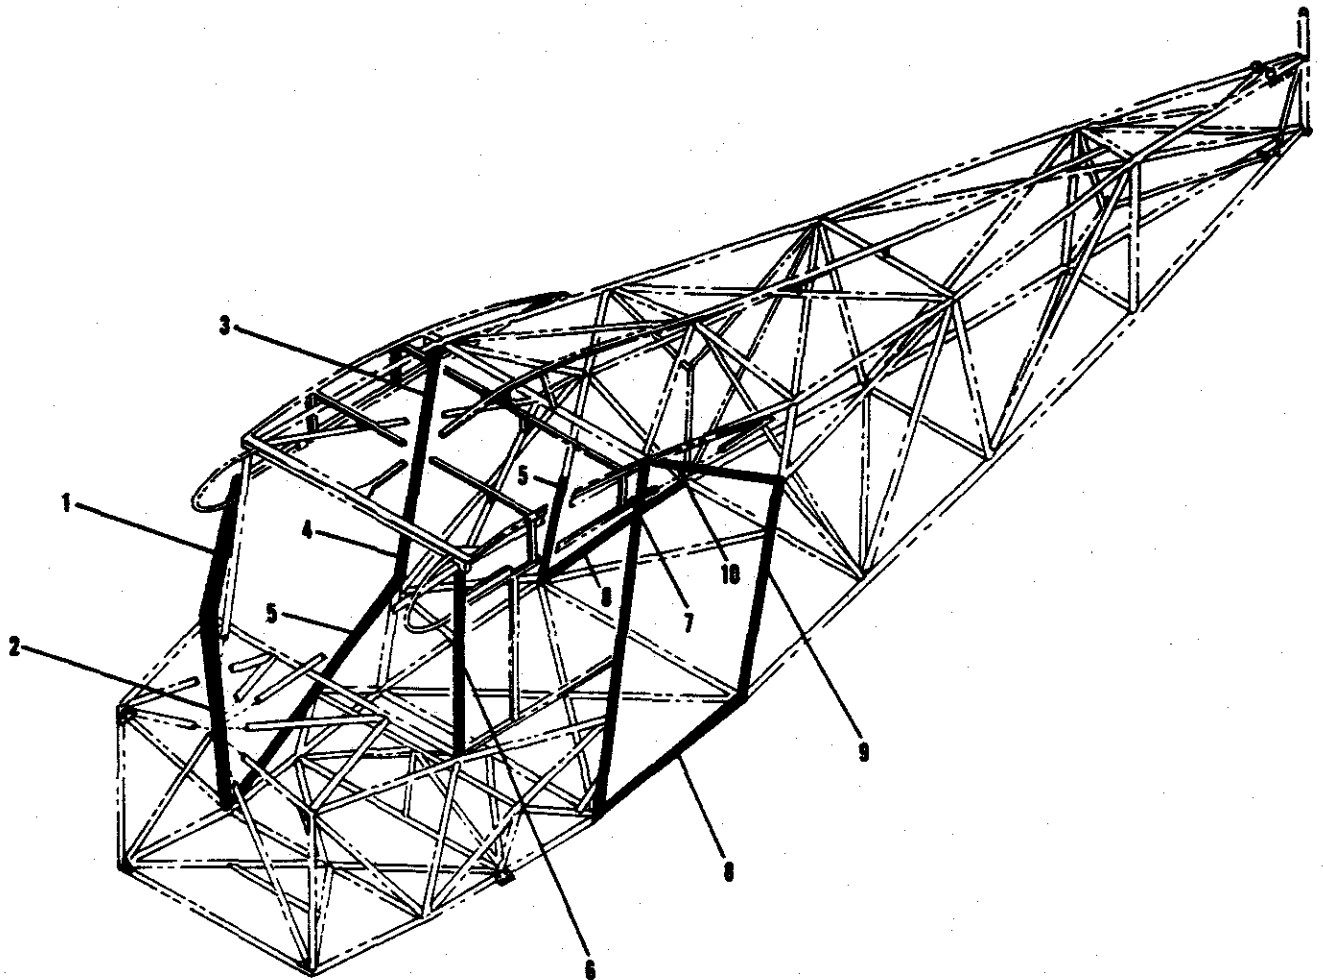
TYPICAL FUSELAGE FRAME ASSEMBLY
(ARTICLE SHOWN IS PA-22)

Reports have been received of the presence of excessive rust and corrosion between steel tubing and preformed sheet steel material, which is welded to the tubing in the door frames, windshield, and baggage areas of the fuselage. The preformed sheet steel can be in the shape of a channel, angle or variation of either which, when welded to the tubing in certain locations, can create a blind area.

If these conditions exist and are left uncorrected, the structural integrity of the fuselage will be compromised.

1. Unless an acceptable alternate method of inspection is approved by the F.A.A., remove the fabric from the door frame, windshield, and baggage areas which are constructed with preformed steel sheet welded over steel tubing. (Ref. drawing).
2. In the door frame(s), windshield and baggage areas, remove the preformed sheet steel from the tubing. Exercise care when smoothing, dressing or cleaning the welds to prevent damage to the tubing.
3. Inspect tubing; repair or replace as required, and add corrosion protection per AC43.13-1A.

4. Install new sheet steel parts fabricated from .032" 4130N steel with a 0.12" minimum bend radius to replace original parts. Tack weld 3/8" lengths on 2" spacing. (See attached Sketch for shapes).
5. Whether or not any repairs are required, coat the blind area between the preformed sheet steel and the tubing with hot linseed oil, paralketone, or other corrosion inhibitor.
6. Clean and refinish exterior of structure per individual preference with good quality aircraft grade primer.
7. Repair or replace fabric as required per AC43.13-1A, or applicable Supplemental Type Certificate.
8. Make an appropriate logbook entry of compliance with this Service Bulletin.
