Piper Aircraft Corporation  
Vero Beach, Florida, U.S.A.

**SERVICE** No. 910A

Date October 10, 1989 S

SUBJECT: **Wing Lift Strut Assembly  
Inspection/Replacement**

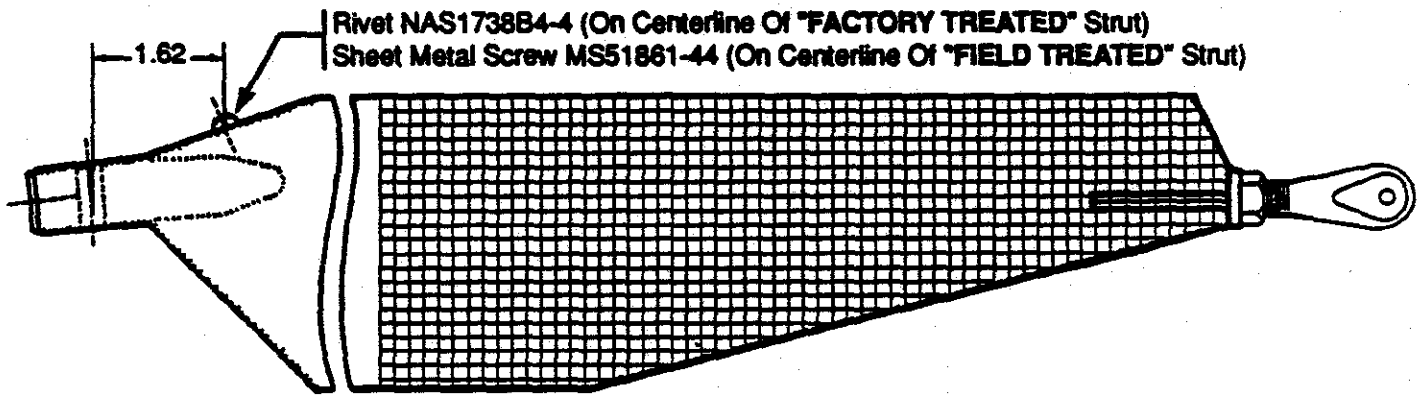
**VIEW OF MAULE FABRIC TESTER**

1. Securely tape a sheet of thin 1/4 inch graph paper to the lower 11 inches of the top and bottom surface on all wing lift struts.
2. Using a Maule "Fabric Tester" and holding tool normal to strut contour, apply pressure at a scale reading of 80 in each of the grid blocks.
3. Remove the paper and inspect the lift strut tubes. A perceptible dent will appear if internal corrosion is present. If any dents are found, be certain the dent are in the metal by carefully removing the paint.
  - a. Lift strut tubes indicating the presence of any perceptible dent in the metal must be replaced with a new lift strut assembly before further flight.
  - b. If no dents appear in the metal, the lift strut may be considered airworthy.

- a. Remove lift strut from aircraft.
  - b. Inject one quart of Valoil, Lionoil Multi-Purpose L-1, Linseed Oil, Paralketone or any alternate preservative conforming to Federal Specification TT-S-1760, into the bolt hole at the top of the strut.
  - c. Plug the bolt holes and slosh oil until interior of strut is thoroughly coated.
  - d. Drain oil from strut (through bolt holes) and install MS51861-44 sheet metal screw, as shown, for future identification.
  - e. Reinstall strut to aircraft and rig.
4. Record lift strut inspection in aircraft logbook.
