BULLETIN

Piper Aircraft Corporation
Vero Beach, Florida, U.S.A.

(Service Bulletin No. 924 supersedes and voids Service Letter No. 392 dated January 17, 1963)

SUBJECT: Shimmy Dampener Replacement

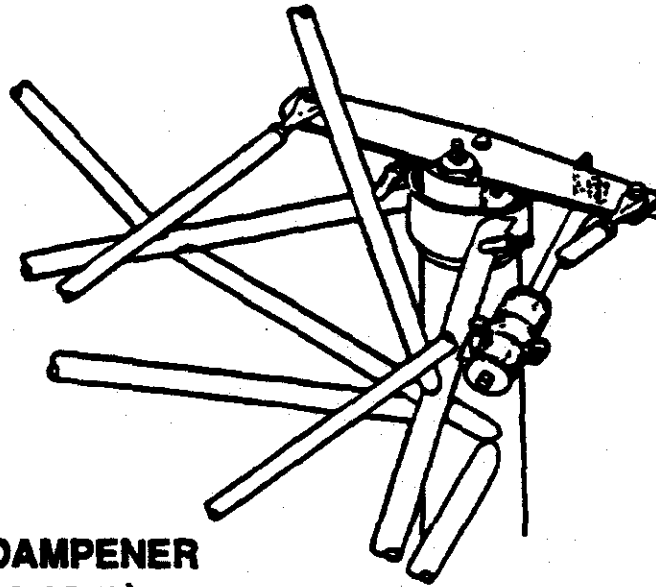
SKETCH "A"

PURPOSE: It is possible that through improper installation or by the lack of maintenance and lubrication that the shimmy dampener may bind or become unserviceable. Should this occur, especially on aircraft equipped with the early model shimmy dampeners, the possibility exists that during a maximum left turn the shimmy dampener shaft may jam or bend, causing loss of nose wheel steering. This condition could possibly lead to partial or total loss of rudder control.

**SHIMMY DAMPENER
(EARLY MODEL)
TRI-PACER - PART NO. 13086-00
(IDENTIFICATION)**

- 1. Remove cowling as necessary to gain access to nose wheel shimmy dampener. Refer to applicable Owners Manual or Parts Catalog.
2. Shimmy Dampeners with Piper Part Number 13086-00, as identified on Sketch A (attached), should be removed, discarded and replaced by Piper Part Number 21701-06.

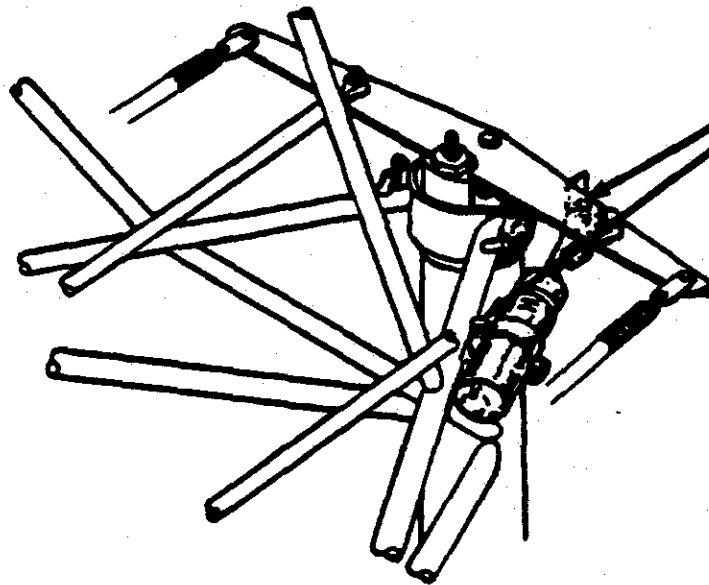
SKETCH "B"

**CHECK FOR
FREEDOM OF
ANGULAR TRAVEL**

**SHIMMY DAMPENER
(LATER MODEL)
TRI-PACER - PART NO. 21701-02
COLT - PART NO. 21701-04
(IDENTIFICATION)**

3. If the shimmy dampeners with Piper Part Numbers 21701-02 and 21701-04, Sketch B (attached), are inspected and determined to be serviceable and airworthy and the instructions below are complied with, those shimmy dampeners may be returned to service.

4. Determine that nose wheel travel is 20 degrees left and right of center.
5. Determine that the shimmy dampener rotates freely on the axis of its attachment bolt throughout its full travel, especially as it approaches the limits of nose wheel travel.

6. Determine that the attachment of the shimmy dampener rod end to the nose wheel steering arm is free to accept angular travel in either direction.
7. Should any stiffness, restrictions, or other maladies be noticed, correct by replacing parts and adjusting as necessary until proper fit and function is obtained.

8. A regular maintenance routine of inspection, cleaning, and lubrication should be performed at each one hundred (100) hours of operation or at any inspection event. Lubricate shimmy dampener rod end and pivot point using general purpose low temperature oil (MIL-L-7870 or equivalent). Wipe shimmy dampener shaft using a clean cloth saturated with MIL-H-5606 hydraulic fluid.
