Service Letter No. 136A

September 2, 1952

**TO: Owners of PA-20 and PA-22 Airplanes with serial numbers  
20-1 through 20-923 and 22-1 through 22-775**

**SUBJECT: Chafing of Fuel Line and Fuel Valve Operation**

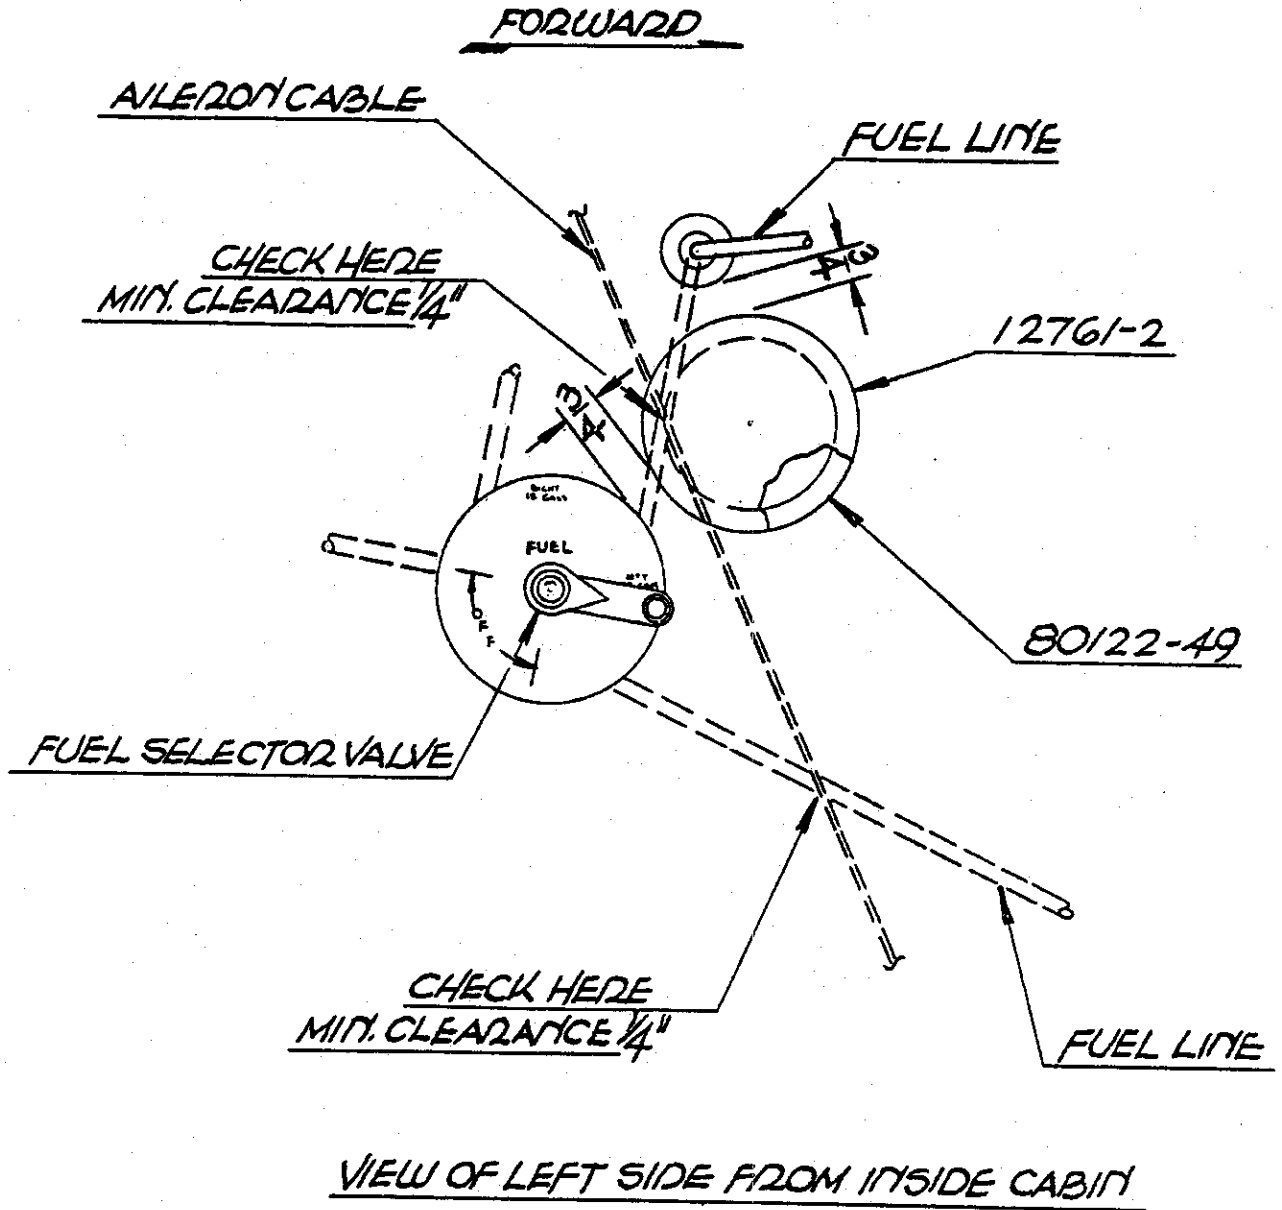
Sketch for Service Letter No. 136A

It is necessary that an inspection be made of the aluminum fuel lines forward of the fuel valve.

Inspect the fuel lines for evidence of chafing by the aileron control cable. Check the clearance between the fuel lines and the cable. If 1/4" or more clearance exists no further action is required. If 1/4" minimum clearance has not been provided, form the fuel lines by hand to obtain this minimum clearance. Exercise care while forming to avoid crushing or kinking the fuel lines.

To accomplish this, dope the pyralin grommet, 80122-49, to the fabric inside the cabin as shown in the sketch. Cut away the fabric enclosed within the grommet.

Upon completion, install the cover, 12761-02, as shown in the sketch.
