SERVICE LETTER

No. 186

Piper Aircraft Corporation

SUBJECT: Clearance between the Engine Mount and the Exhaust Tail Pipe and
Clearance in the Nose Wheel Steering Mechanism

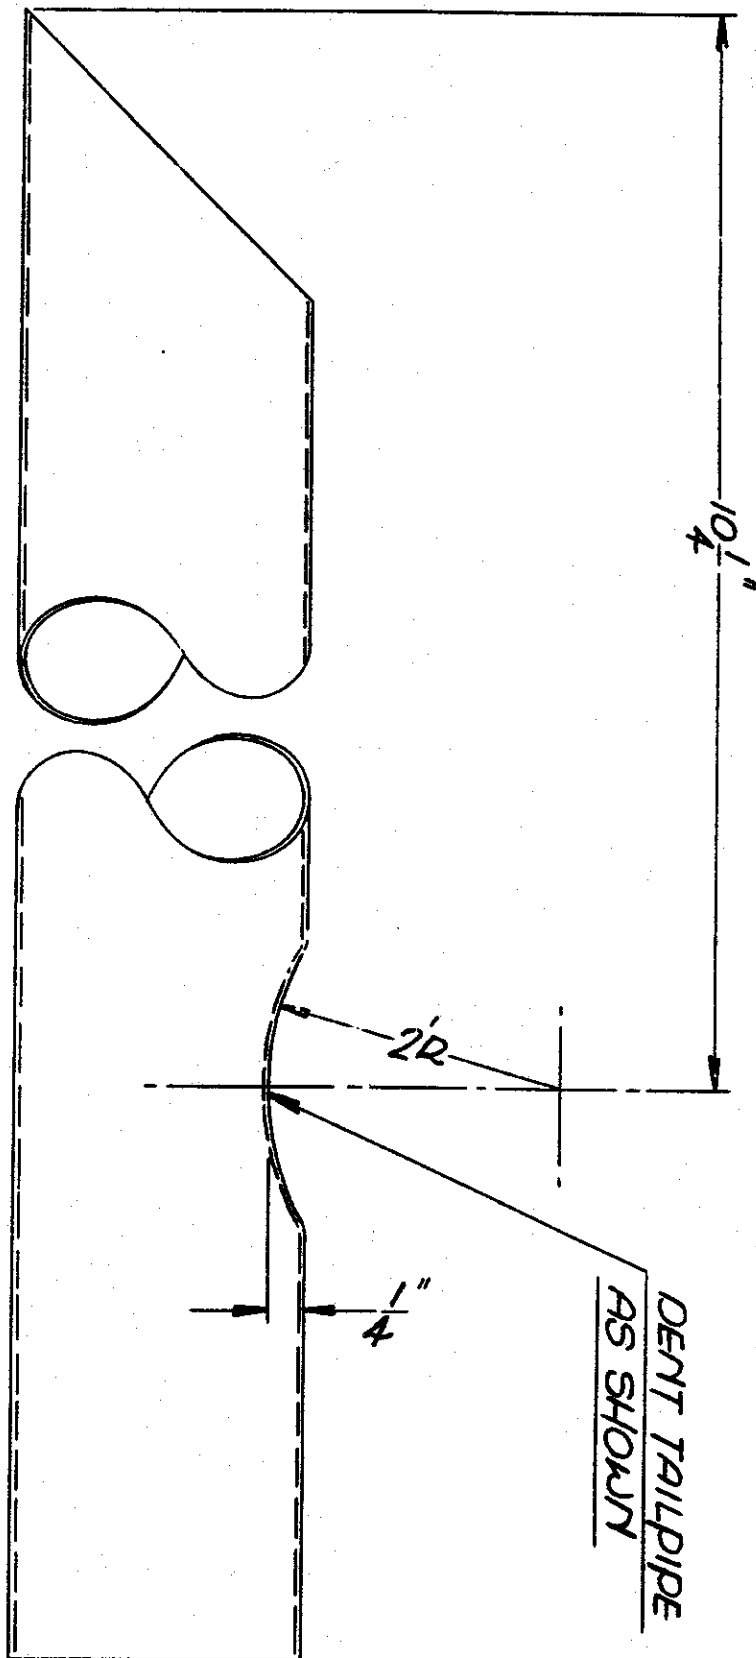
Sketch for Service Letter No. 186

It has been brought to our attention that the clearance between the engine mount and the tail pipe on the subject model airplane is not adequate and in some cases the tail pipe has rubbed the diagonal motor mount tube causing the tube to become somewhat grooved, due to the rubbing and scrubbing action of the tail pipe.

It has been reported that there have been cases of interference between the cross-over exhaust stacks and the nose wheel steering rod ends. We suggest that you investigate the possibility of this condition existing in your airplane and take corrective action if necessary. Proper clearances can be obtained by denting the exhaust stack tubes at the points of contact by using the same steps and dimensions as shown in the tail pipe sketch.

In the event it is impossible to obtain the proper clearance then the tail pipe should be modified in accordance with the attached sketch.
