Service Letter No. 212

**Subject:** Nose Wheel Shimmy Dampener, Part No. 13086-00

**Models Affected:** All 1953 Model PA-22's with serial numbers 22-807 to 22-1614 inclusive, 22-1616 to 22-1631 inclusive, 22-1633 to 22-1635 inclusive, 22-1638, 22-1642, 22-1646 to 22-1648 inclusive, 22-1651, 22-1653, 22-1655, 22-1656, 22-1658 to 22-1661 inclusive, 22-1666, 23-1667, 22-1672, 22-1678, 22-1680, 22-1682 and 22-1683.

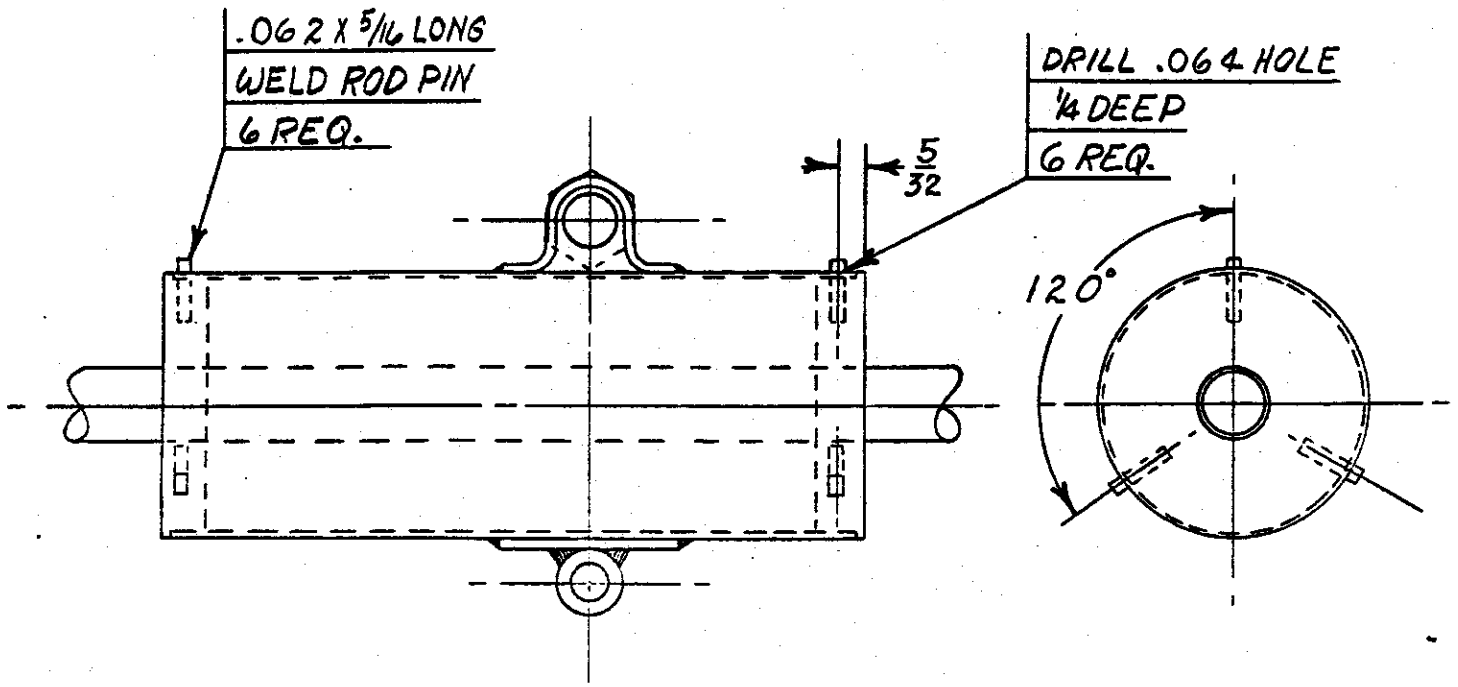
During the past few months we have received from the field a number of shimmy dampeners, part number 13086-00, on which a separation has occurred between the assembly body and the end plate. This separation was due to solder breaking loose and the internal fluid pressure plus the friction of the plunger forcing the end plate outward.

All production airplanes have been modified in accordance with the sketch shown on the reverse side of this Letter and it is felt that this modification can be satisfactorily executed in the field as a service-fix. Upon inspection if the shimmy dampener shows signs of separation, it will be exchanged free-of-charge at the nearest Piper Distributor or Dealer.

DRIVE PIN INTO EACH HOLE AND SOLDER END, COVERING  
PIN WITH SOLDER.
