# SERVICE LETTER

No. 328

Piper Aircraft Corporation

SUBJECT: Replacement of Guide Collars with New Forged Collars on Certain Non-Feathering Flange Mounted Propellers.

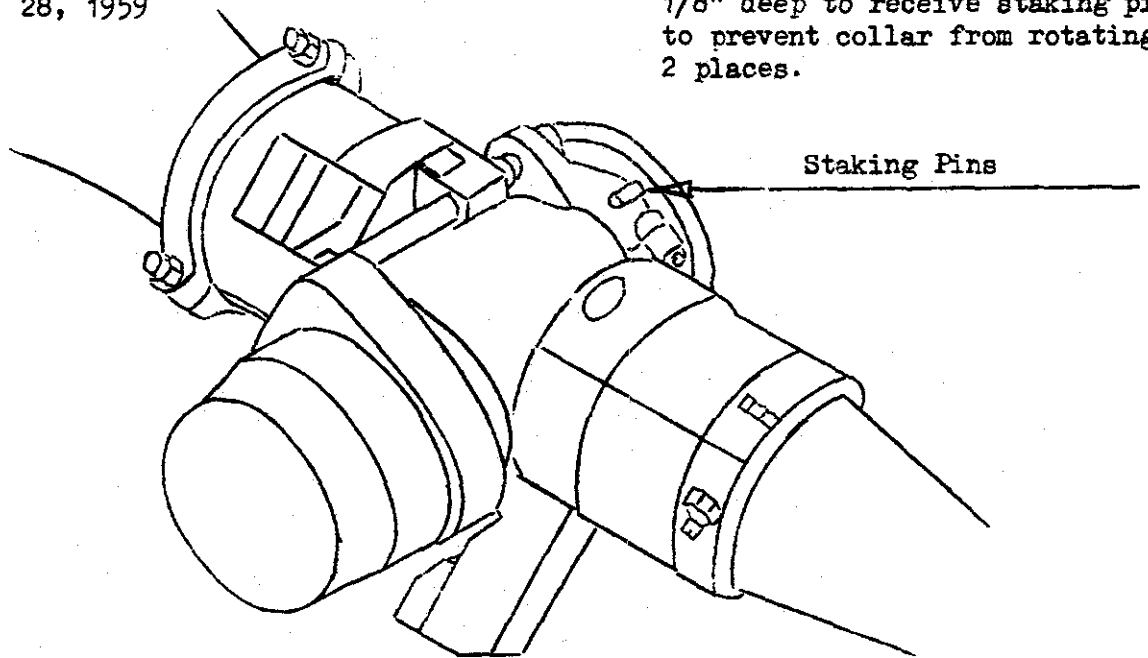
After collar is properly located to receive piston guide rods, spot face edge of collar, approx. 1/8" deep to receive staking pins to prevent collar from rotating, 2 places.

Models

HC-82XG-1D  
HC-82XG-6DL  
HC-82XL-1D  
HC-92ZK-8D  
HC-82XK-1D  
HC-92ZK-8L

When the new collar is installed, it will be necessary to spot face the edge of the new guide collar thru the two dowel pin holes and reinstall the dowel pins as shown on Page 3.

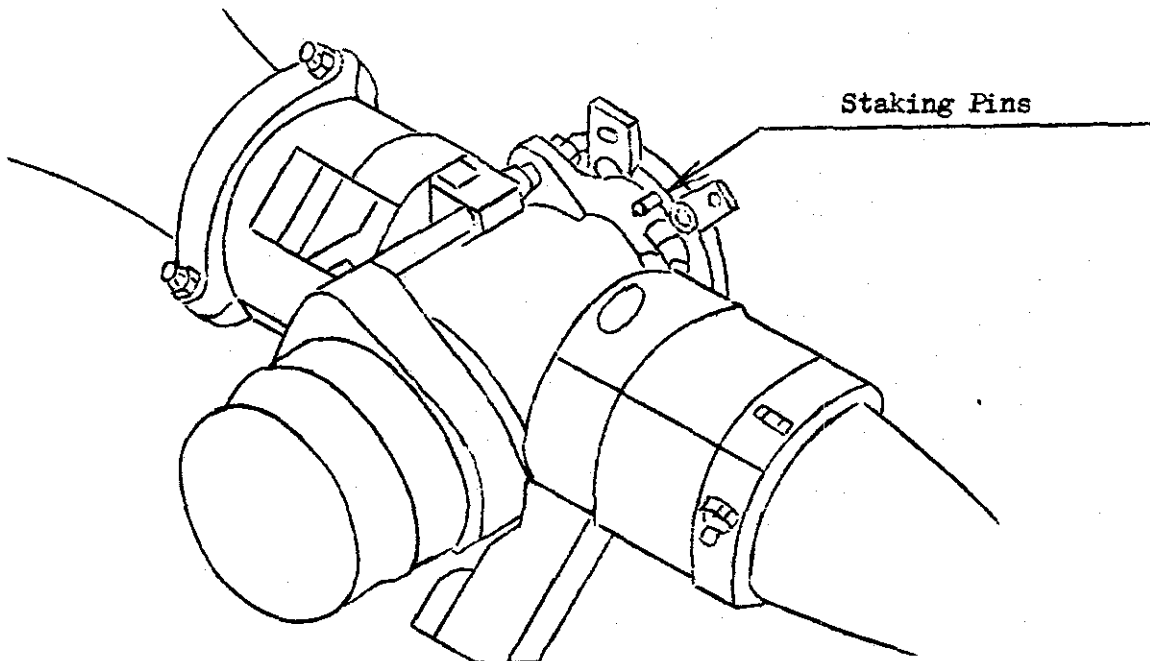
Models

HC-82XF-1D  
HC-82XF-1DB

First, install 4 spinner lugs, using new AN4E-4A bolts. After collar is properly located to receive piston guide rods, spot face edge of collar approximately 3/32" deep to receive staking pins to prevent collar from rotating, 2 places.

CAUTION!!! - For Model HC-82XF-1DB, the two steel dowel pins inserted in both the engine and propeller flanges are located 60° from the aluminum staking pins shown. BE SURE TO REPLACE THESE PINS. For the other models, the dowel pins also serve as collar staking pins.

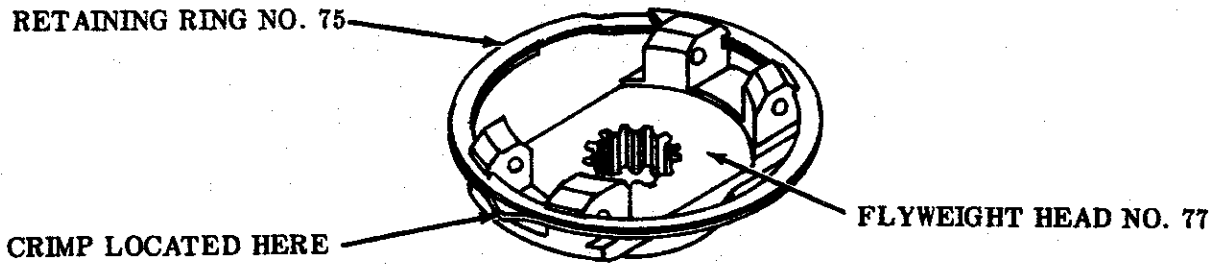
To describe the proper installation of the flyweight retaining ring. Torsional vibration from the engine to the governor drive tends to cause relative rotation between the flyweight head (77) and the retaining ring (75). If the crimped leaf of the retaining ring climbs the chamfer on the lug of the flyweight head, the crimp will no longer be positively retained between the flyweight head lugs, and the retaining ring may be rotated out of the retaining ring groove. Removal of the retaining ring from the flyweight head releases the flyweight pins which causes the governor to be non-controlling, in addition to causing internal damage to the flyweight cavity of the governor body. Installation of the retaining ring, with the crimp down, prevents the crimped leaf from climbing out of the groove on the flyweight head lug.

**DETAILS** Retaining ring (75) must be installed on the flyweight head with the crimp of the retaining ring toward the thrust bearing surface and between the flyweight lugs as shown in Figure No. 1. Be sure that the retaining ring is properly seated in the groove. ALL GOVERNORS SO MODIFIED MUST BE STAMPED WITH S22 ON THE GOVERNOR NAMEPLATE.
