# SERVICE LETTER

No. 329A

Piper Aircraft Corporation  
(Supersedes Service Letter No. 329)

**SUBJECT:** Inspection of Oil Cooler Lines, Oil Cooler Line Securing Clamps and Oil Cooler Line Attachments to Oil Radiator

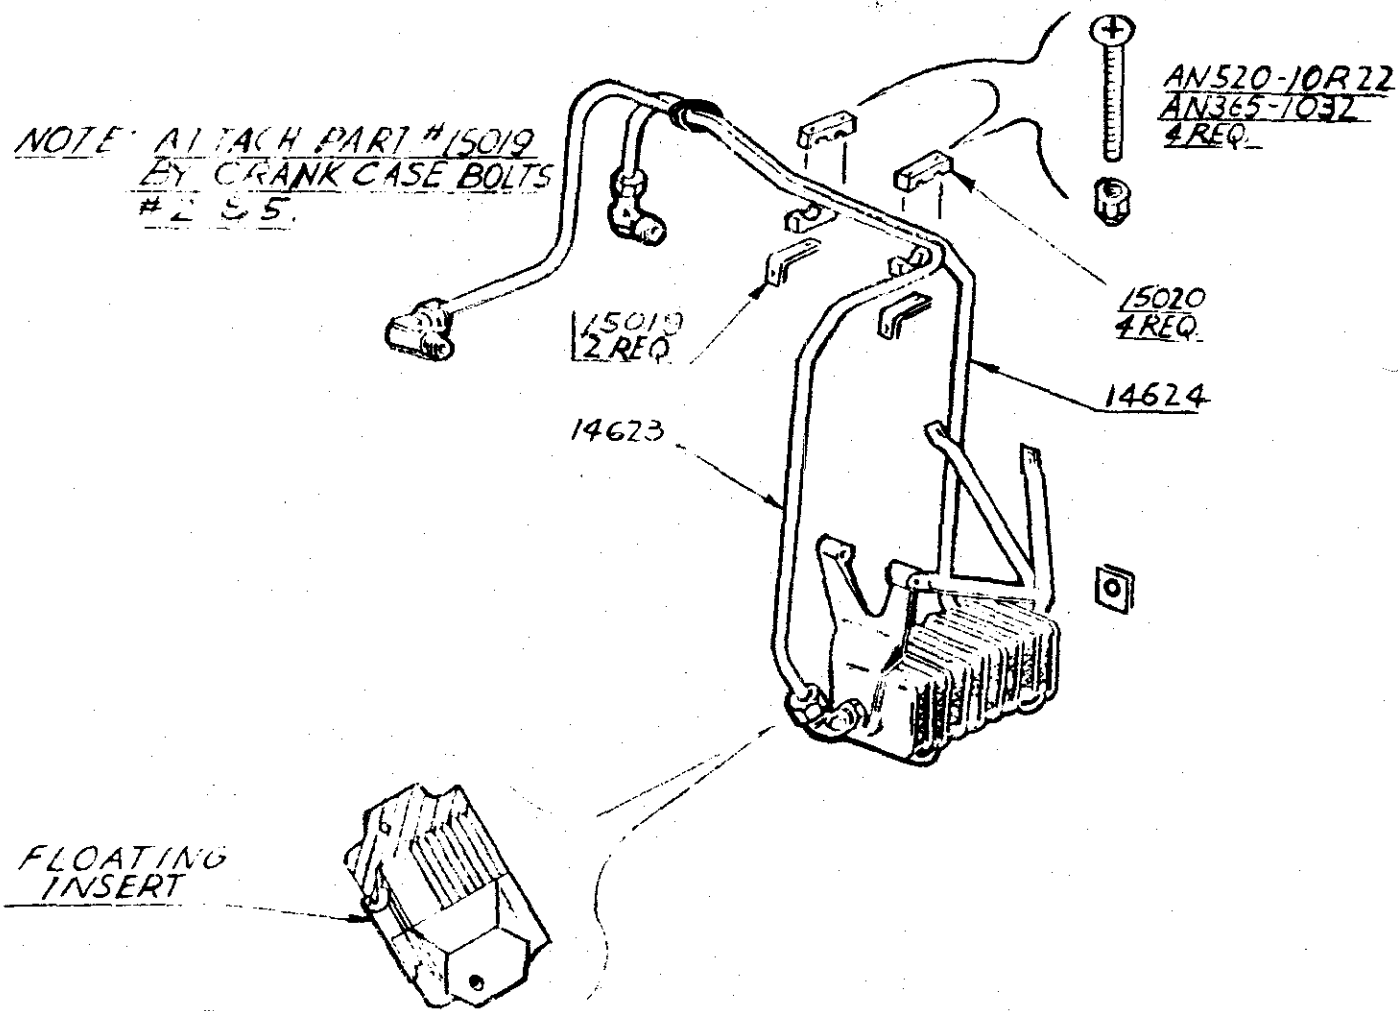
SERVICE LETTER 329 A

Improperly installed compression nuts, misalignment of oil cooler lines, worn or loose retaining blocks may result in a broken oil line and loss of power.

Serial Nos. 22-6760, 22-6761, 22-6763 and up were equipped with improved oil line retaining blocks, part number 15020-00, and brackets, part number 15019-00. These will aid in further reducing the effects of misalignment and vibration. We recommend the installation of the new type retaining block and bracket on Serial Nos. 22-3886 to 22-6759 inclusive and 22-6762. See Sketch on reverse side.

We wish to advise that on Serial Nos. 22-6880 and up the oil radiator lines were equipped with compression nuts containing a floating insert, part number 14623-00 - 14624-00. These new oil lines will reduce the effects of misalignment and vibration and recommend that on Serial Nos. 22-3886 to 22-6879 inclusive, these improved lines be installed if present lines do not incorporate compression nuts with floating inserts.

NOTE:  
OIL COMPRESSION NUT SEAL  
RING ALL OVER BEFORE  
TIGHTENING. TIGHTEN TO  
125 IN. LBS. THEN SAFETY.
