# SERVICE LETTER

No. 373

Piper Aircraft Corporation

**SUBJECT:** Installation of Oil Shields on Airborne Mechanisms Dry Vacuum Pumps, Models 113A1 and 113A5

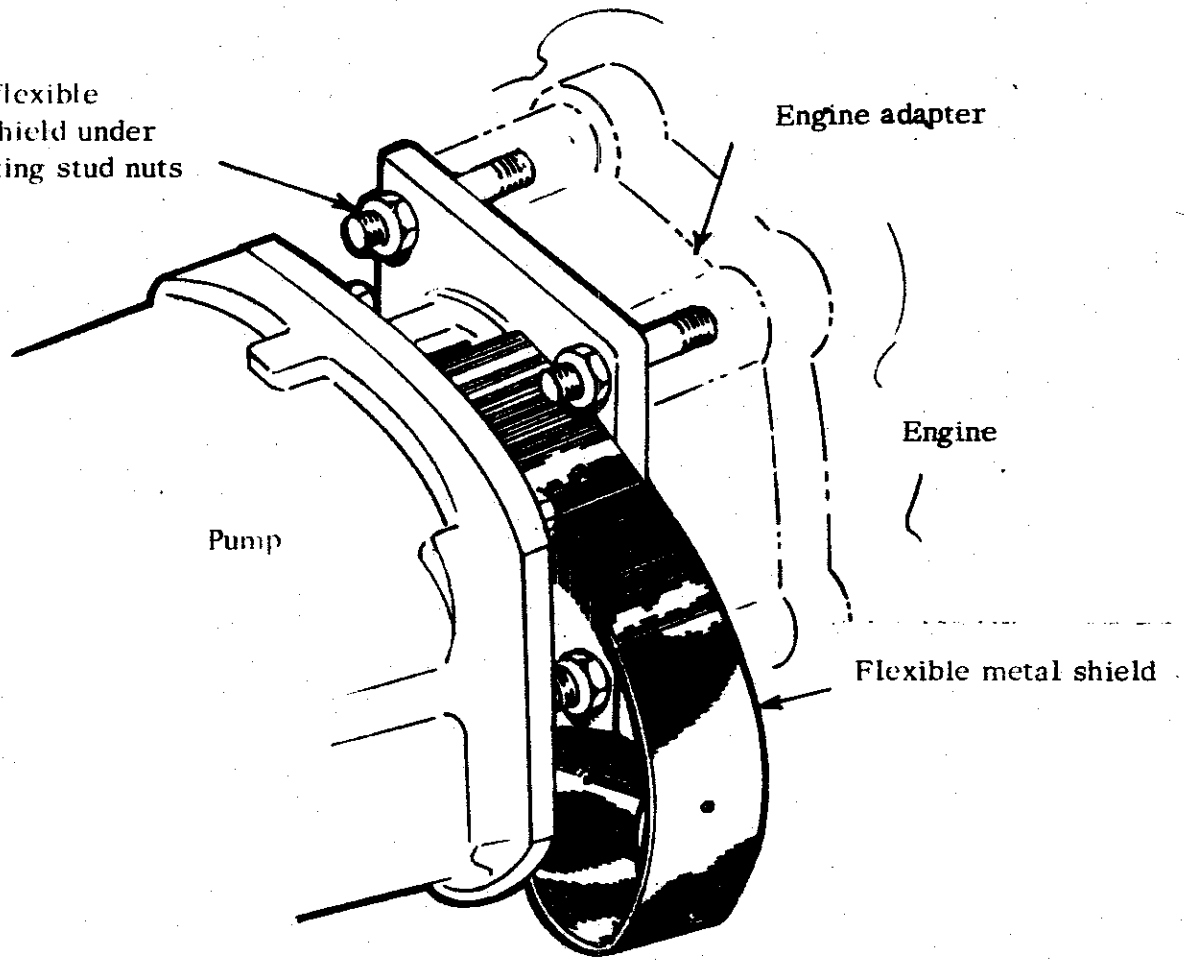
It has been determined that occasionally oil or cleaning solvents have entered the ventholes in the face of the mounting flange of the 113A1 and 113A5 Airborne Mechanisms dry vacuum pump.

A flexible metal shield, part number 756 143, which is easily installed by threading under the pump mounting bolts, has been designed to protect these openings. Removing the pump is not necessary and the shield does not require fastening as the spring tension of the shield will hold it in its proper position, once installed. Installation of this shield is recommended on the subject aircraft equipped with Airborne Mechanisms Dry Vacuum Pumps. See sketch on the reverse side of this letter.

Install flexible  
metal shield under  
4 mounting stud nuts

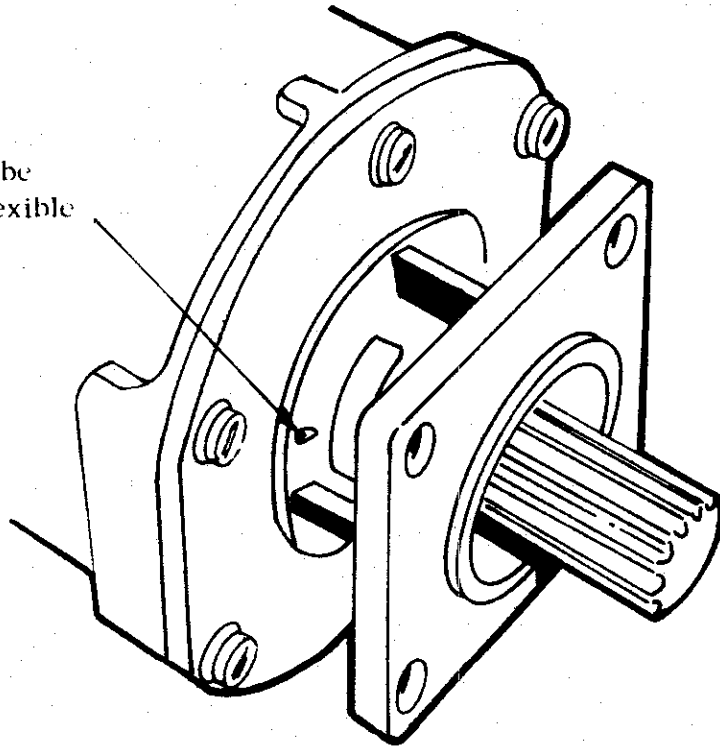
Vent holes to be  
covered by flexible  
metal shield
