# SERVICE LETTER

No. 392

Piper Aircraft Corporation

**SUBJECT:** Inspection and Adjustment of Nose Wheel Shimmy Dampener Assembly

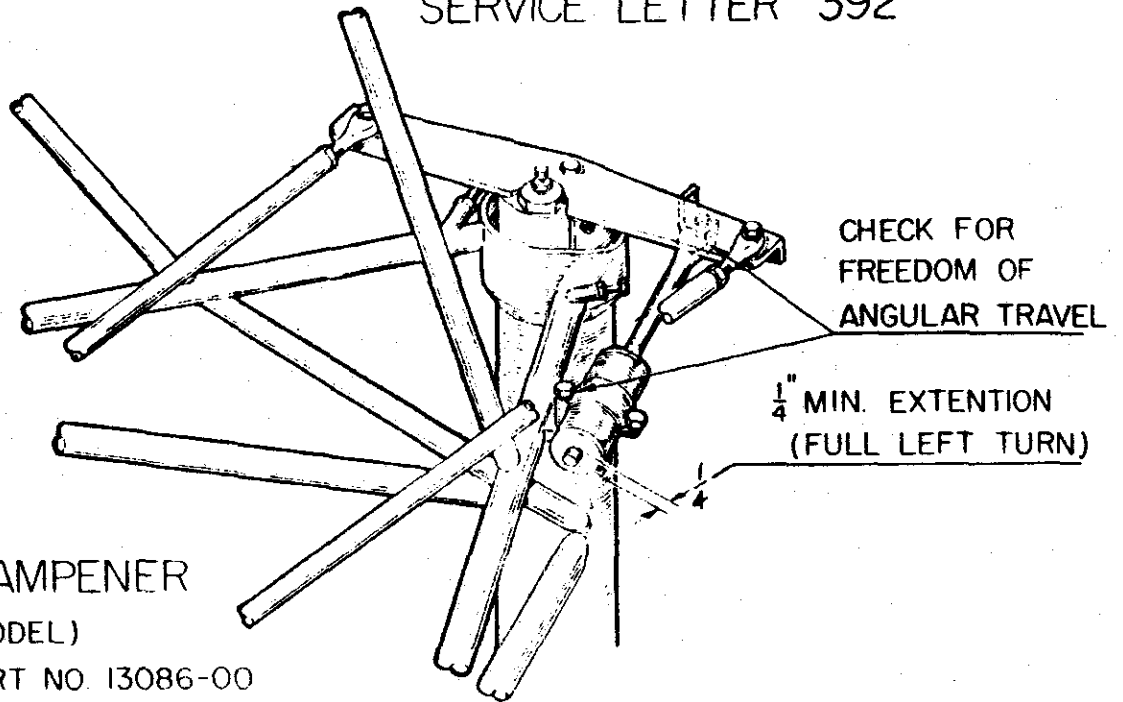
SHIMMY DAMPENER

- I. Should the above systems become maladjusted on aircraft equipped with the early model nose wheel shimmy dampener, part number 13086-00, it is possible that, in a maximum left turn, the shaft of the shimmy dampener may enter the end of the dampener housing and jam; thus making any further movement of the nose wheel impossible.

- II. It may also be possible that, through lack of attention during maintenance and inspection, the shimmy dampener may "freeze" to its attachment to the nose wheel structure. In other words, at large angles of nose wheel steering, relative angular travel must be maintained for the dampener. Should the bolt which attaches the dampener become corroded to the supporting structure etc., it would be possible to bend the shaft at the point where it exits from the dampener body.

- III. Freedom of angular travel must also be maintained at the point where the rod end attaches to the nose wheel steering arm. Lack of angular travel at this point could cause bending of the dampener shaft or bending of the rod end with possible failure of the rod end in the threads.

1. Determine that the nose wheel travel is 20° left and right.
2. Determine that the shimmy dampener rotates freely on the axis of its attachment bolt when approaching the limits of nose wheel travel.
3. Determine that the attachment of the rod end to the nose wheel steering arm is free to accept angular travel.
4. The shimmy dampener should be adjusted, if necessary, so that at full left nose wheel travel, not less than 1/4 inch of the shaft shall be exposed on the back side of the dampener. (Applicable to early type shimmy dampener, part number 13086-00 only.)
