S. M. No. 10

Rib Repair Diagram

PIPER AIRCRAFT CORP.
LOCK HAVEN, PENNA.
SERVICE DEPARTMENT

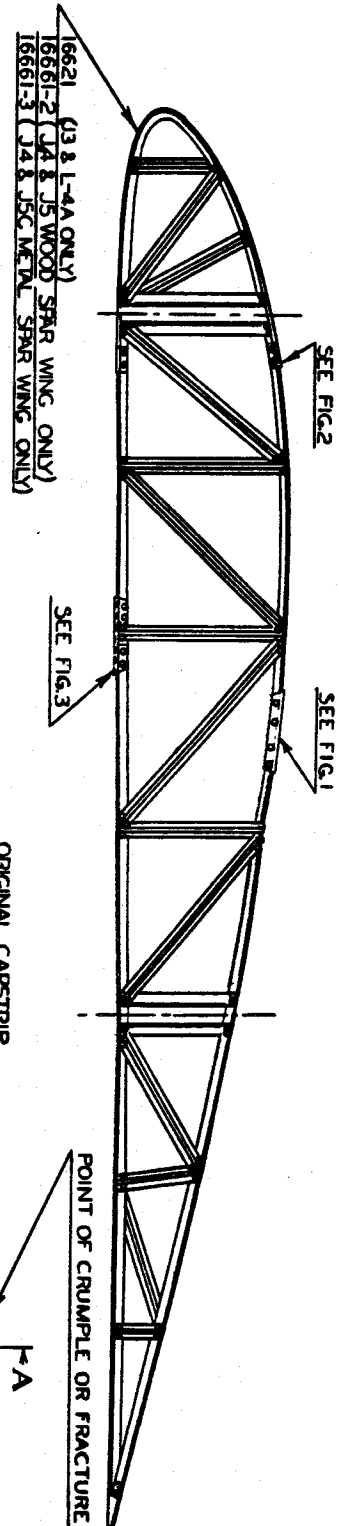
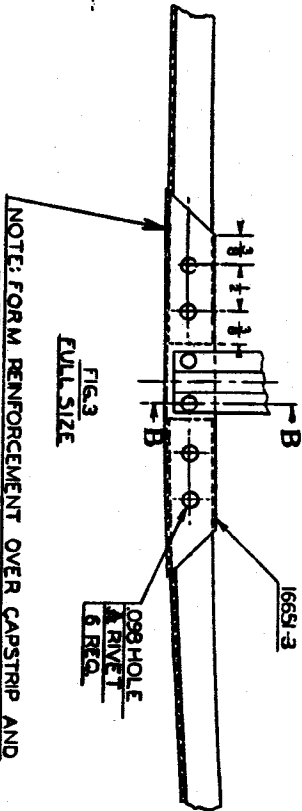
NOTE: CAPSTRIP MAY BE SPLICED OR REINFORCED ANYWHERE EXCEPT FORWARD OF FRONT SPAR OR AT A CLUSTER.

NOTE: THIS REPAIR MAY BE USED AT ANY POINT ON CAPSTRIP EXCEPT AT CLUSTERS OR FORWARD OF FRONT SPAR.

NOTE: FORM REINFORCEMENT OVER CAPSTRIP AND RIVET TO WEB OF CAPSTRIP AS SHOWN.
