SERVICE No. 1041 BULLETIN

SUBJECT: Distribution of Airborne Service Letter Number 56, "Inspection and Cleaning of Airborne Air Filter Elements"

Service Letter Number: 56

Subject: Inspection and Cleaning of Airborne Air Filter Elements.

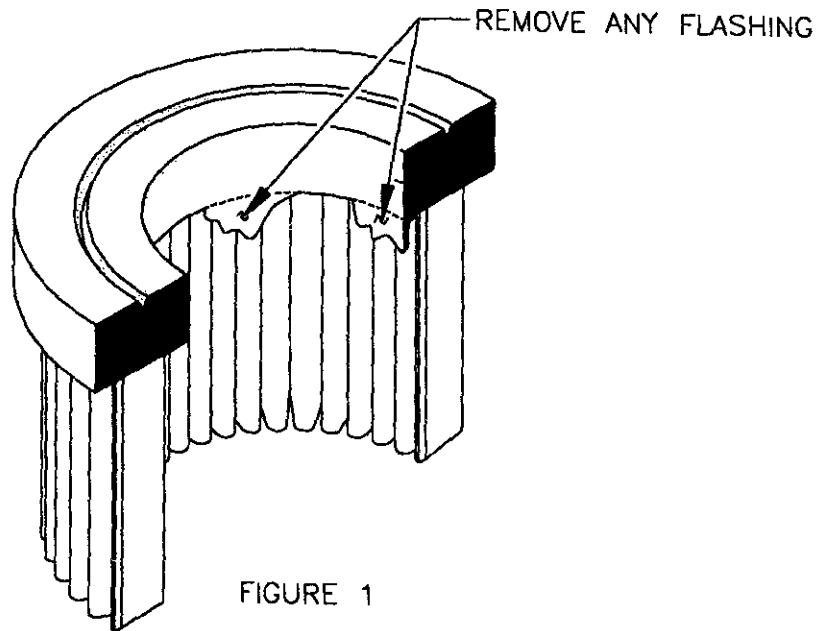
- 1) Remove the affected air filter element from aircraft per the instructions outlined in the appropriate maintenance/service manual provided by the airframe manufacturer.
- 2) Inspect the inner diameter of the black end piece(s) of these elements for flashing (Figure 1). Remove all flashing using a sharp knife. Caution: Do not cut the paper filter portion of the element.

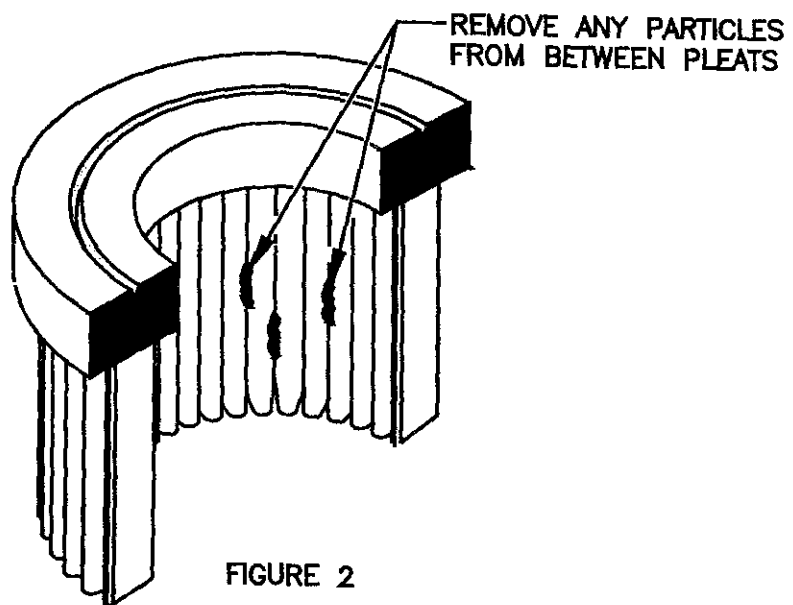
- 3) Tap the element lightly on a clean work surface in order to remove any loose particles from between the pleat tips on the inside of the paper filter (Figure 2).

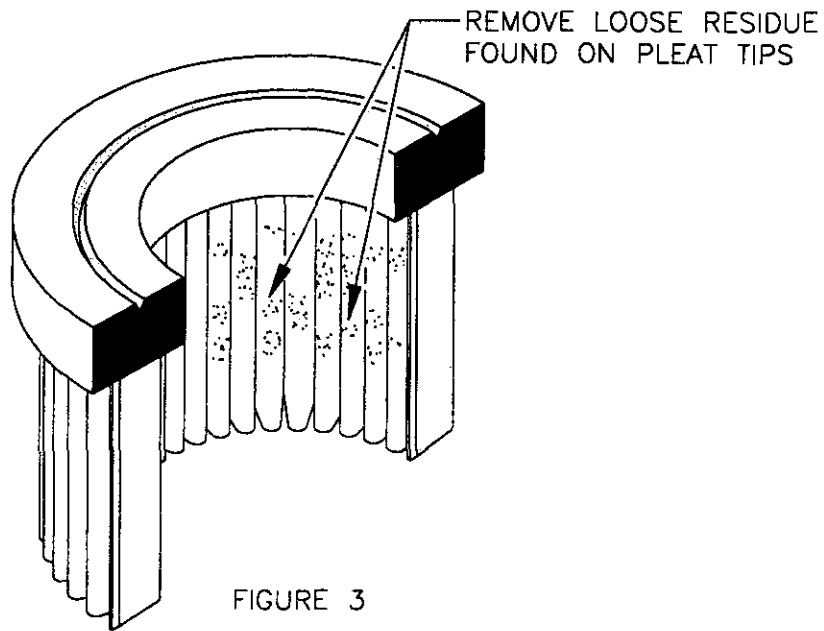
- 4) Inspect the inner diameter (pleat tips) of the paper filter for black residue (Figure 3). Remove all loose residue using the "sticky side" of a strip of masking tape attached to the end of a blunt instrument.

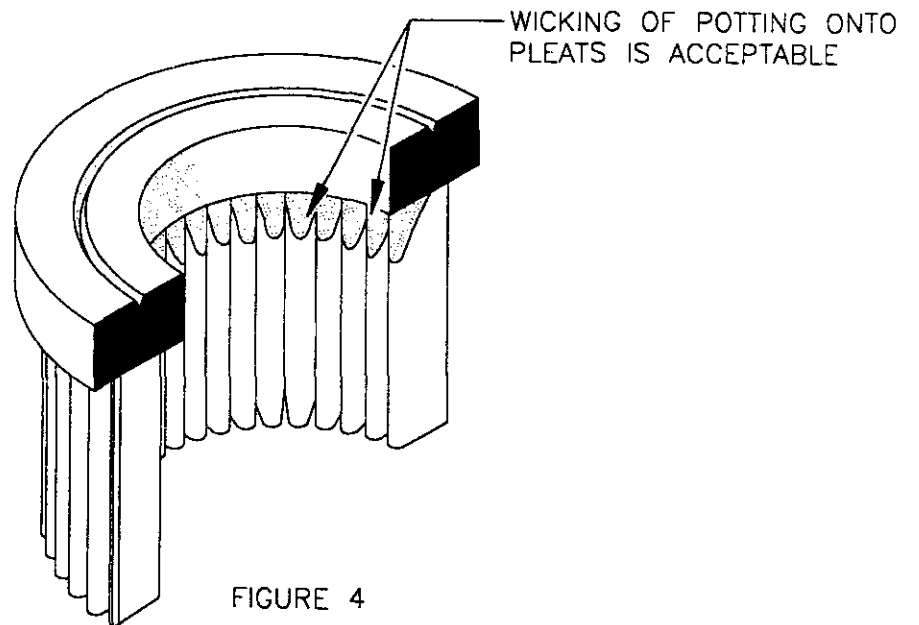
- 6) Thoroughly inspect all internal surfaces of the element for any loose particles. Remove any remaining loose particles using any combination of the above steps. Note: The wicking of black potting material onto pleats of paper filter is acceptable (Figure 4).
